# Investigation of March 15, 2018 Pedestrian Bridge Collapse at Florida International University, Miami, FL

U.S Department of Labor  
Occupational Safety and Health Administration  
Directorate of Construction

July 2019

**Report prepared by**  
**Mohammad Ayub, PE, SE**  
Director, Office of Engineering Services  
Directorate of Construction  
OSHA National Office  
Washington, D.C.

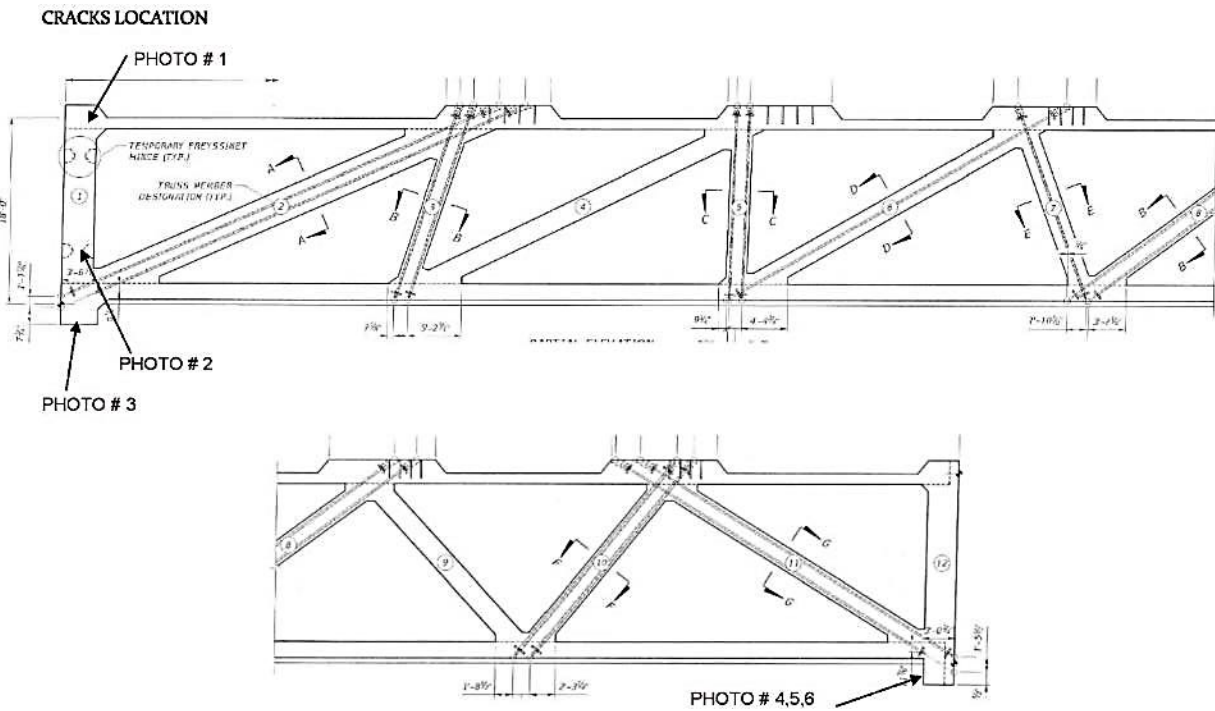
Figure 21 Location of cracks in 2/28/2018 E-mail from MCM to FIGG as per BPA

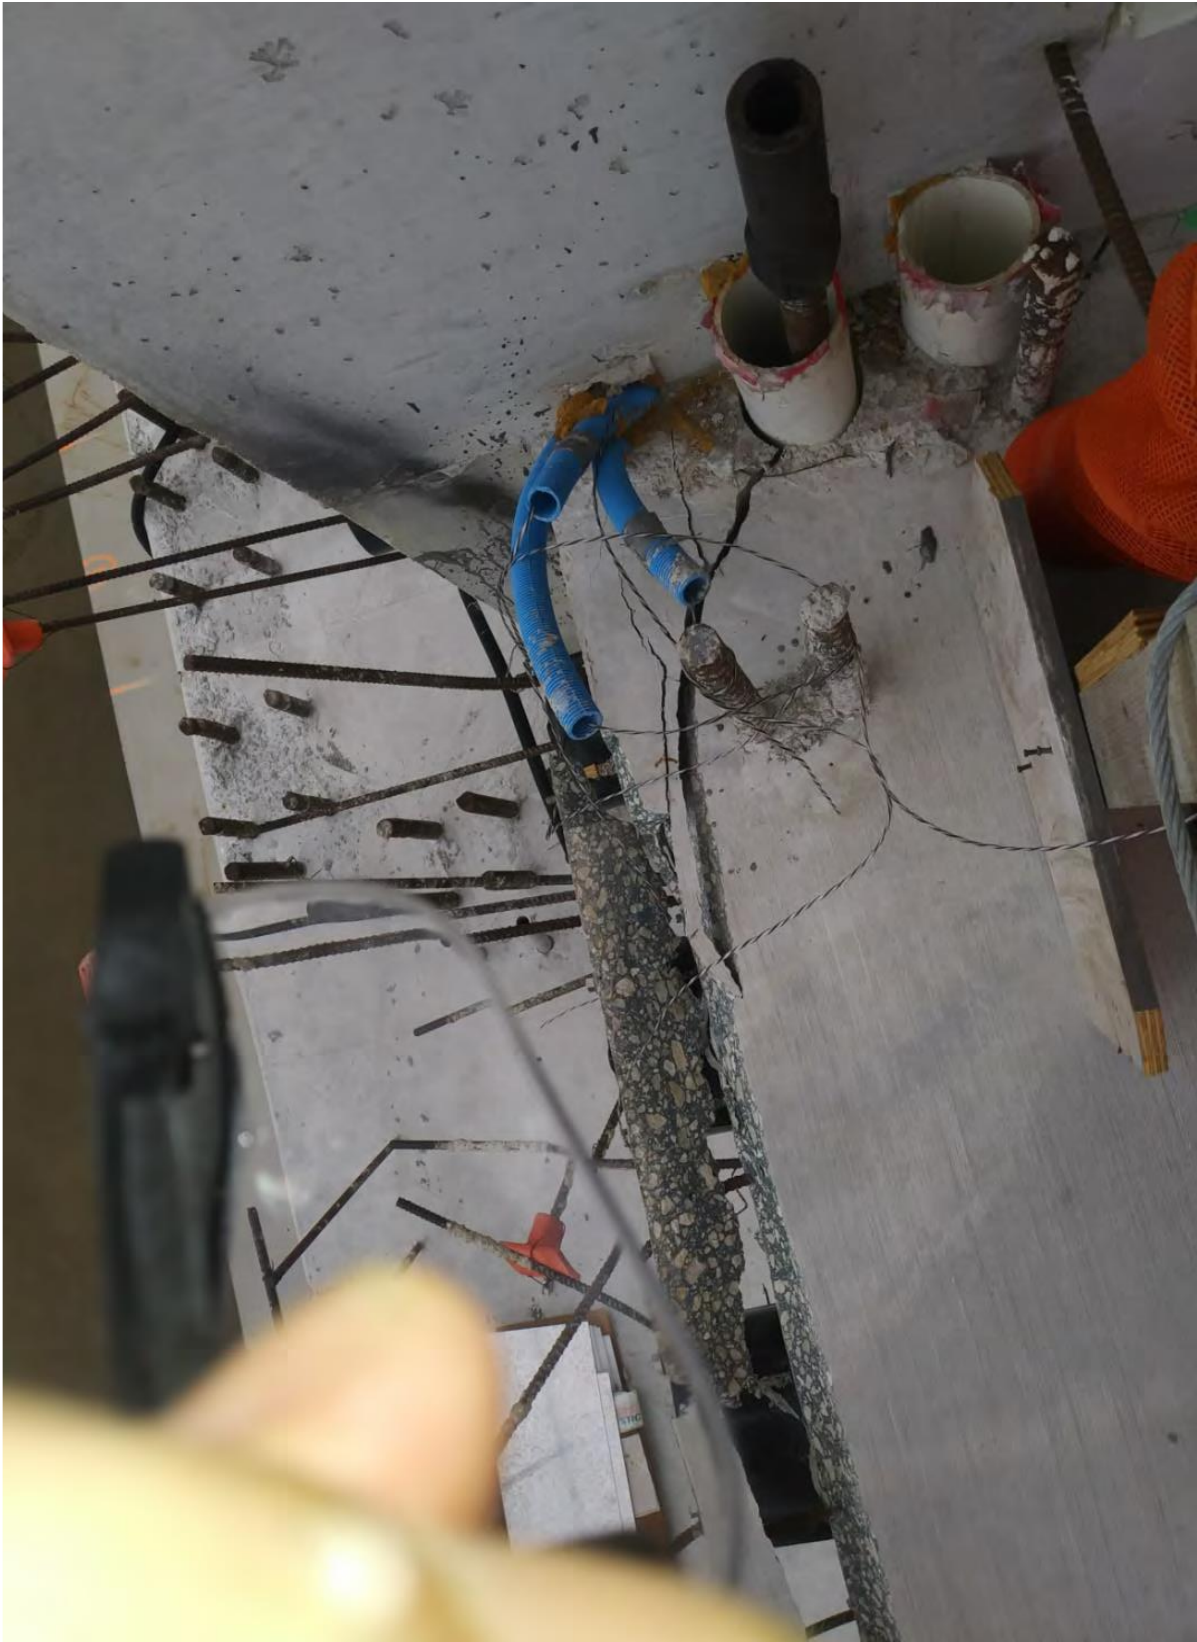
Figure 24 Cracks at the west side diaphragm II MCM email of 3/12/2018 – top face, by BPA.

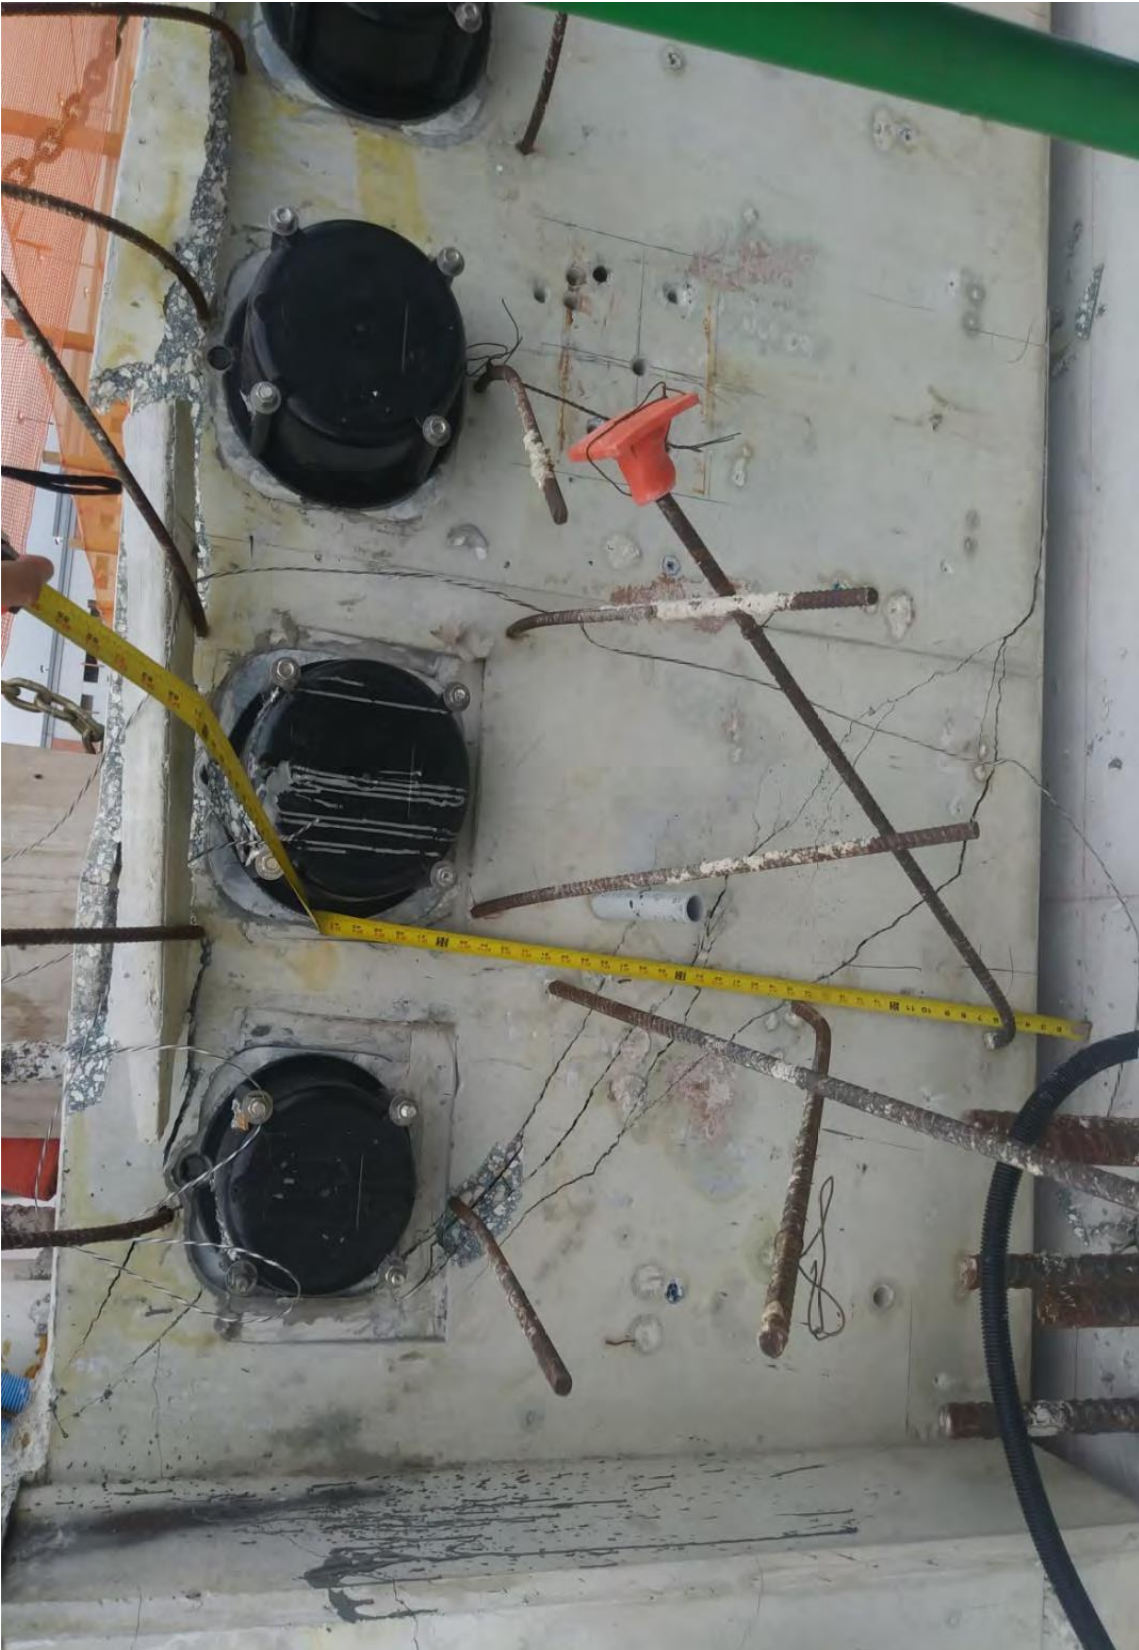
Figure 25 Cracks at the west side diaphragm II MCM email of 3/12/2018, by BPA – side face

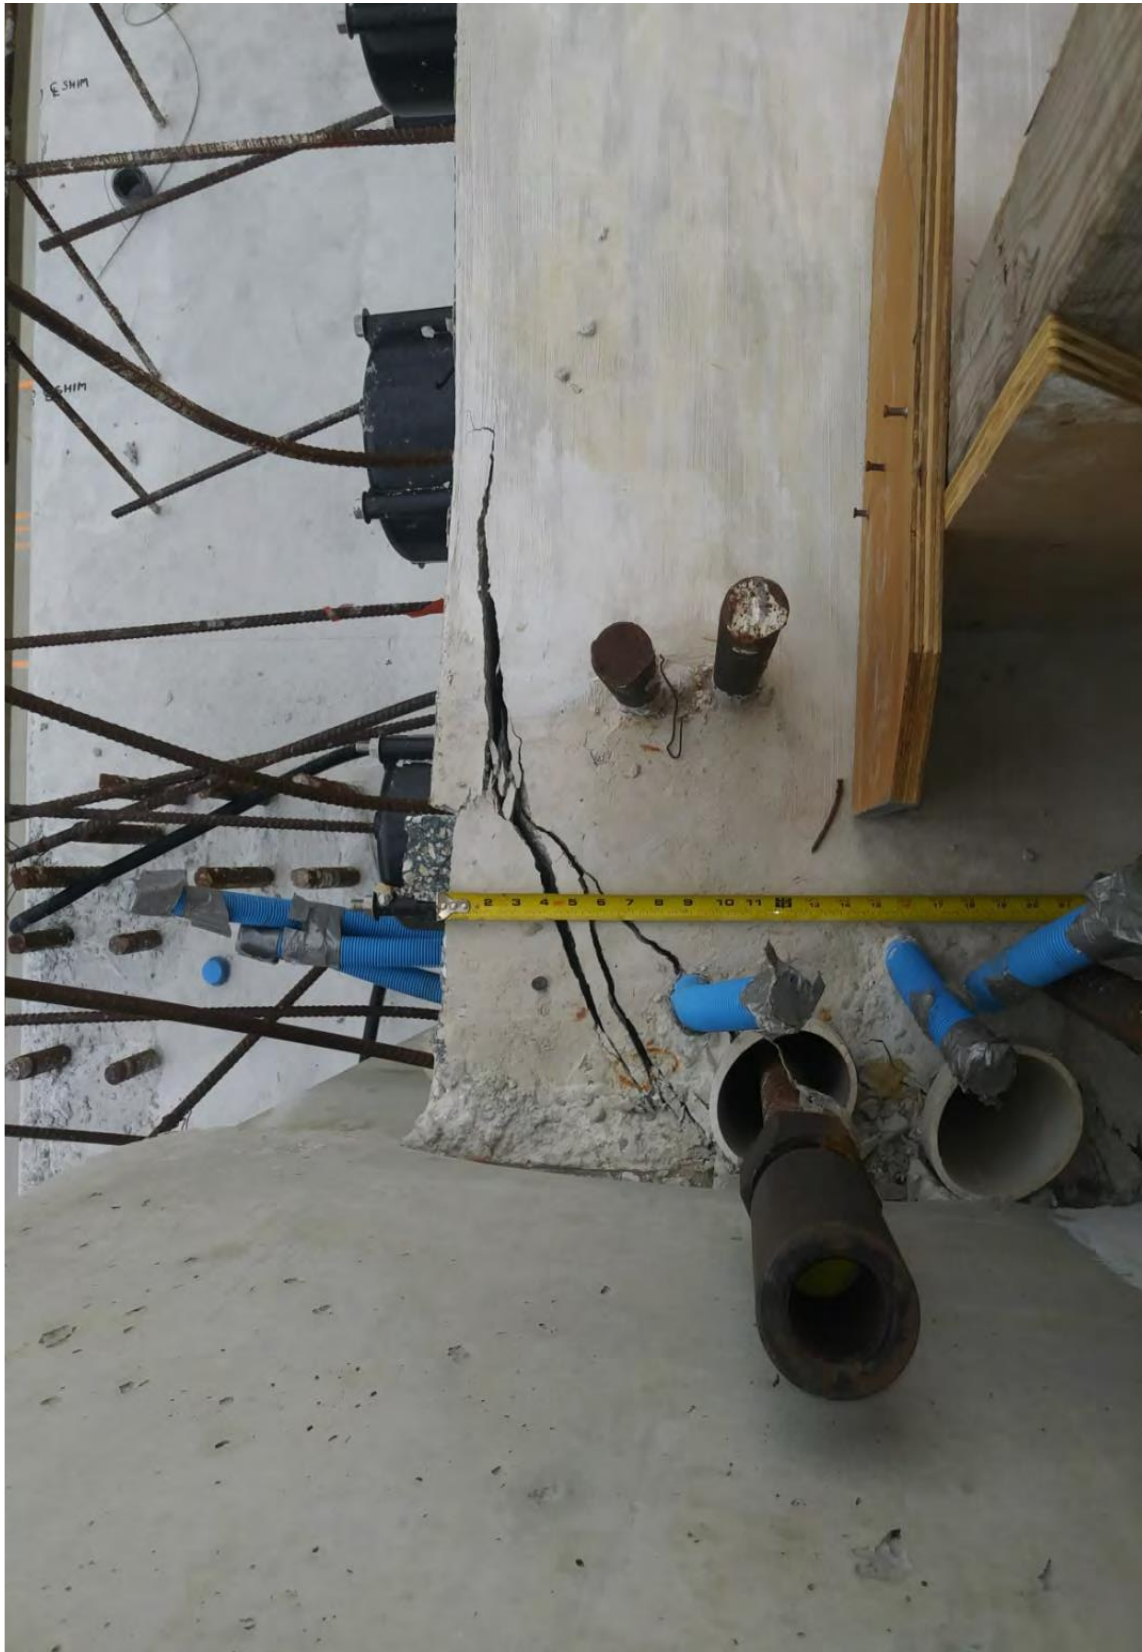
Figure 26 Cracks at the east side diaphragm II MCM email of 3/12/2018, by BPA – top face

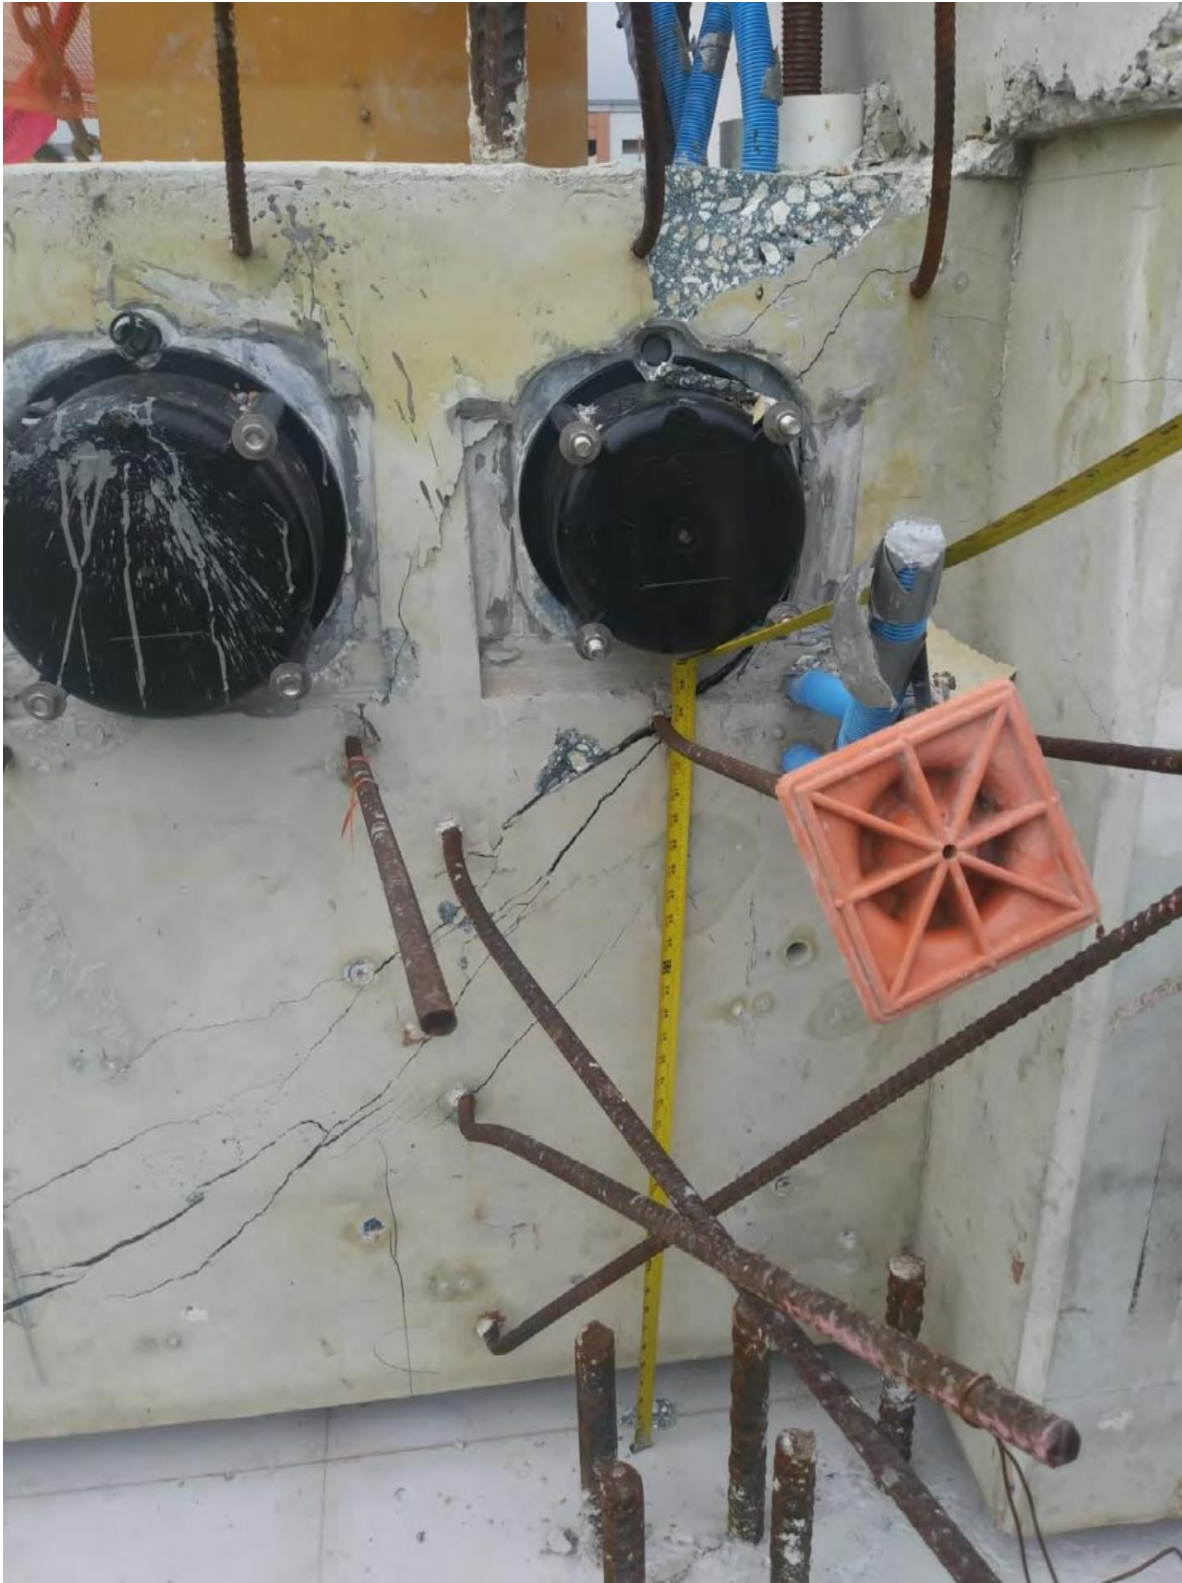
Figure 27 Cracks on the east side diaphragm II MCM email of 3/12/2018, by BPA – side face

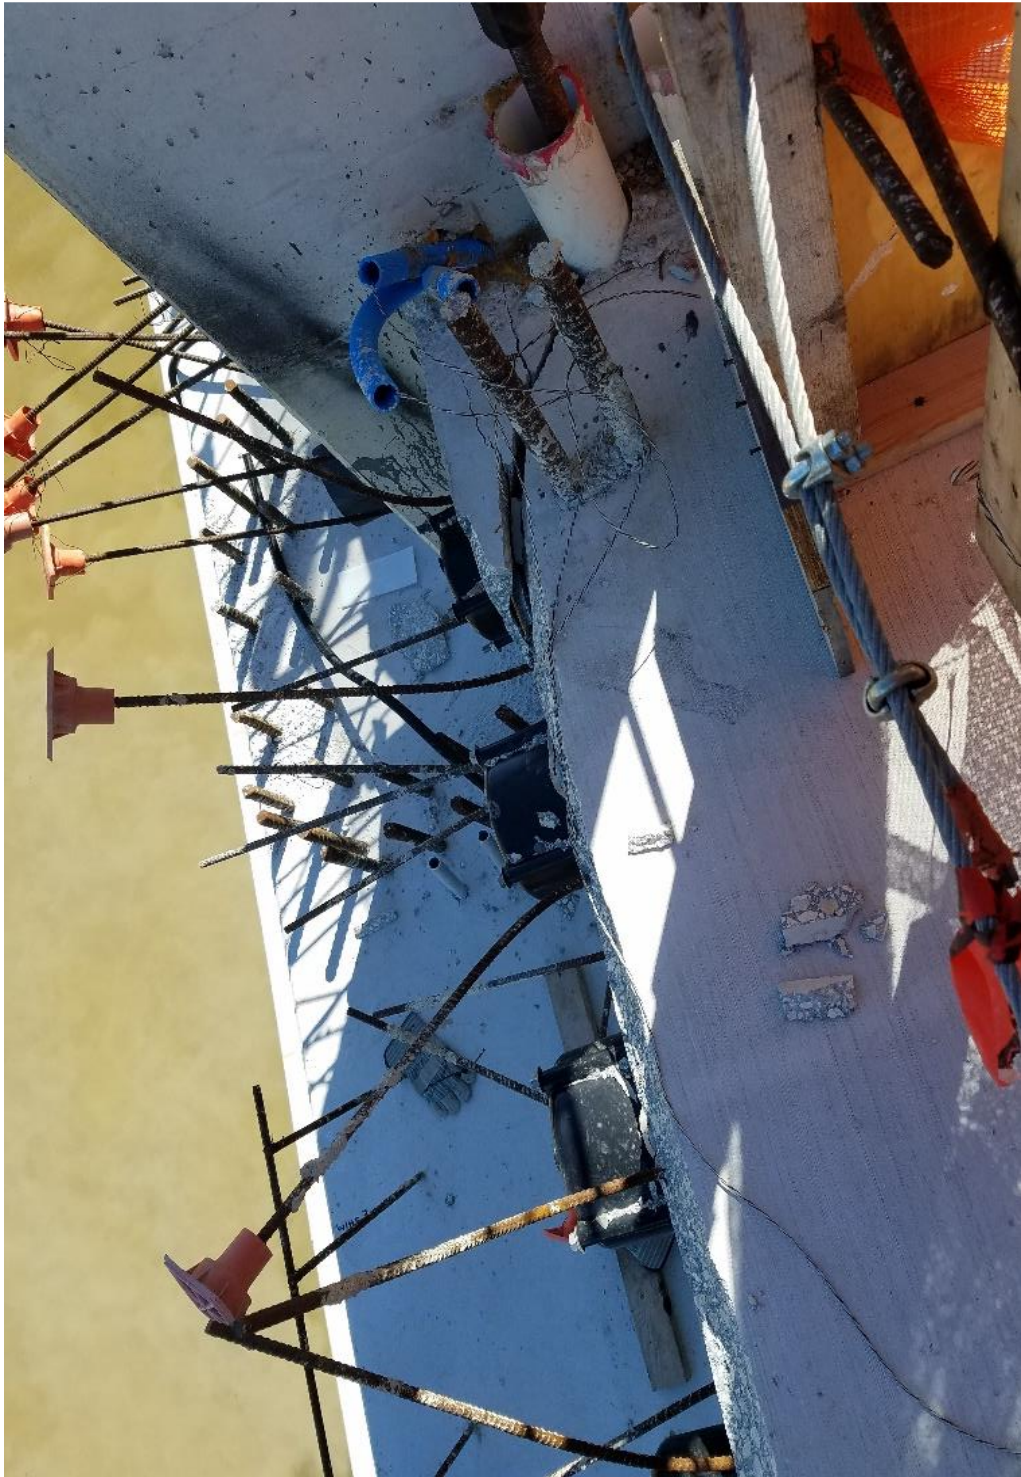
Figure 28 Diagonal cracks on the west side of diaphragm II on 3/13/2018, by BPA – top face

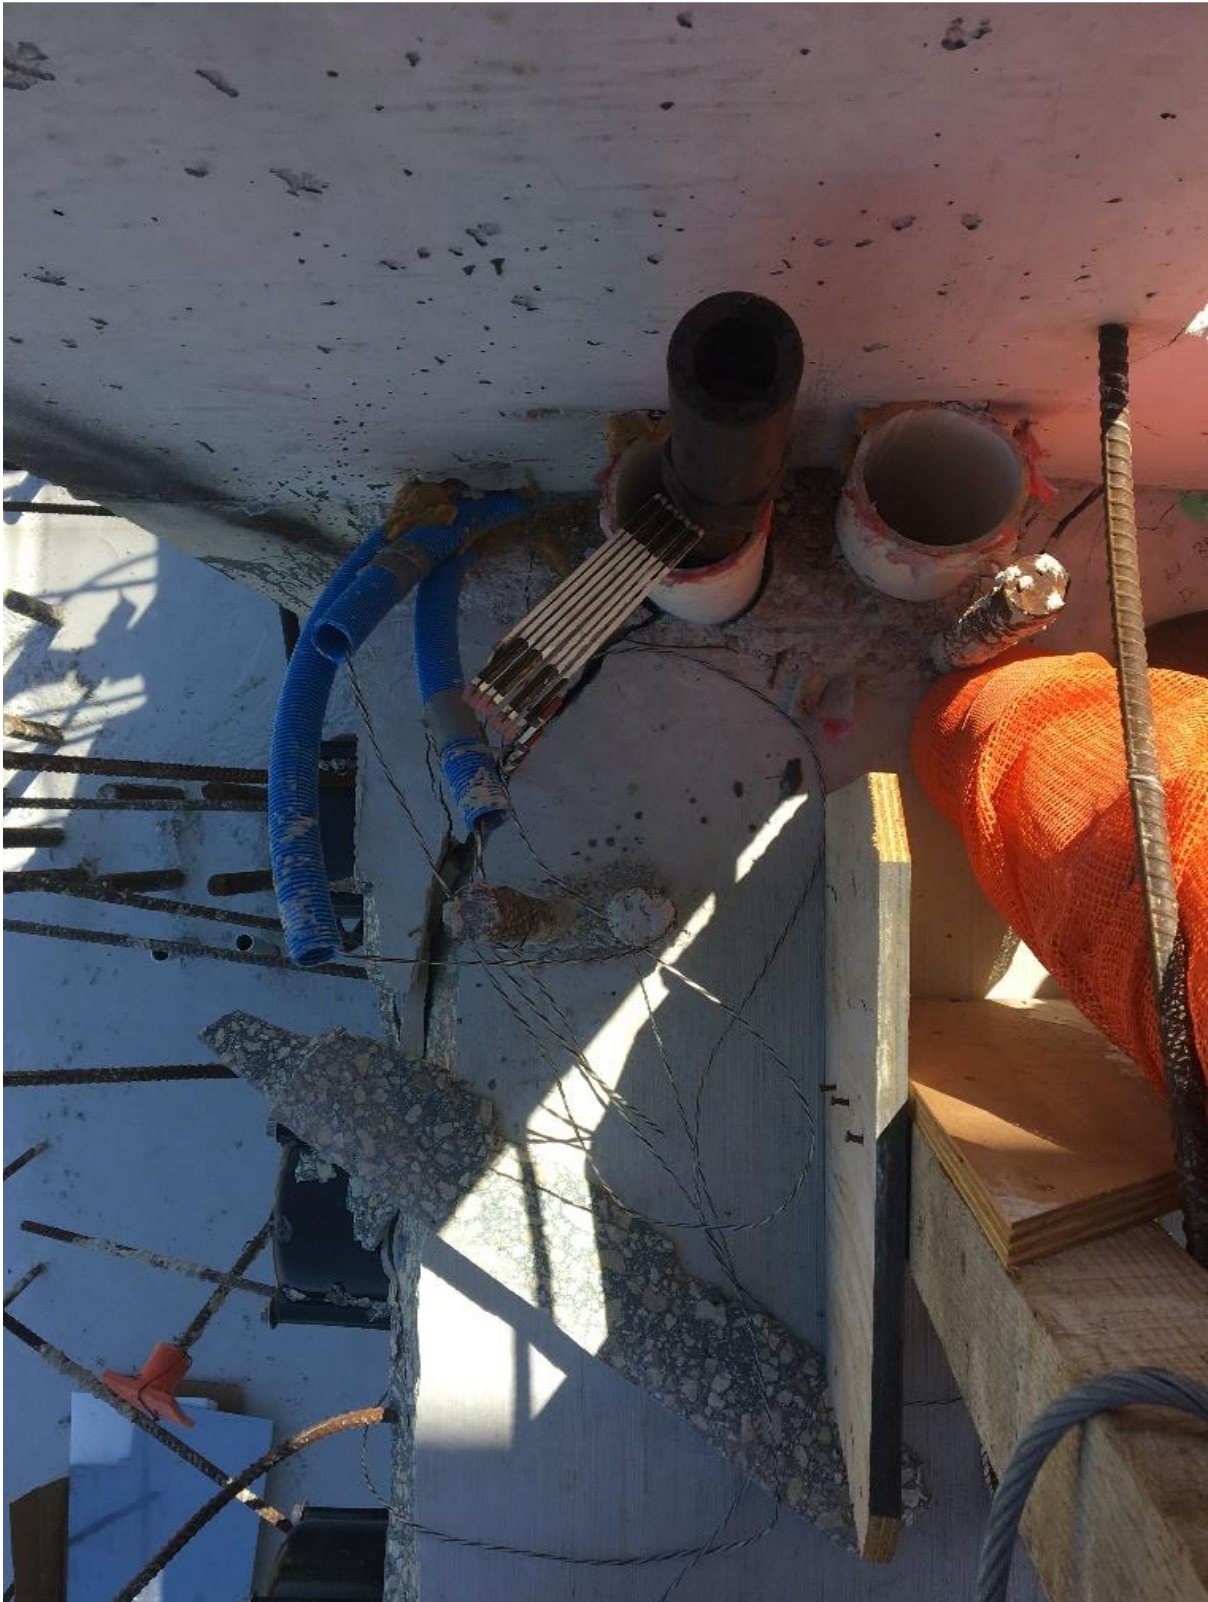
Figure 29 Close-up of cracks at the west side of diaphragm II on 3/13/2018, by BPA

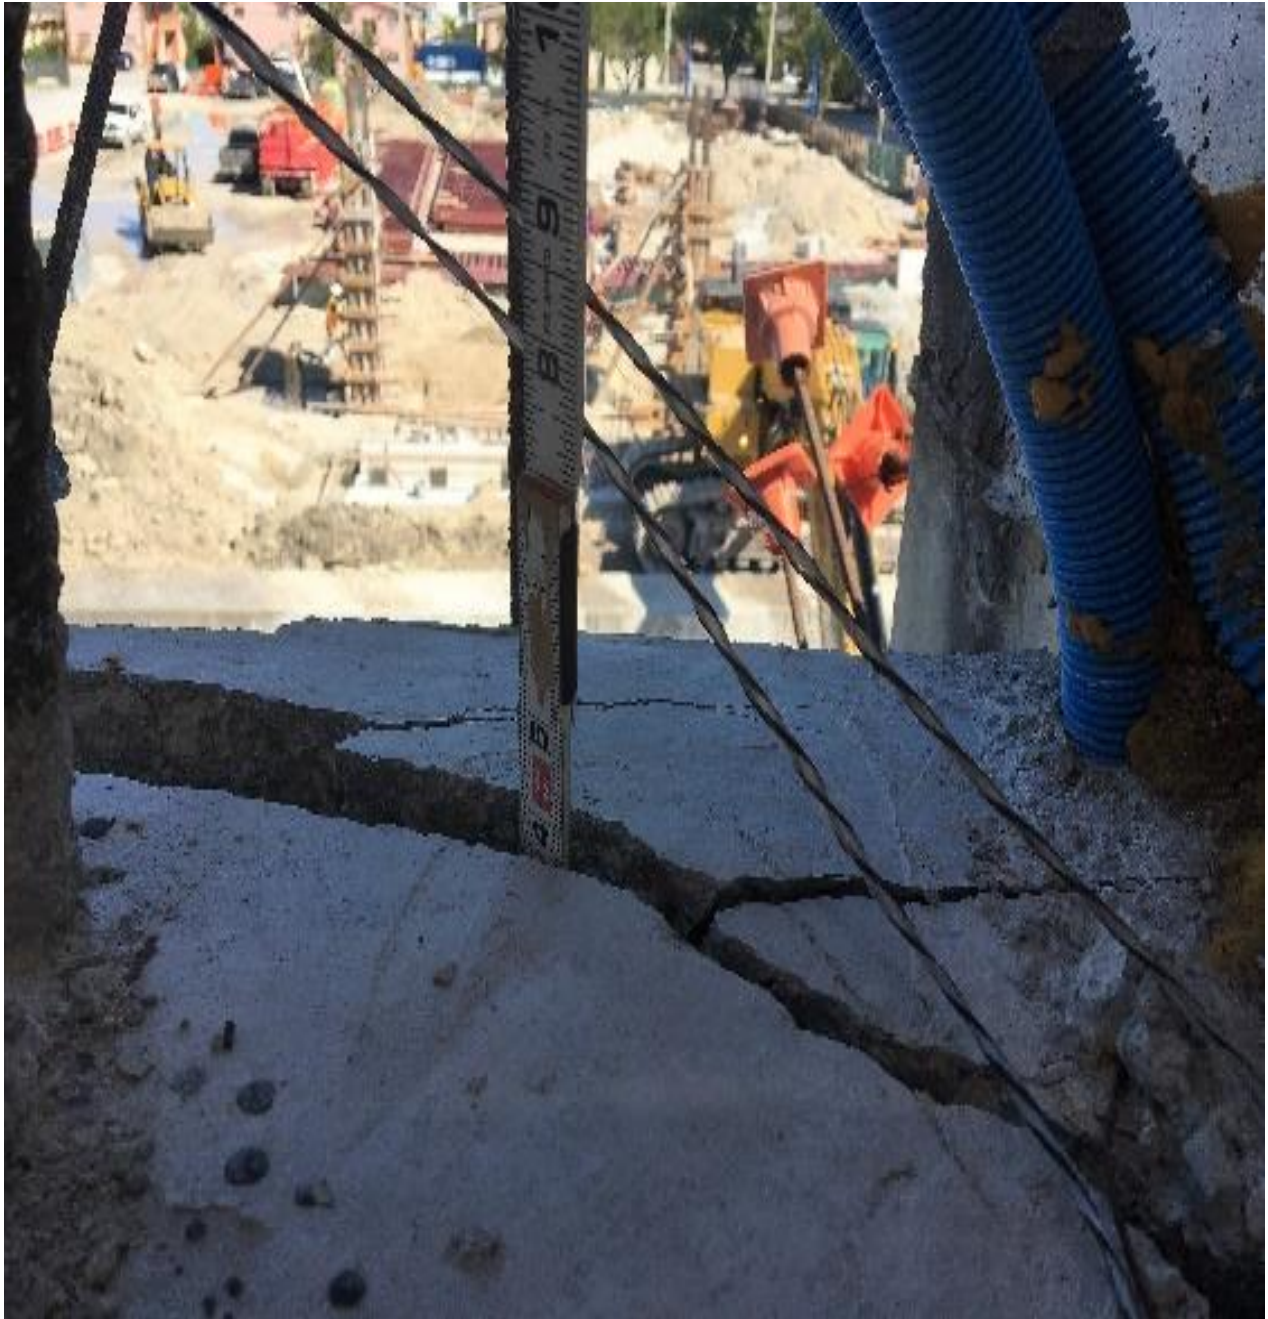
Figure 30 Notice the depth and width of diagonal cracks at the west side of diaphragm II on  
3/14/2018 by BPA

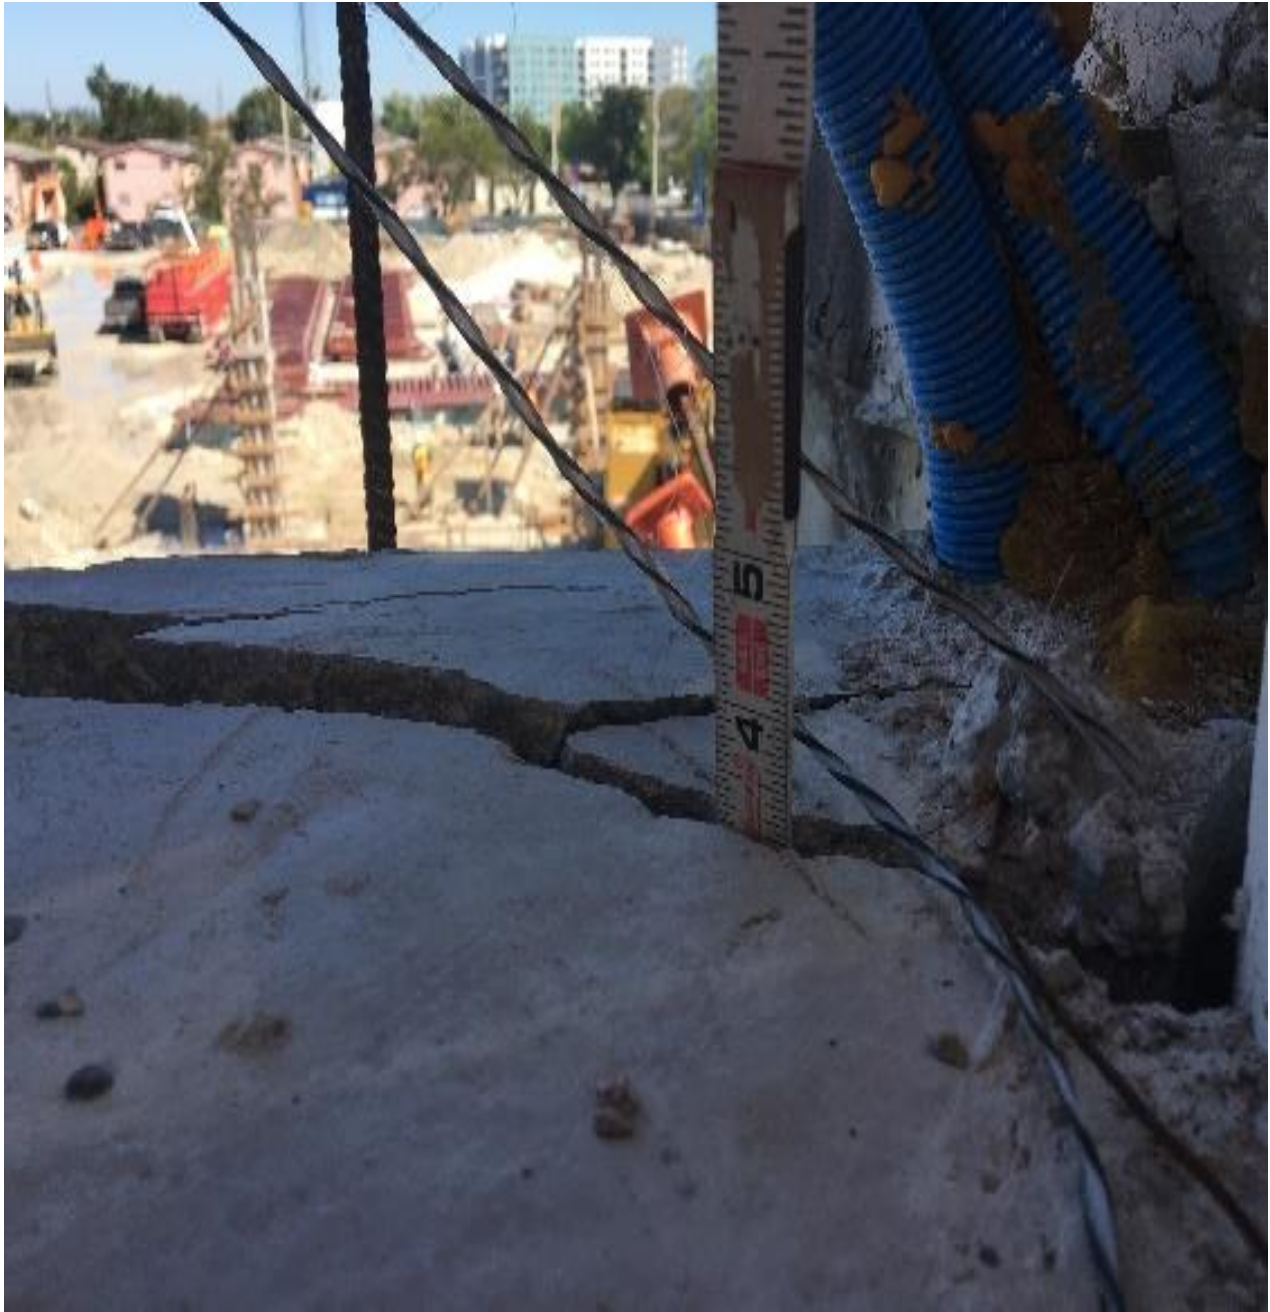
Figure 31 Notice the depth and width of cracks near column 12 at the west side of diaphragm II  
on 3/14/2018 by BPA

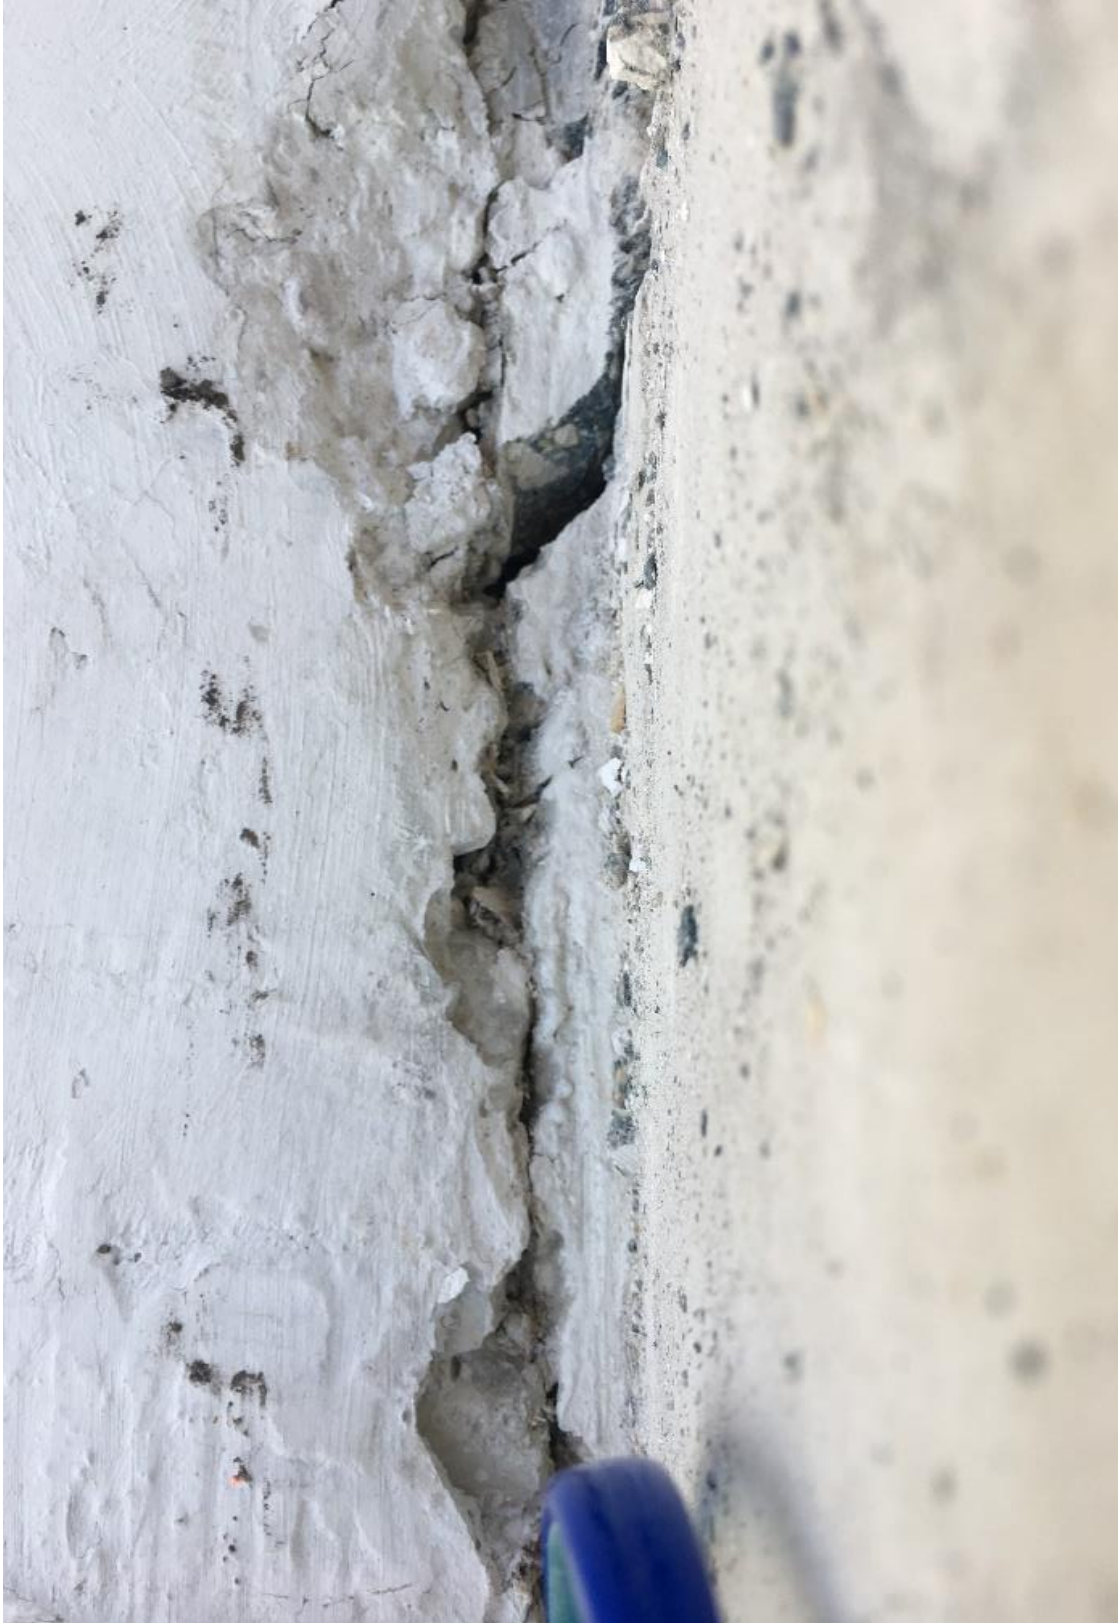
Figure 32 Cracks at the construction joint of the main span deck and diagonal 11 on 3/13/2018 by BPA

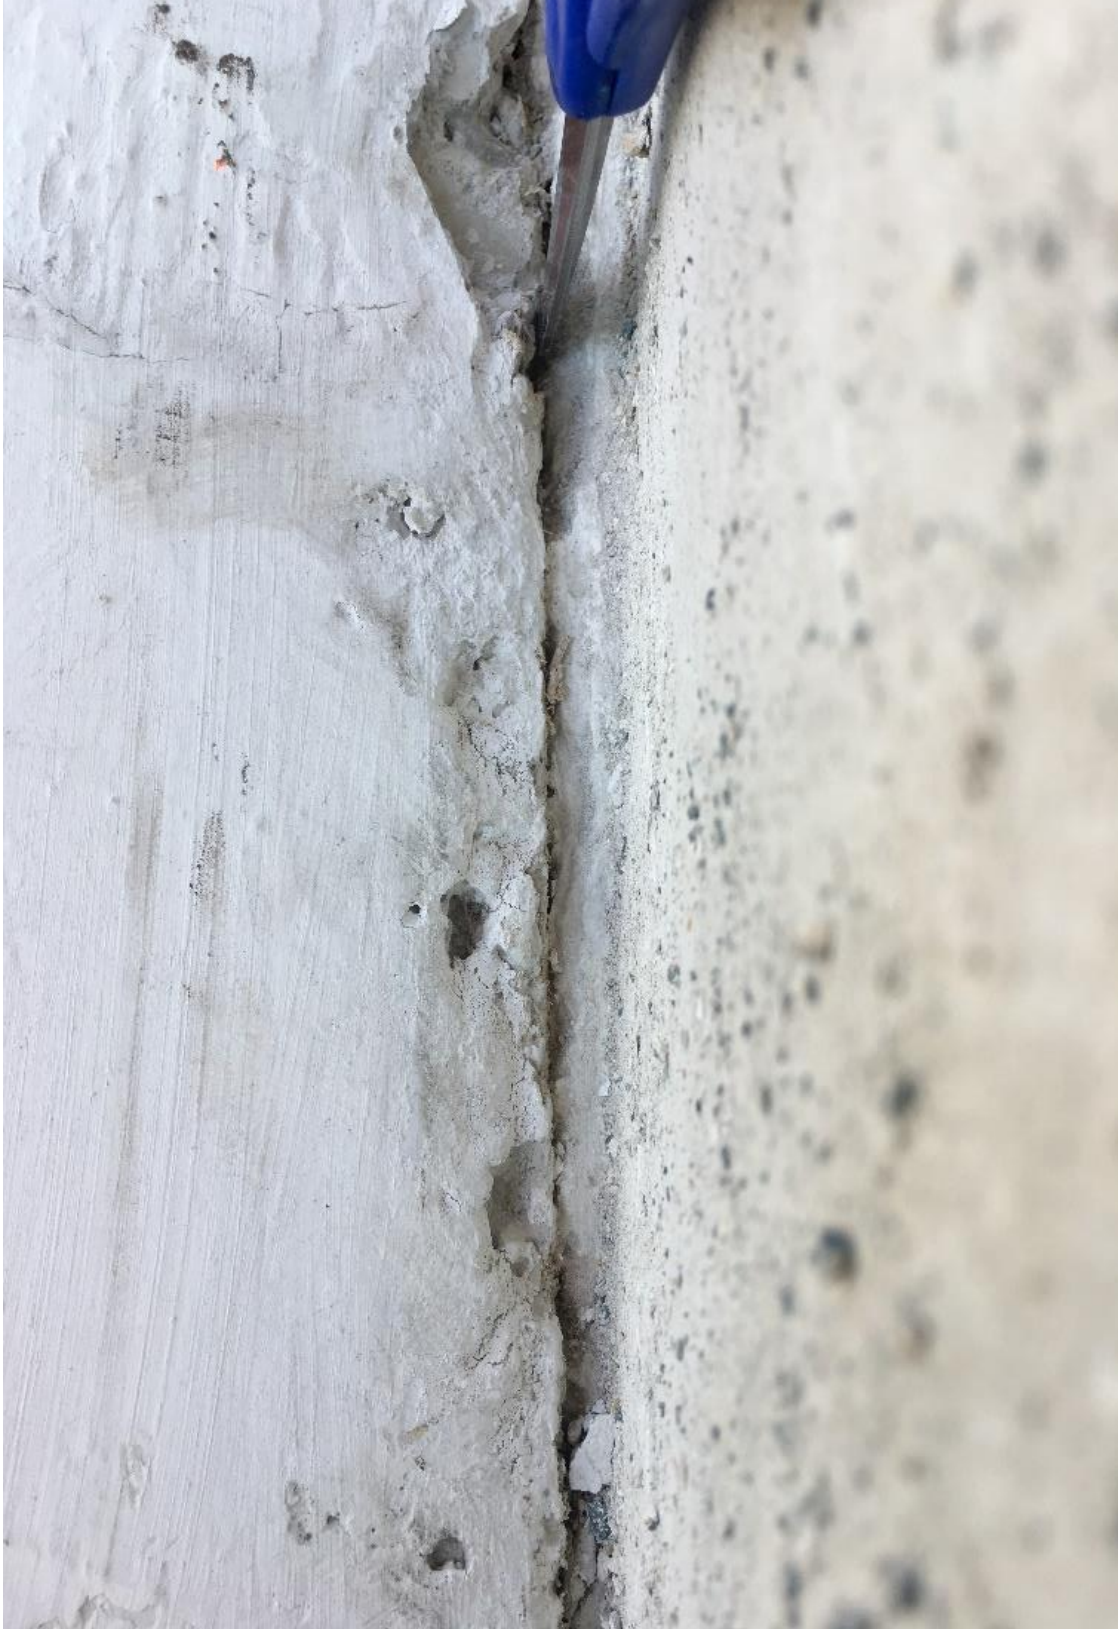
Figure 33 Cracks at the construction joint of the main span deck and diagonal 11 on 3/13/2018 by BPA

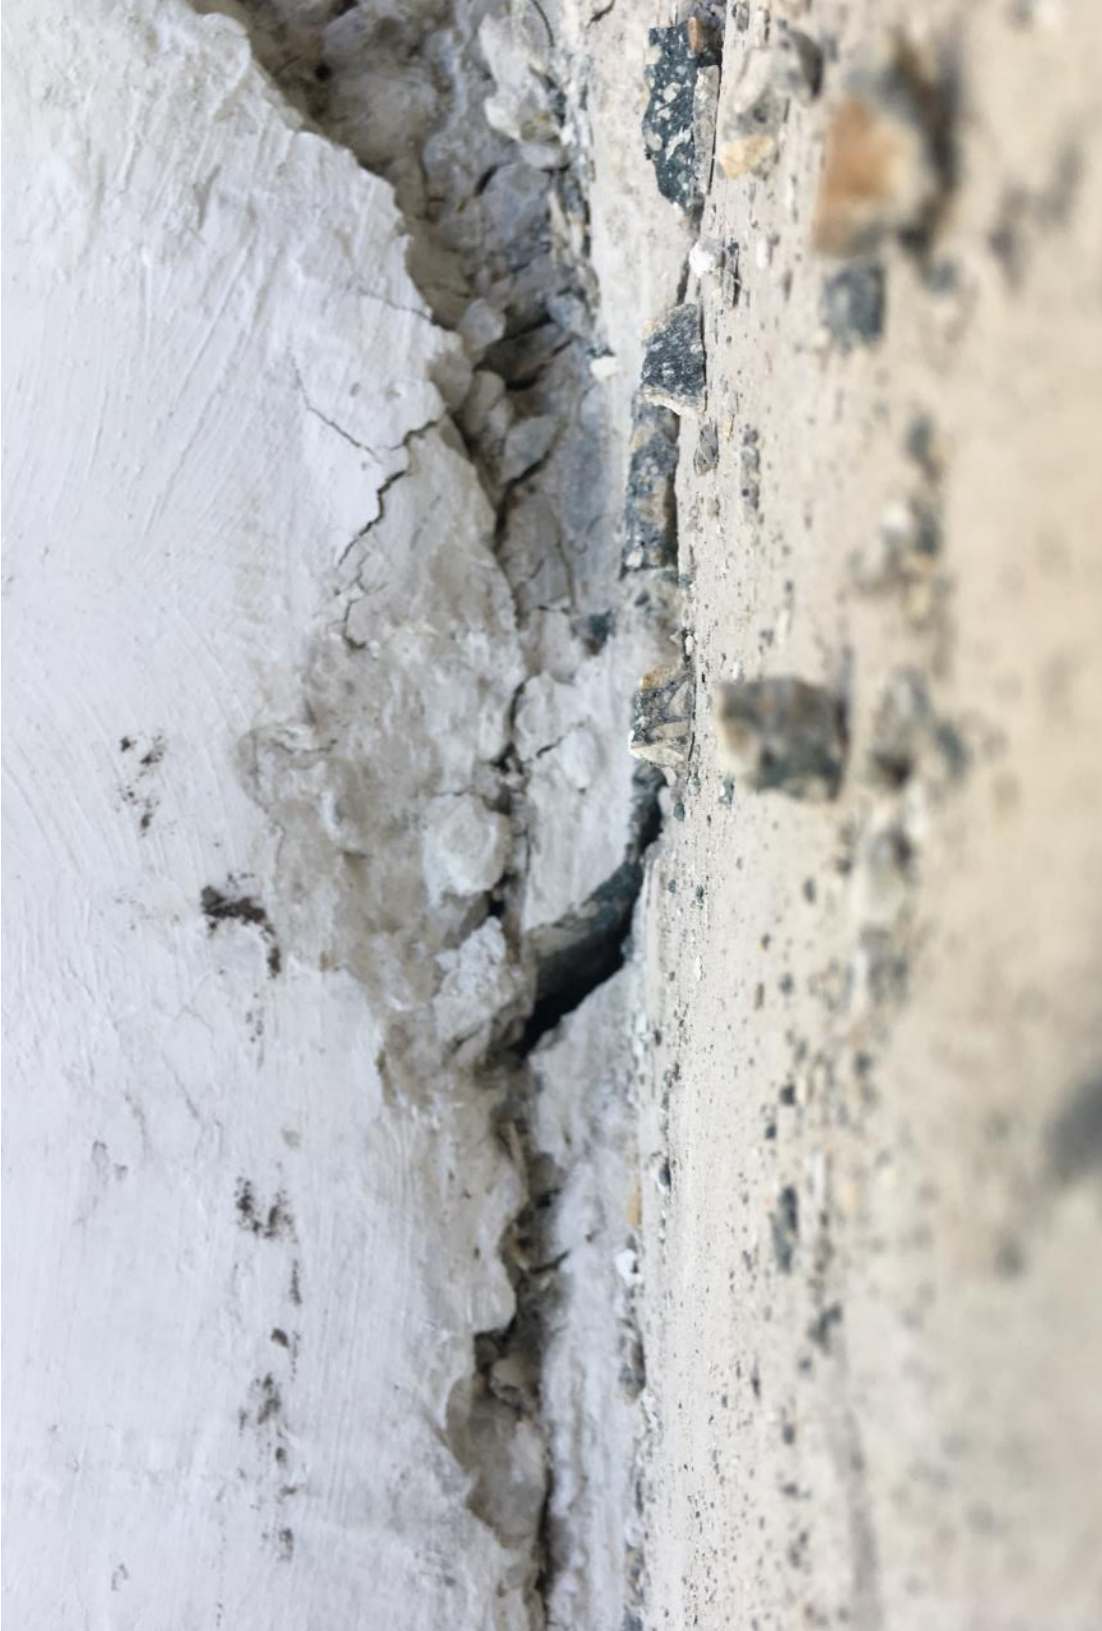
Figure 34 Cracks at the construction joint of the main span deck and diagonal 11 on 3/13/2018 by BPA

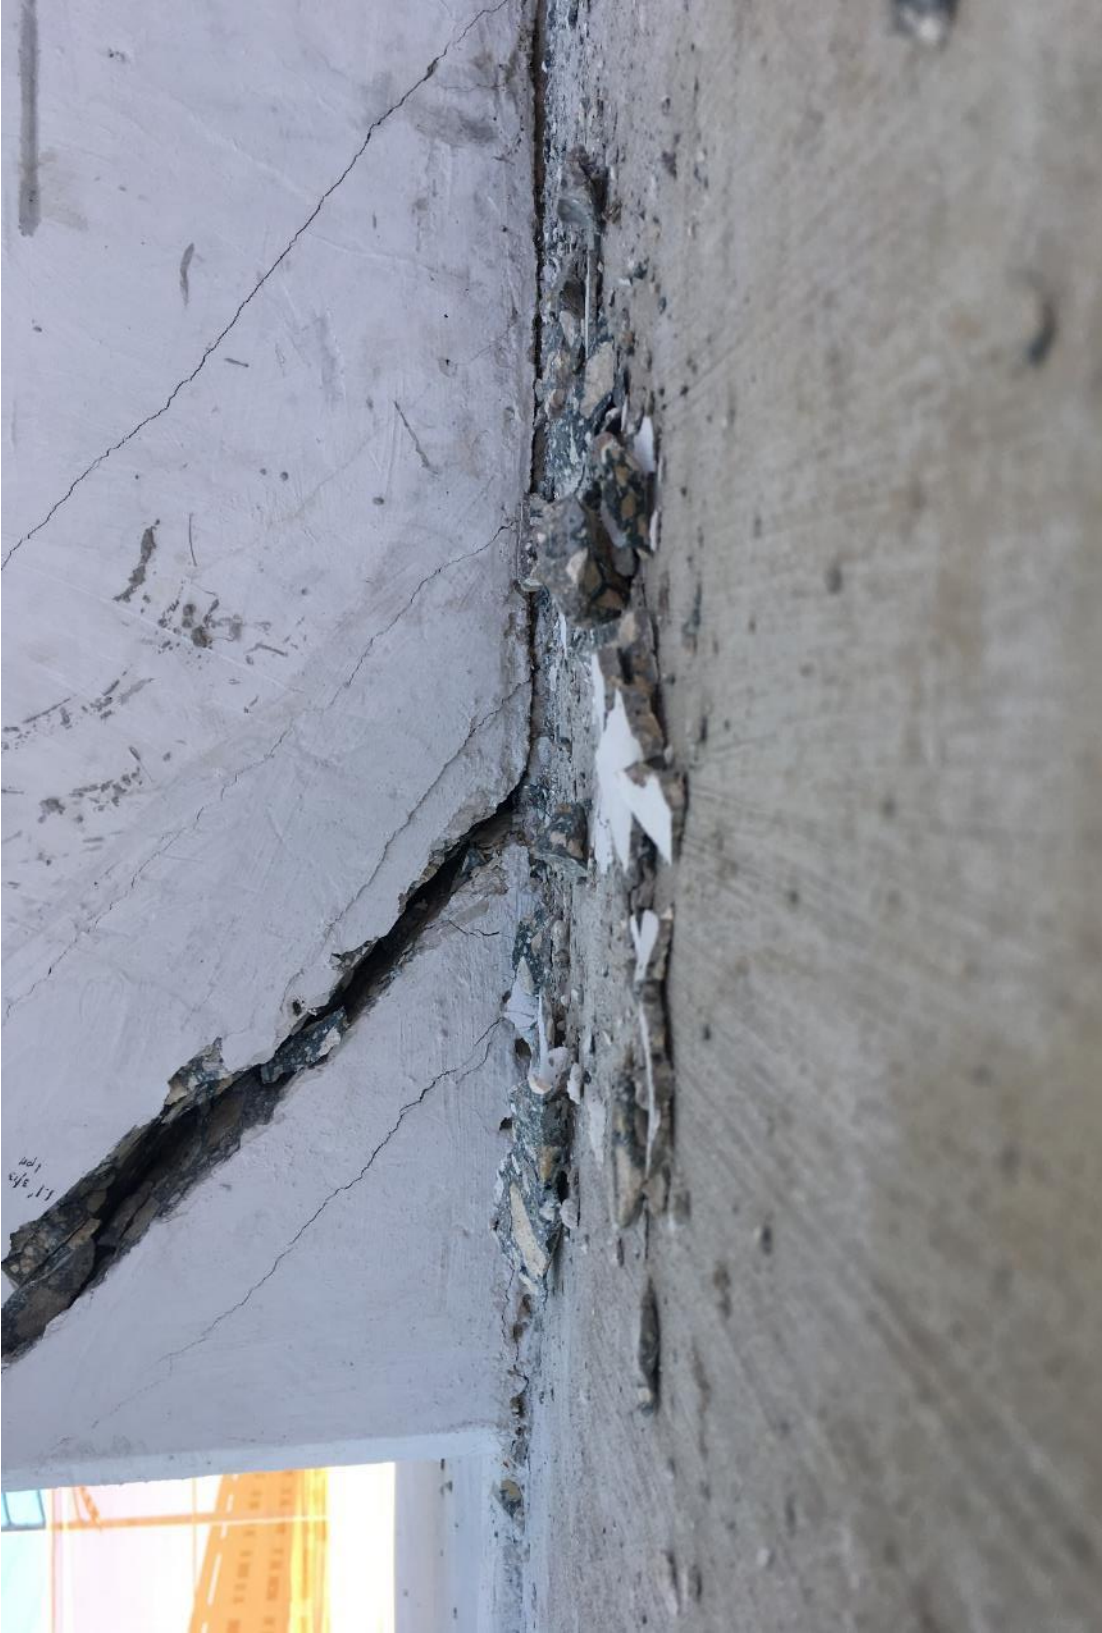
Figure 35 Cracks at the construction joint of the main span deck, diagonal 11 and the chamfer of diagonal 11 on  
3/13/2018 by BPA
