# Investigation of March 15, 2018 Pedestrian Bridge Collapse at Florida International University, Miami, FL

U.S Department of Labor  
Occupational Safety and Health Administration  
Directorate of Construction

July 2019

**Report prepared by**  
**Mohammad Ayub, PE, SE**  
Director, Office of Engineering Services  
Directorate of Construction  
OSHA National Office  
Washington, D.C.

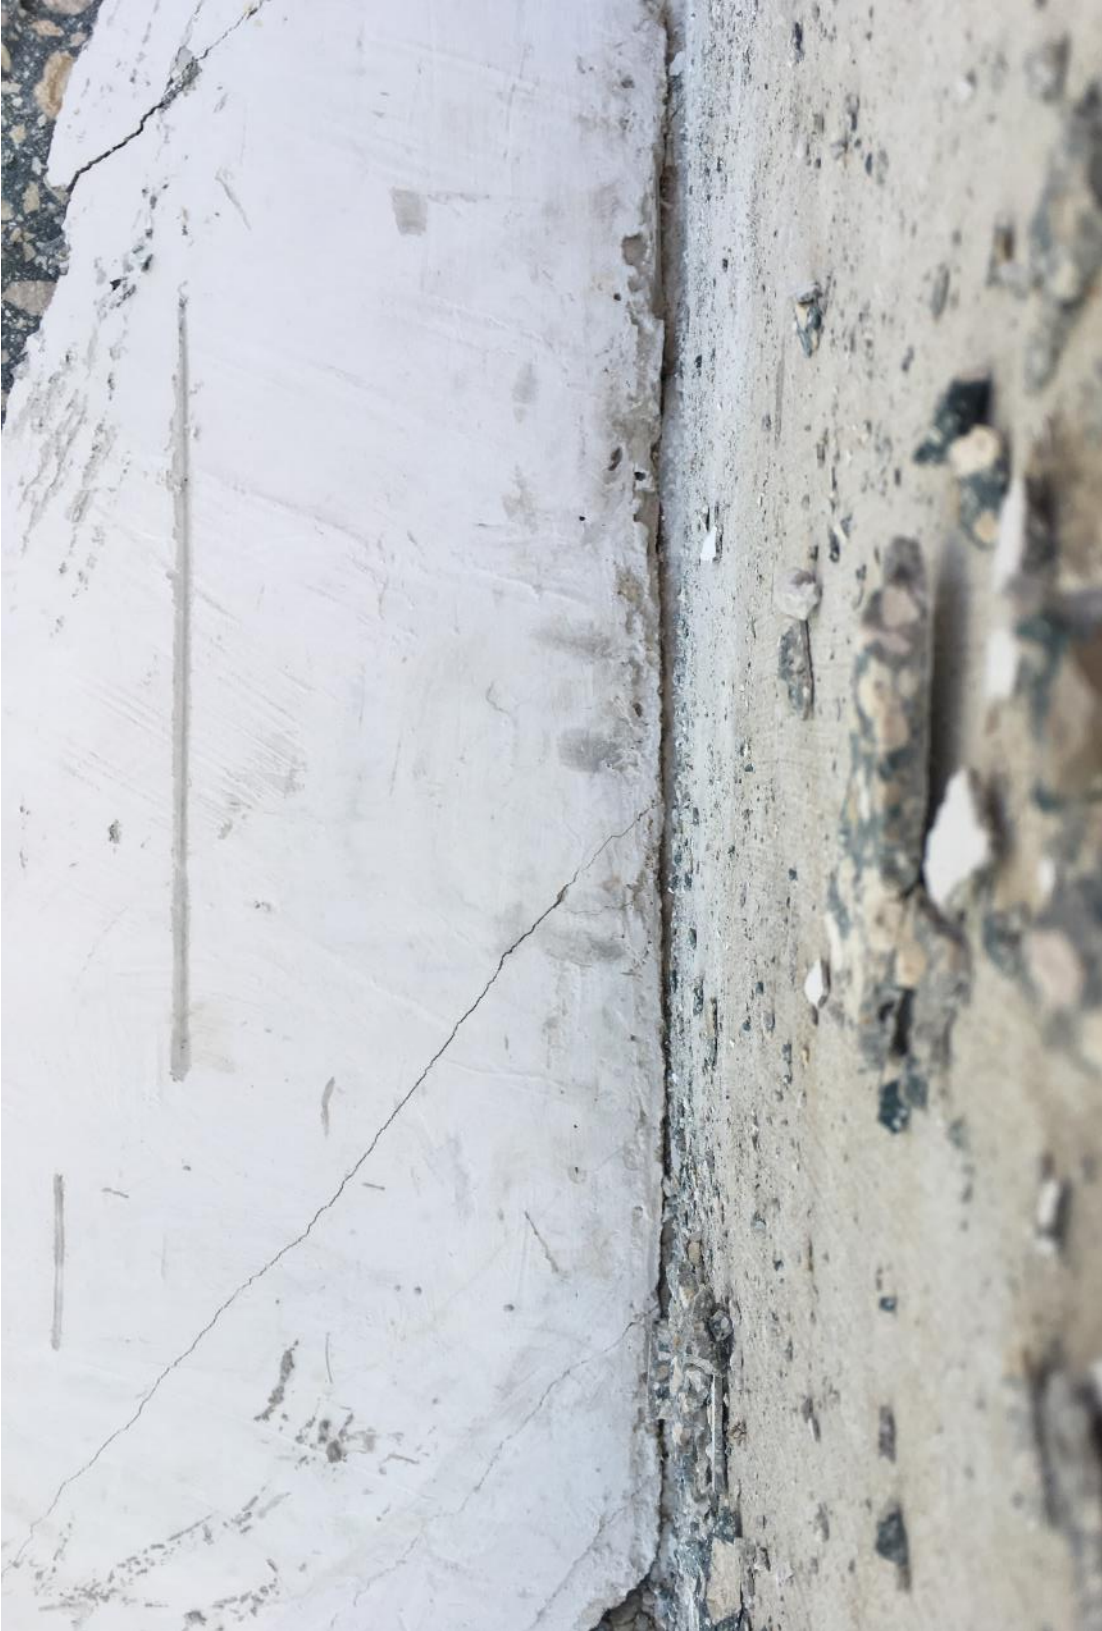
Figure 36 Cracks at the construction joint of the main span deck and diagonal 11 on 3/13/2018 by BPA

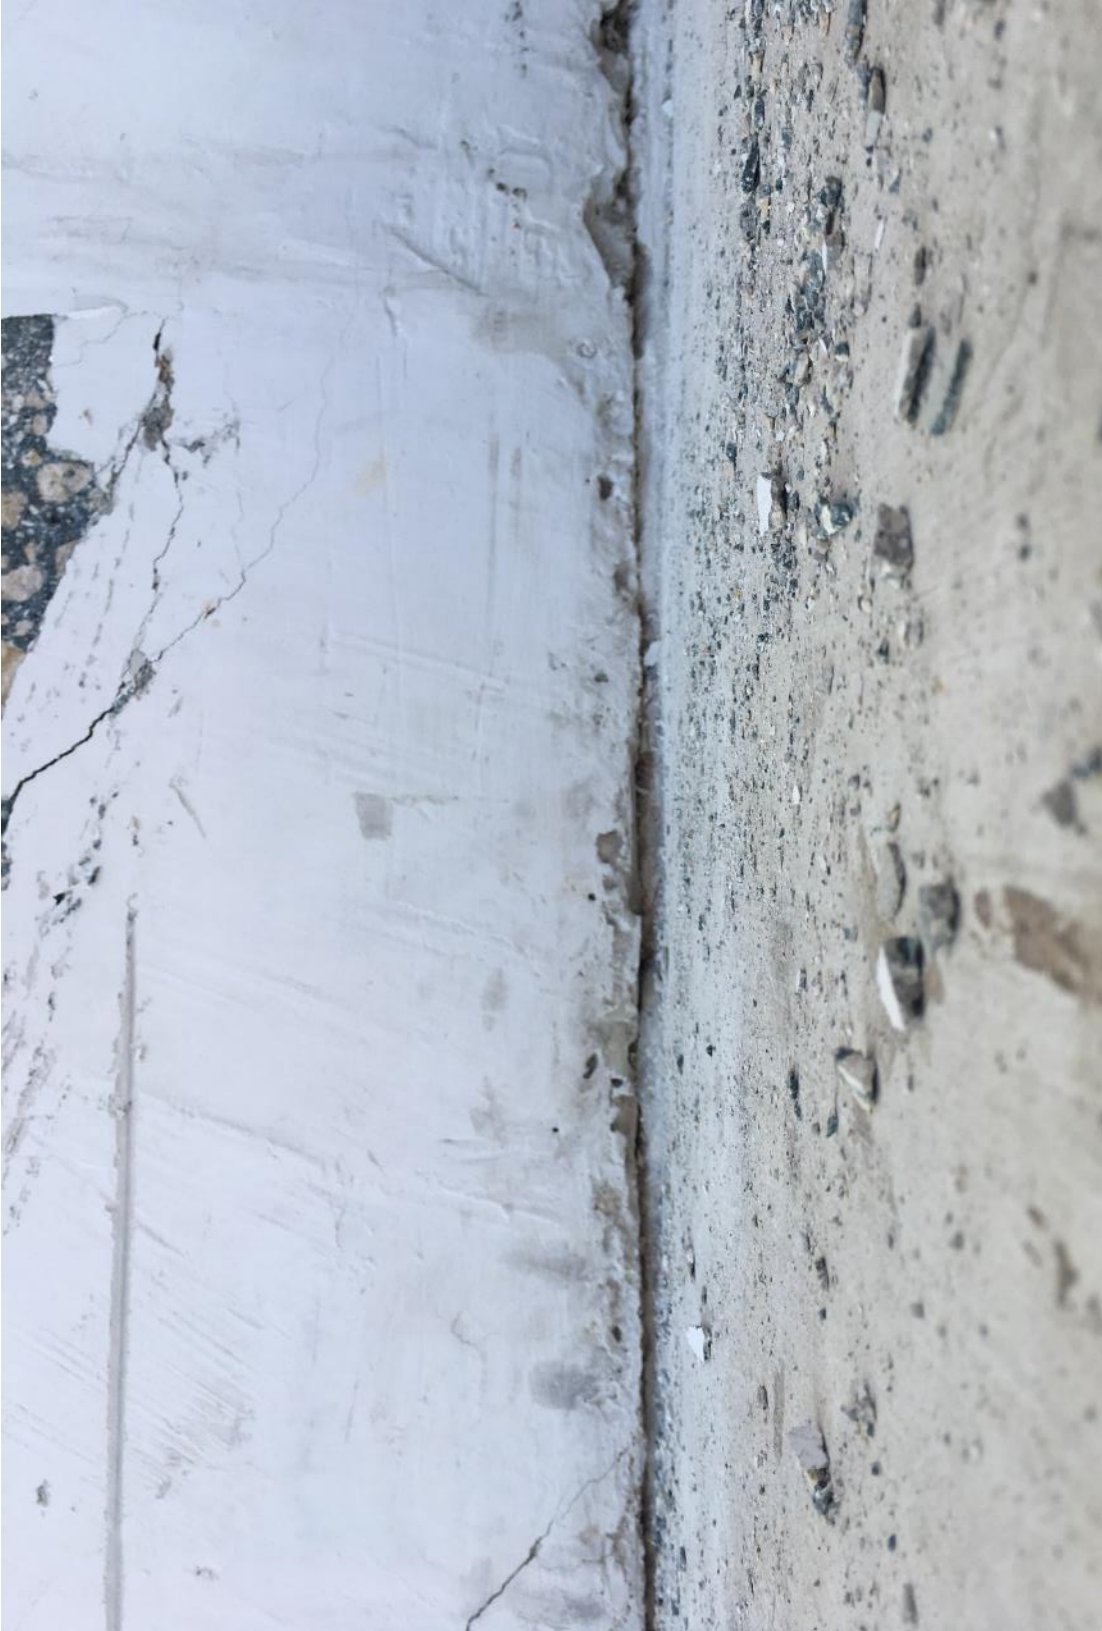
Figure 37 Cracks at the construction joint of the main span deck and diagonal 11 on 3/13/2018 by BPA

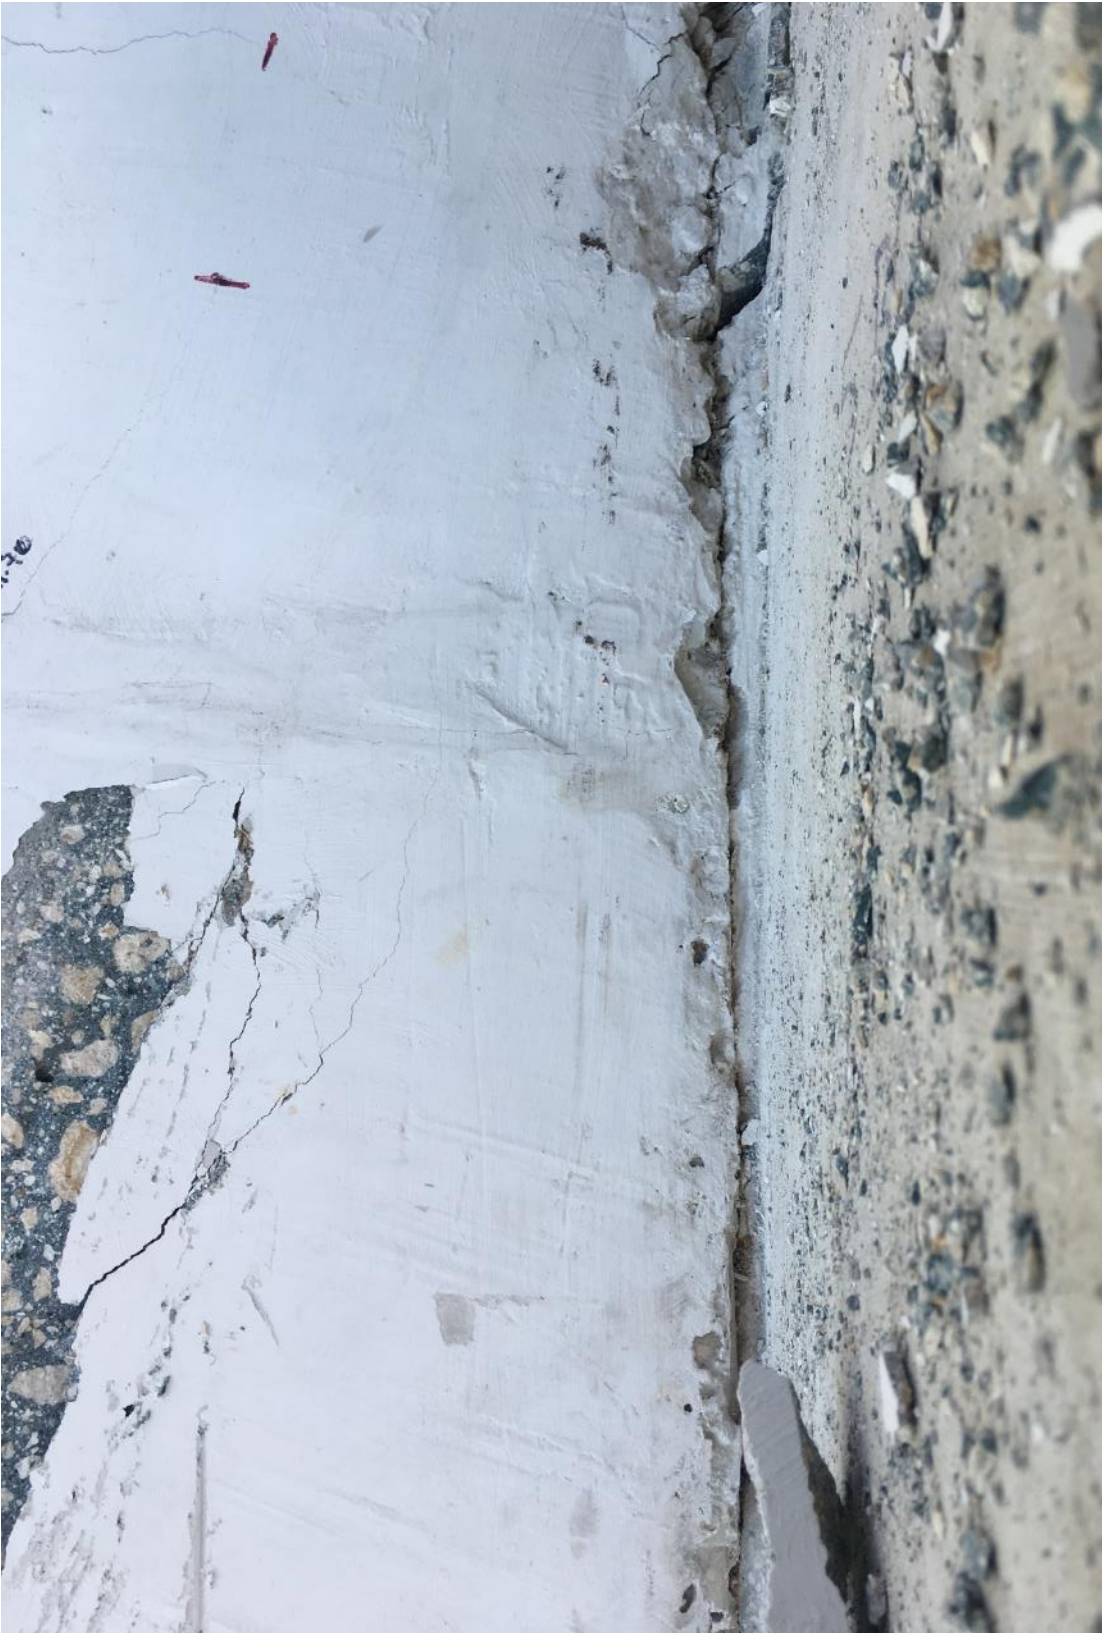
Figure 38 Cracks at the construction joint of the main span deck and diagonal 11 on 3/13/2018 by BPA

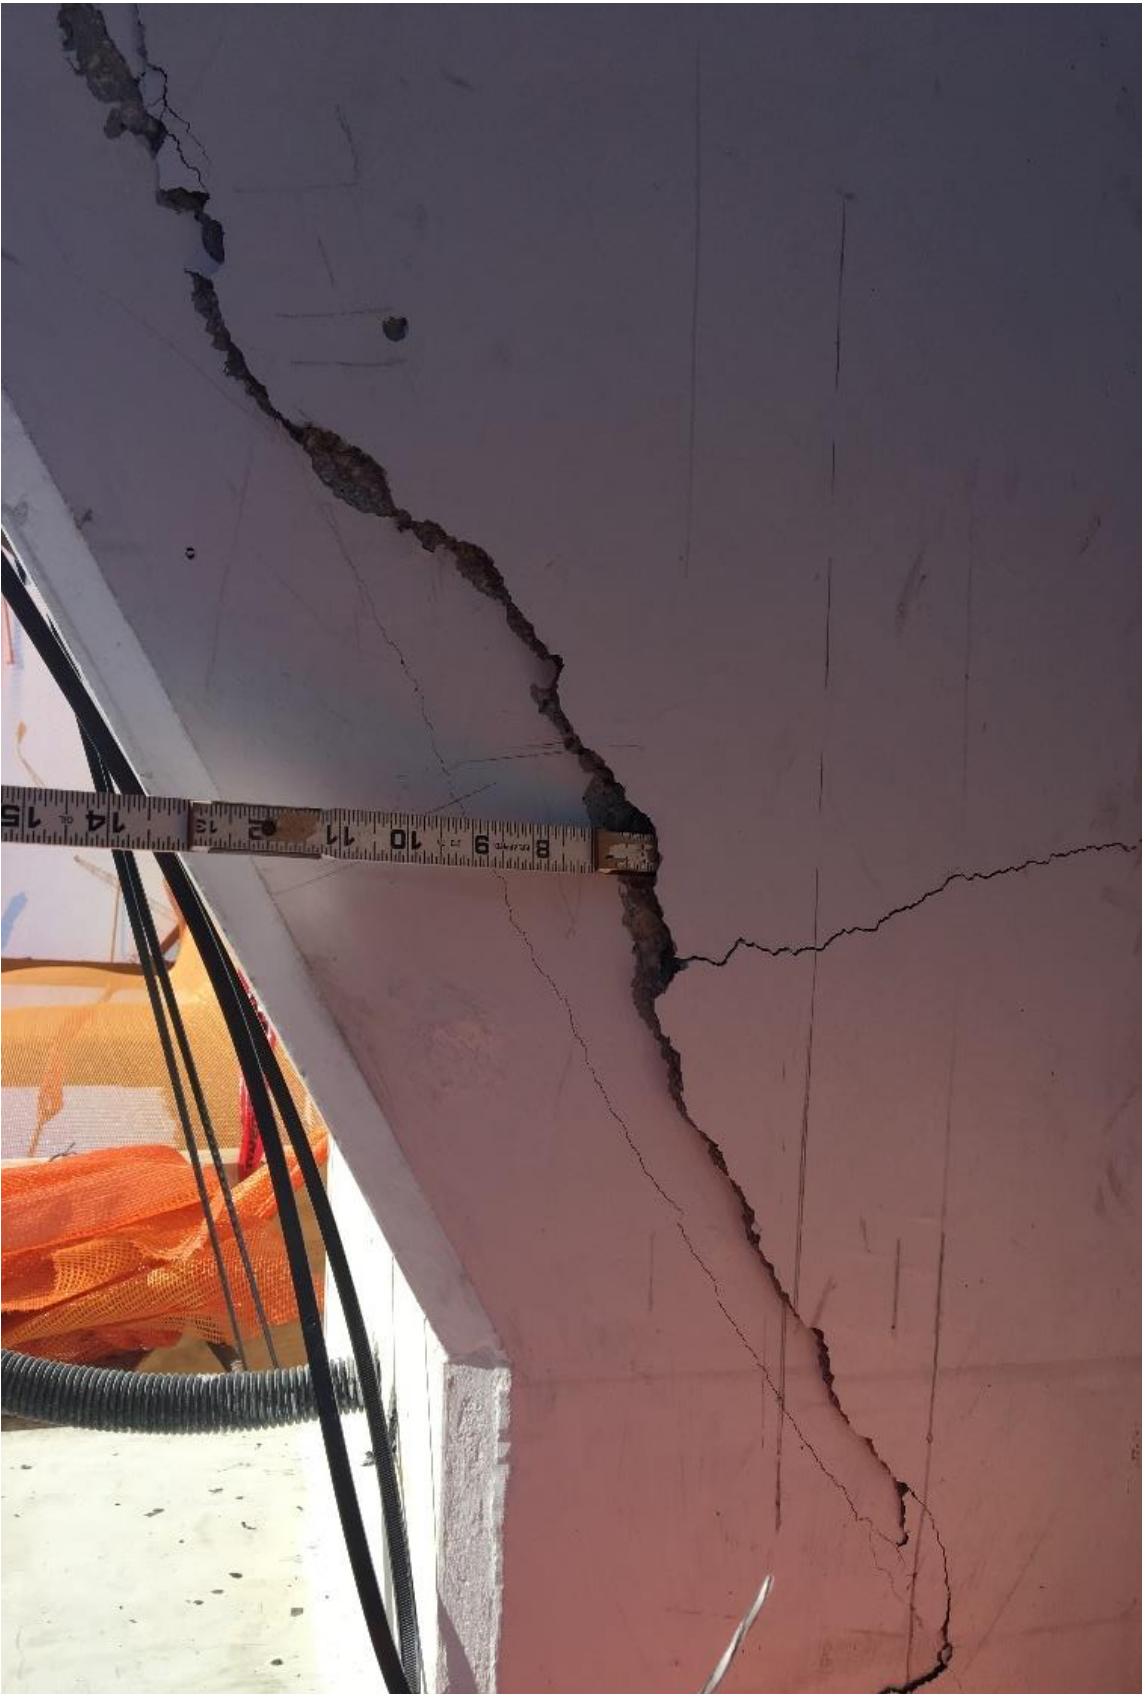
Figure 39 Close-up of longitudinal cracks in diagonal 11 on 3/14/2018 by BPA

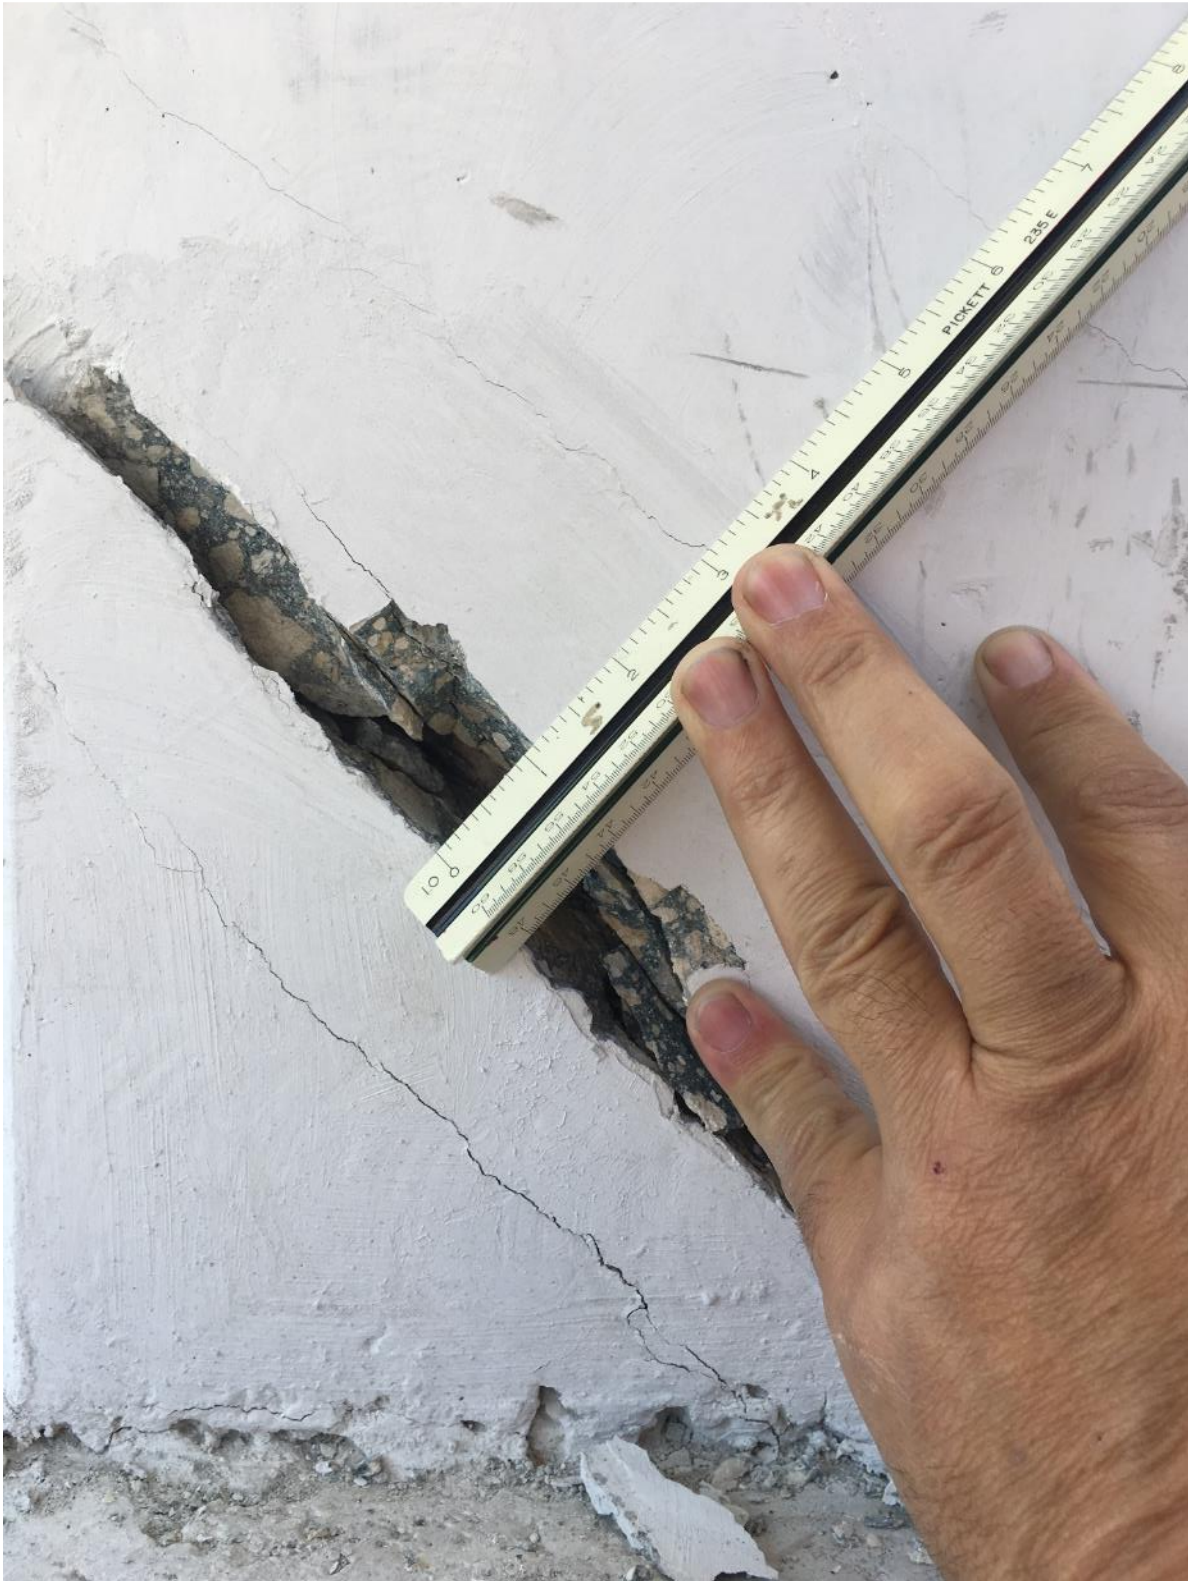
Figure 40 Close-up of longitudinal cracks in diagonal 11 on 3/13/2018 by BPA

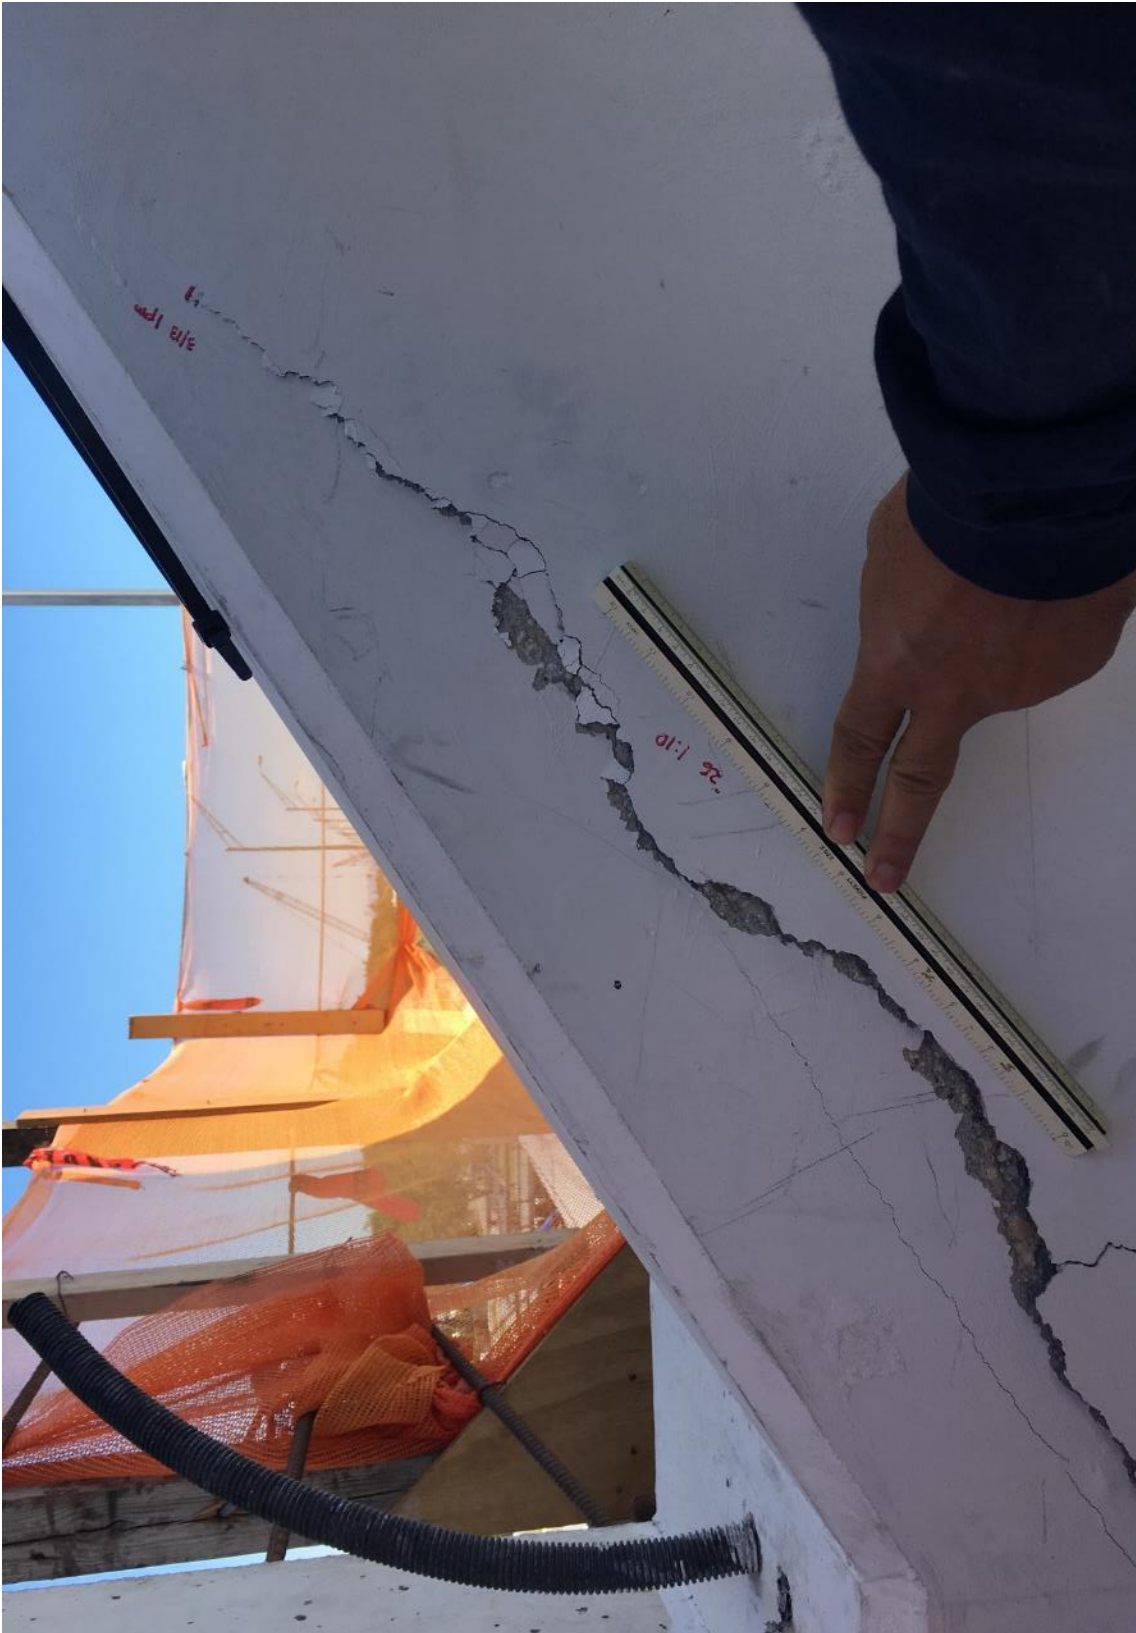
Figure 41 Close-up of longitudinal cracks in diagonal 11 on 3/13/2018 by BPA

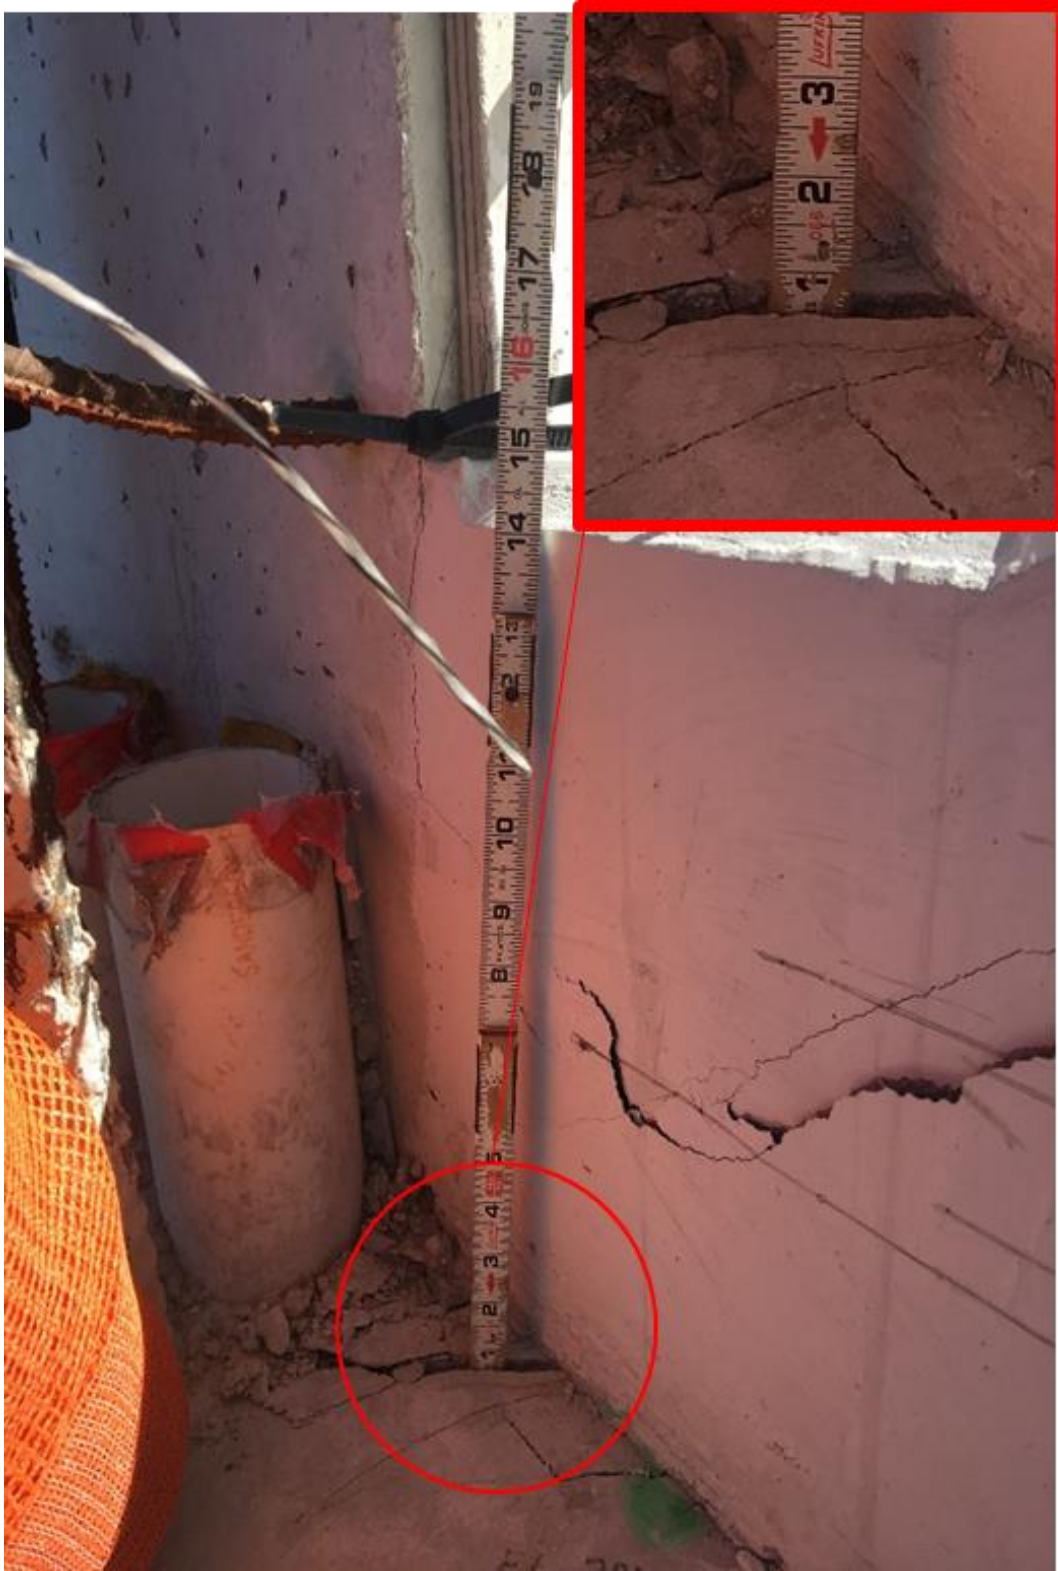
Figure 42 Cracks at the west side of diaphragm II on 3/14/2018 by BPA

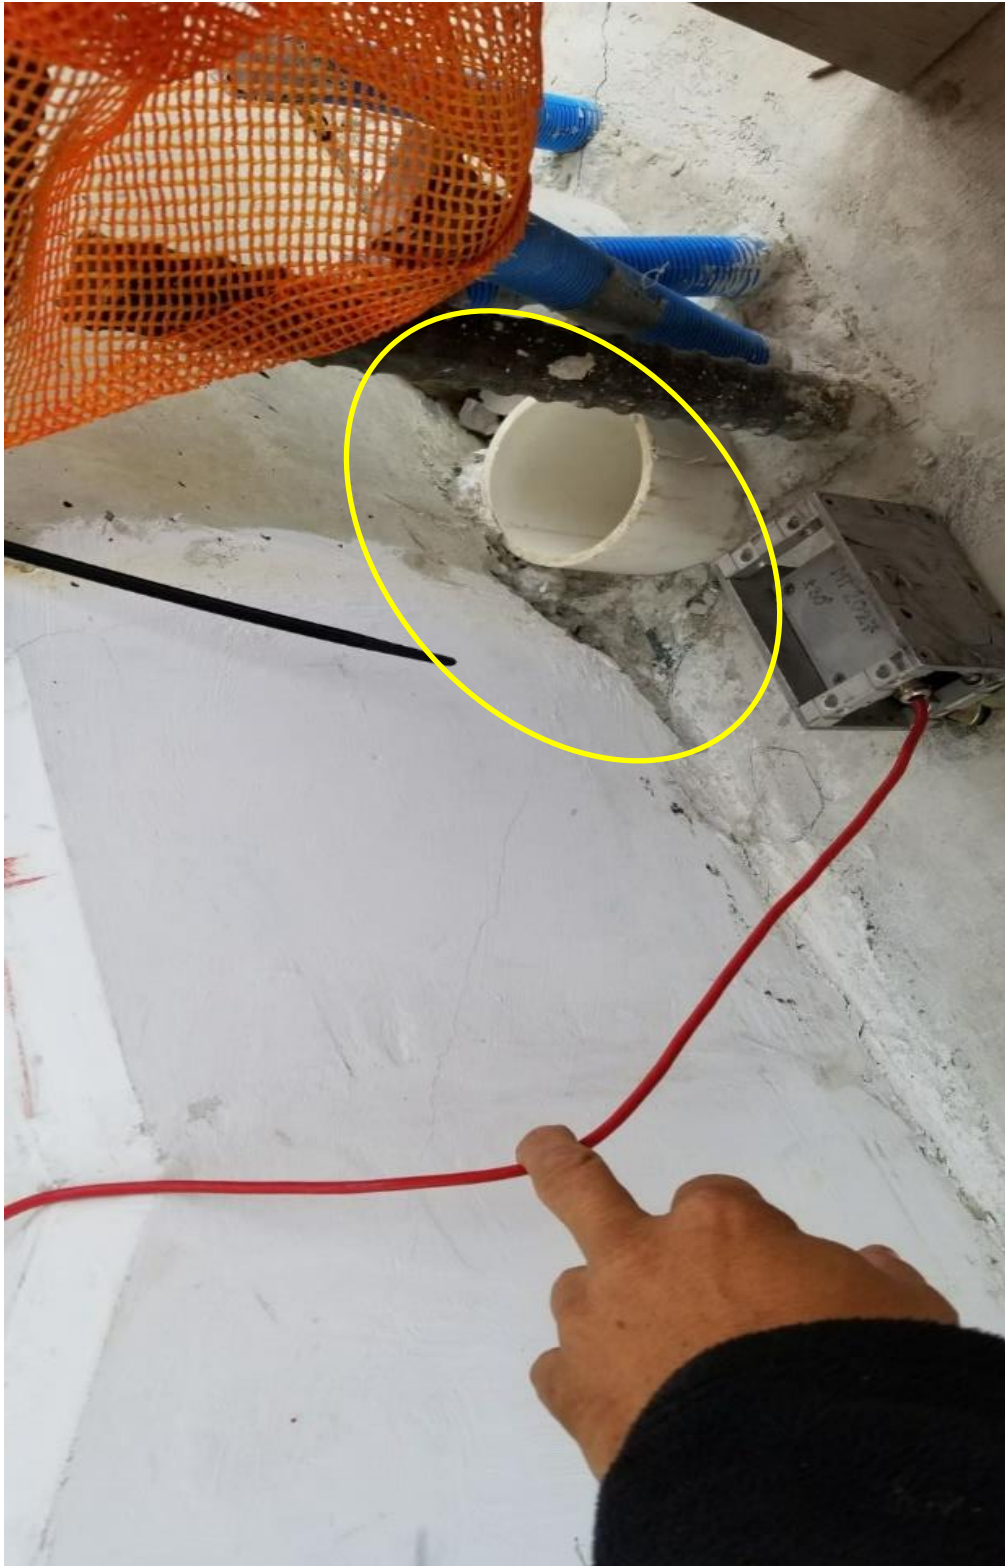
Figure 43 Cracks at the east side diaphragm II on 3/10/2018 – top face, by Corradino

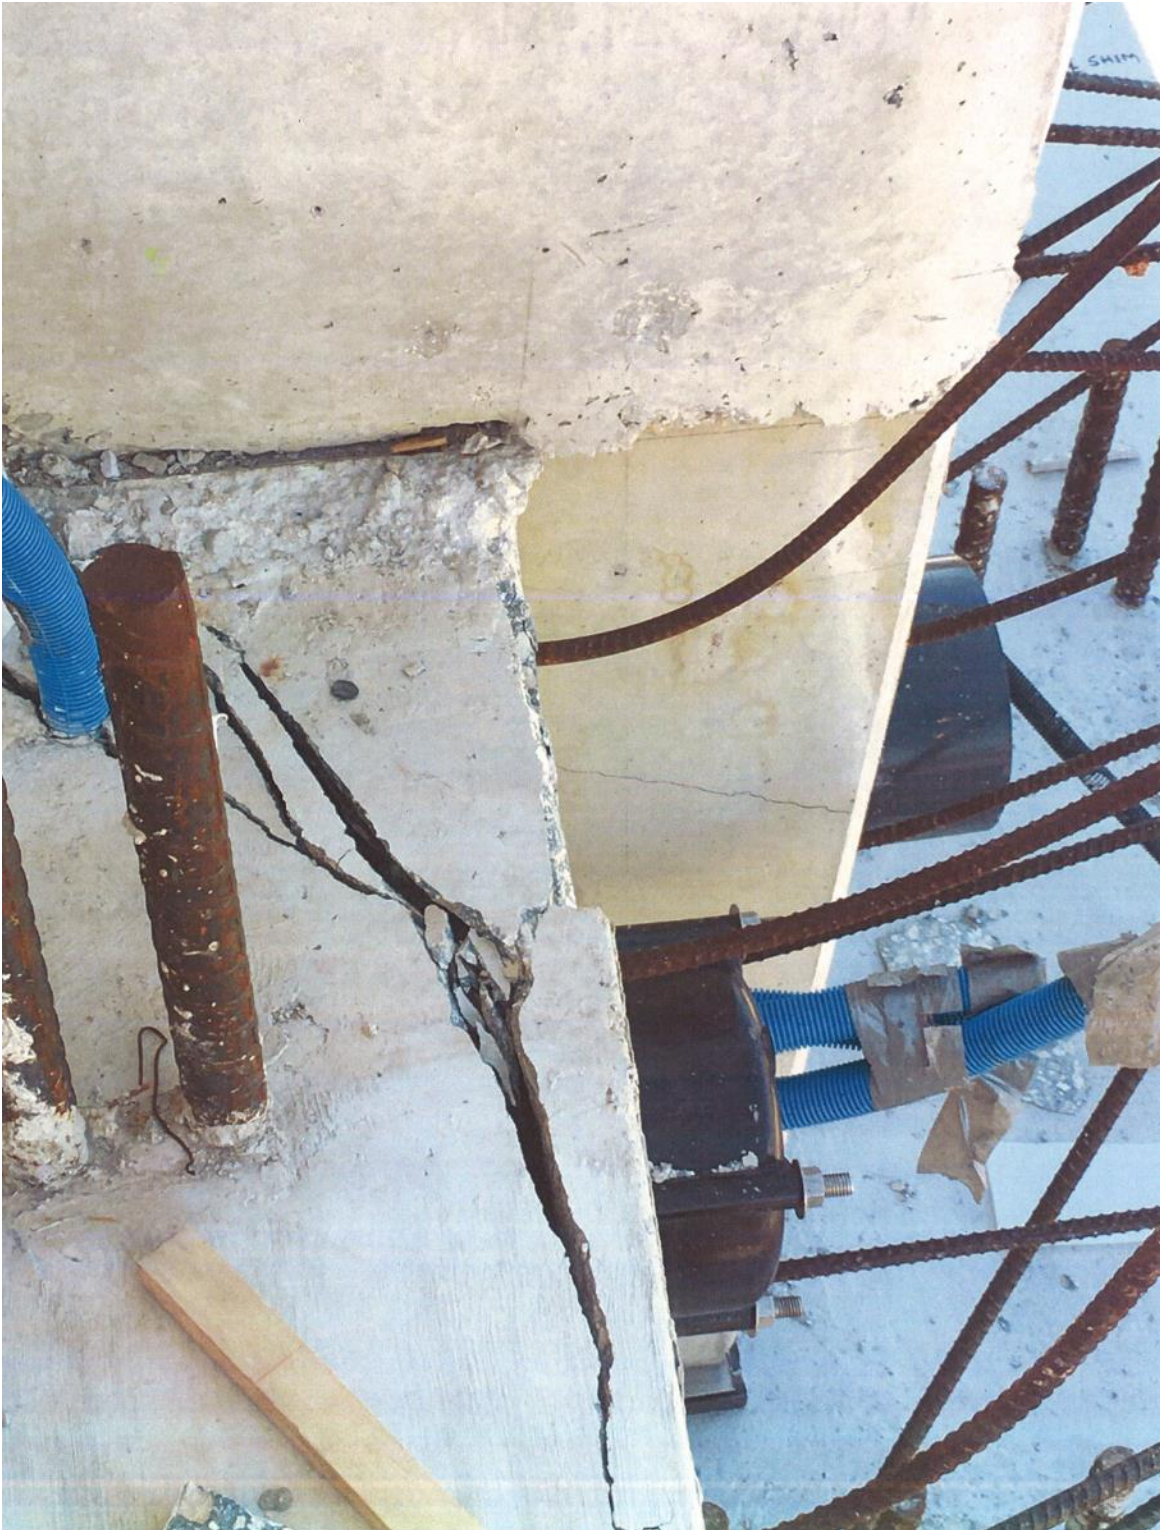
Figure 44 Cracks and movement of the column at the east side of diaphragm II on  
3/14/2018 by BPA

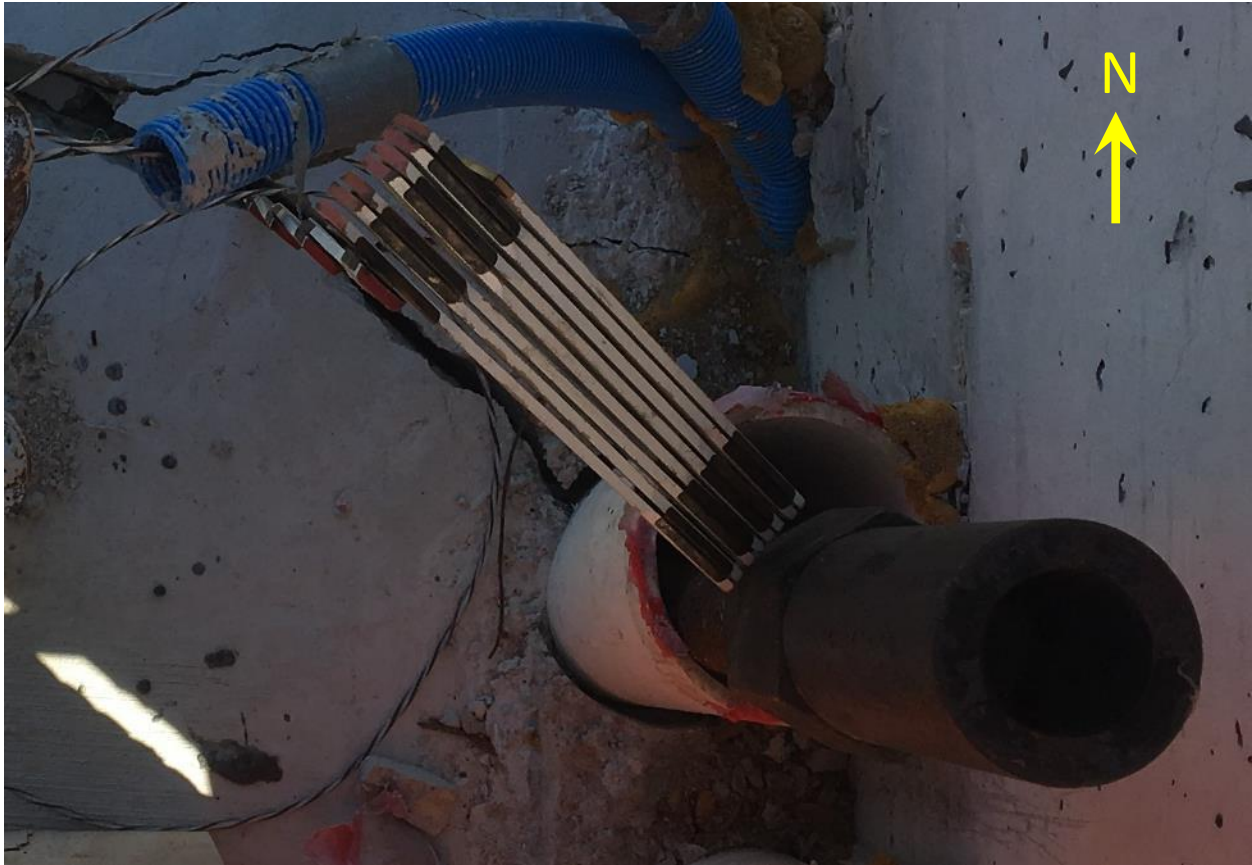
Figure 45 Note the gap indicative of movement between sleeve pipe and concrete, pictured on 3/13/2018 by BPA

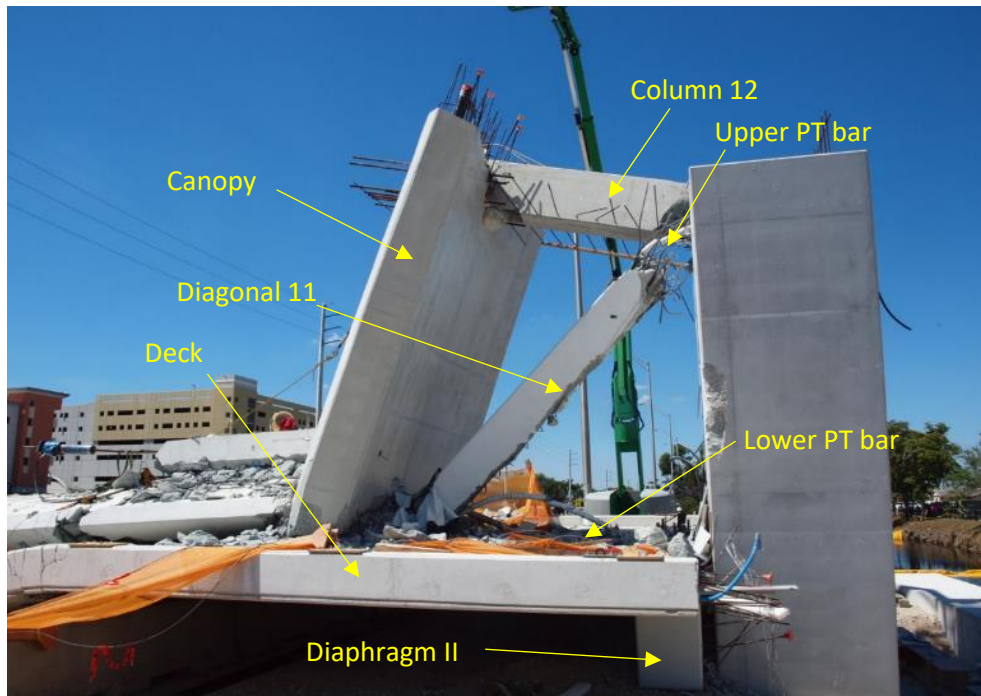
perilously attached to the bottom of the column 12 over the pylon with some rebar, and the other end remained connected to the canopy as shown in Figure 52. As a result of the blow-out, the lower end of the upper PT bar separated from the diaphragm II and rested on the top of the pylon. The lower PT bar of diagonal 11 peeled off from diagonal 11 but remained embedded in the diaphragm. The top ends of the upper and lower PT bars in diagonal 11 remained in the blister. The upper PT bar lost its tension completely and so did the lower PT bar which still carried the Jack used to re-tension the PT bars. The deck laid down approximately 140 feet flat on the ground covering all the four east bound lanes, and three west bound lanes, as shown in Figure 51. The south end of the deck and column 1 were still precariously on the top of the south pier, see Figure 52. The column 1 tilted approximately 15 degrees towards the north with canopy firmly attached. All diagonals other than diagonals 2, 3 and 4 were crushed. The canopy laid flat approximately 80 ft. over the fallen deck. Two blisters on the south side remained intact with the canopy but the rest of the blisters were badly damaged. The blisters at the junction of diagonal 11 and 10 were damaged with the bottom PT bar extending beyond the blister with the ram still attached to the PT bar. As a result of the blow-out, three #7 shear reinforcements at the construction joint of diagonal 11 and the deck were sheared but the southernmost shear reinforcement remained intact. The width of the blow-out was 2 ft. at the southern end gradually enlarging towards the north. The blow-out encompassed the two 4" pipes on either side of column 12, and was symmetrical to the center line of the deck.

Figure 52 Column 12, diagonal 11 and part of the canopy after bridge deck and diaphragm fell to the ground, March 17, 2018, by OSHA

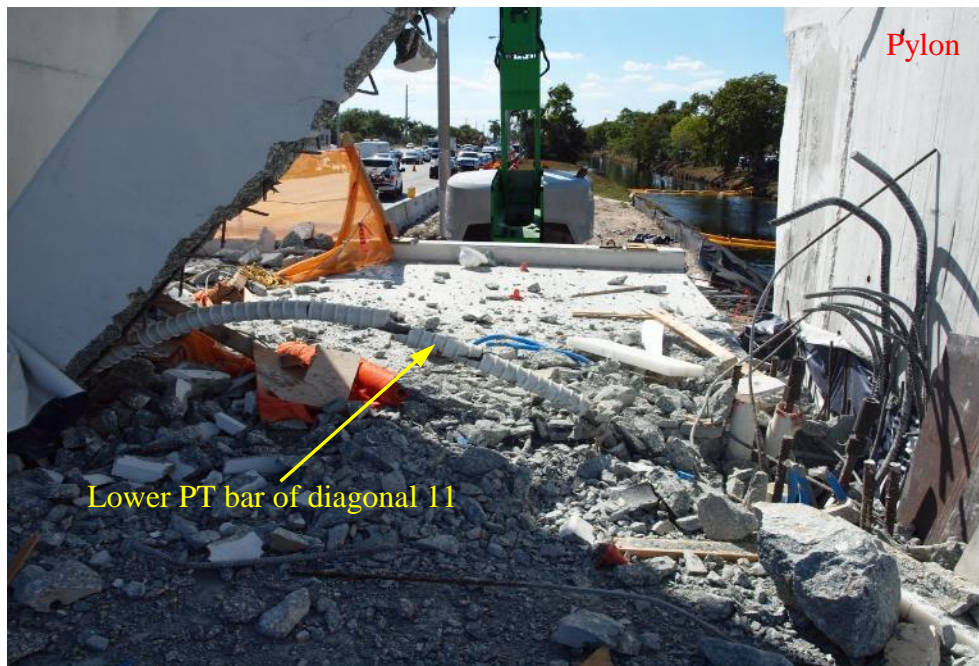
Figure 57 Lower PT separated from the diagonal 11 still embedded in diaphragm after bridge collapse, March 17, 2018 by OSHA

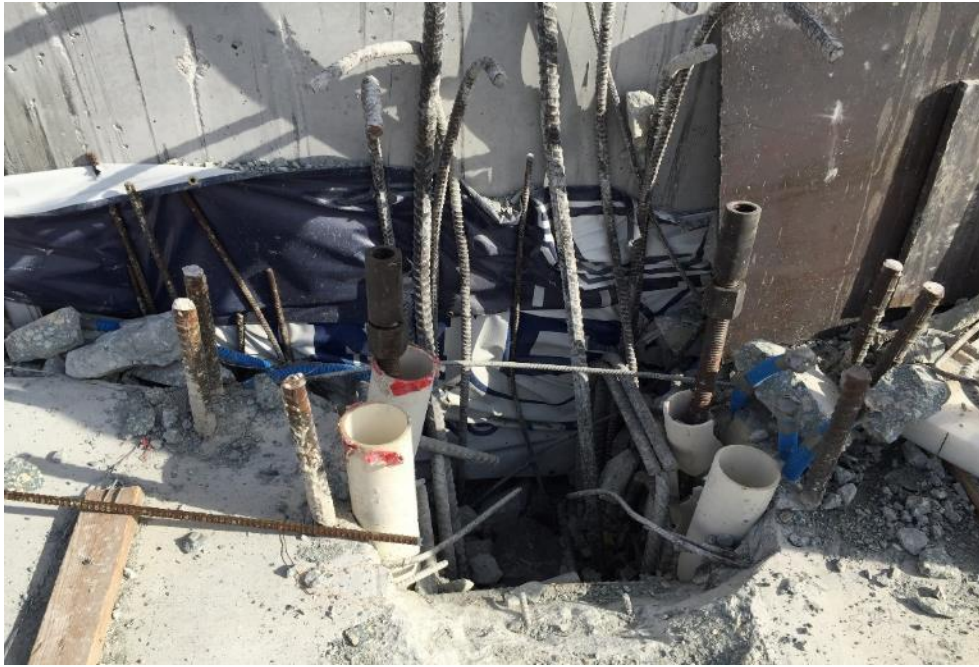
Figure 58 Concrete blow-out failure in Diaphragm II at the time of bridge collapse at the site looking north from south, March 21, 2018, by OSHA

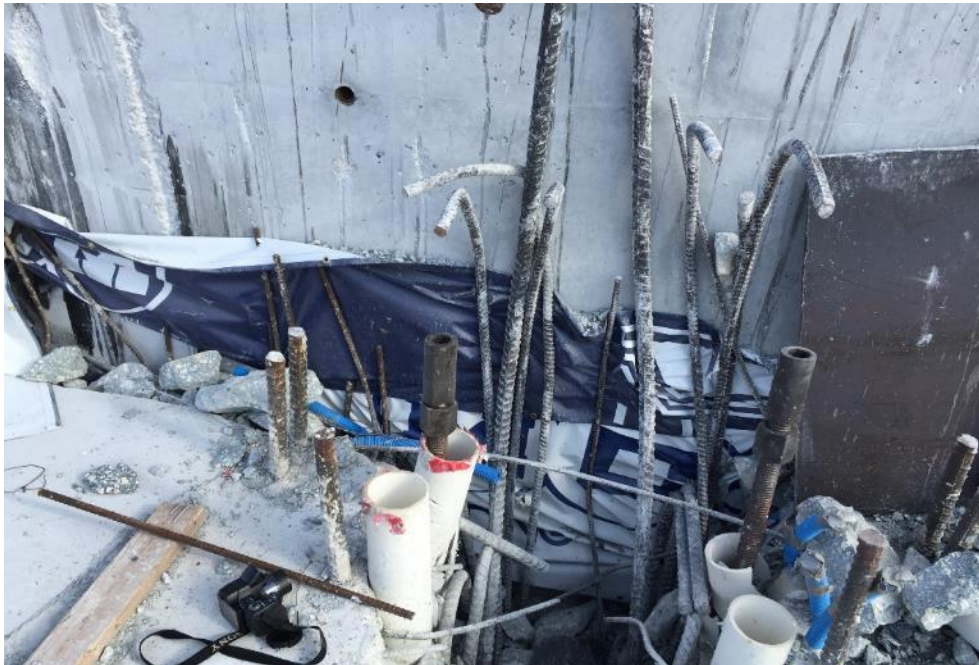
Figure 59 Concrete blow-out failure in Diaphragm II at the time of bridge collapse at the site looking north from south, March 21, 2018, by OSHA

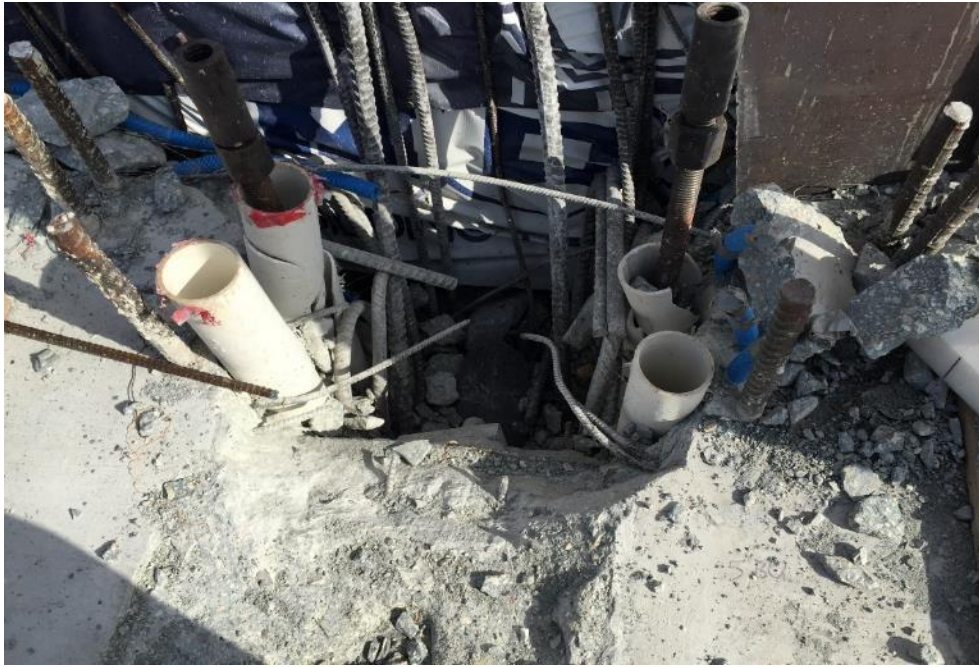
Figure 60 Concrete blow-out failure in Diaphragm II at the time of bridge collapse at the site looking north from south, March 21, 2018, by OSHA

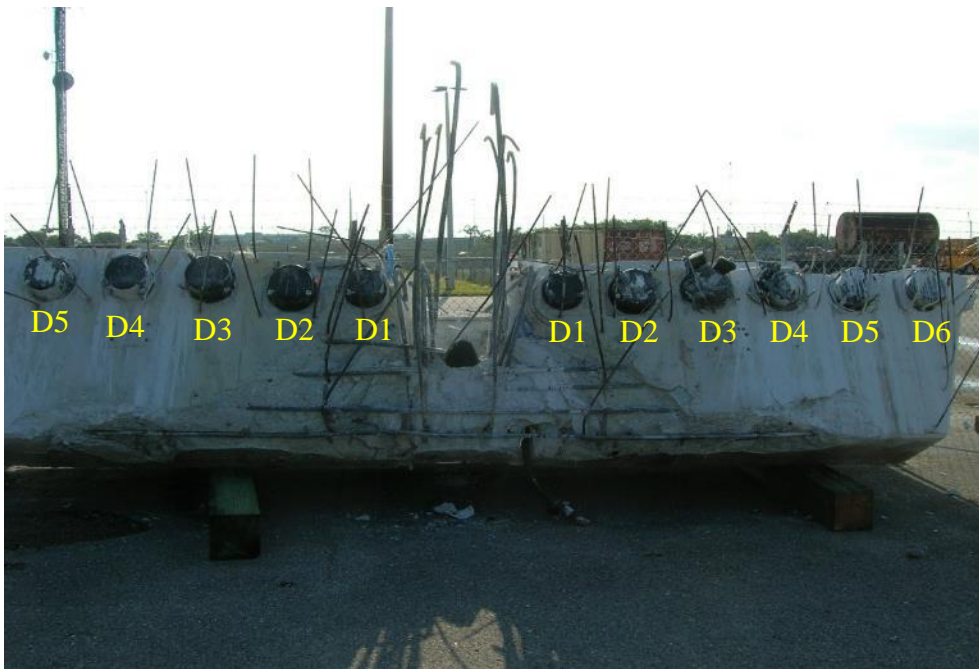
Figure 61 Remnants of diaphragm II at the time of the bridge collapse in the storage yard – looking north from south, April 9, 2018, by OSHA

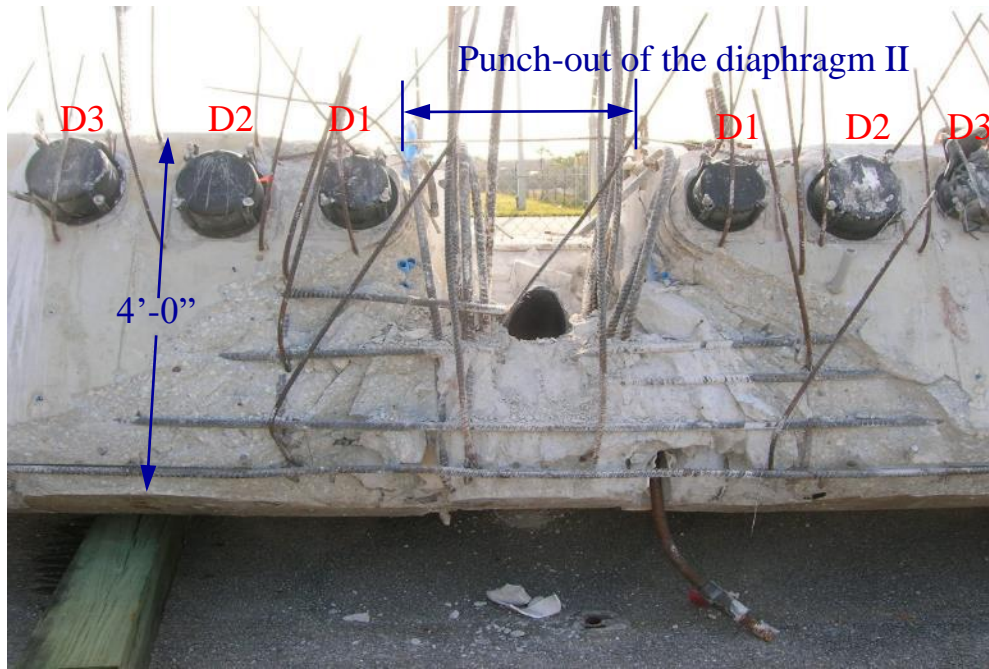
Figure 62 Concrete blow-out failure in Diaphragm II at the time of bridge collapse in the storage yard looking north from south, April 9, 2018, by OSHA
