# Investigation of March 15, 2018 Pedestrian Bridge Collapse at Florida International University, Miami, FL

U.S Department of Labor  
Occupational Safety and Health Administration  
Directorate of Construction

July 2019

**Report prepared by**  
**Mohammad Ayub, PE, SE**  
Director, Office of Engineering Services  
Directorate of Construction  
OSHA National Office  
Washington, D.C.

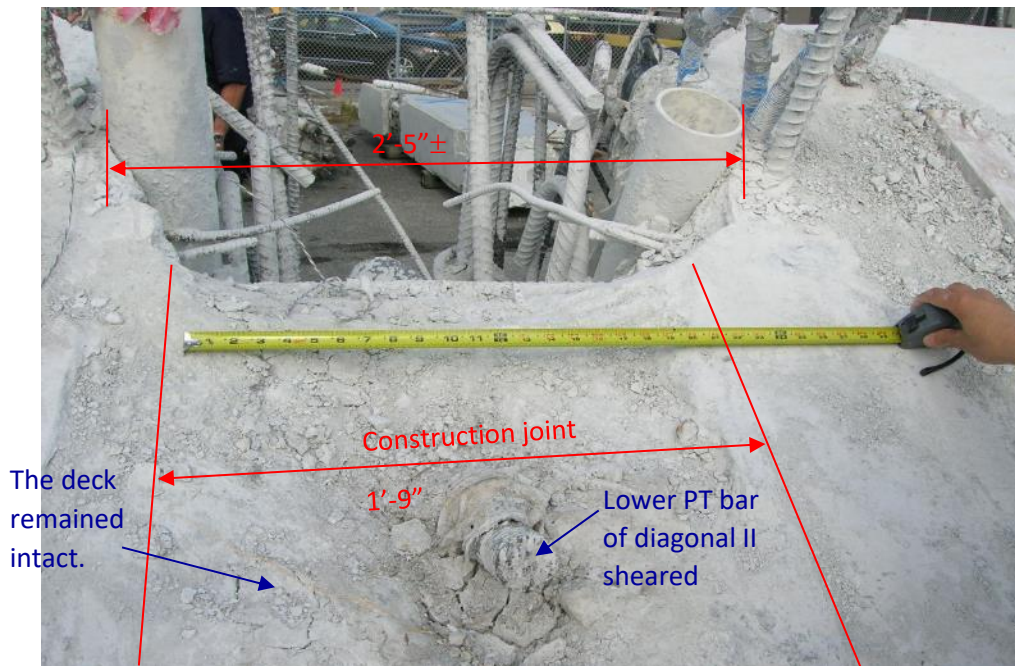
Figure 63 Blow-out hole in Diaphragm II at the time of the bridge collapse in the storage yard looking north from south, April 9, 2018, by OSHA

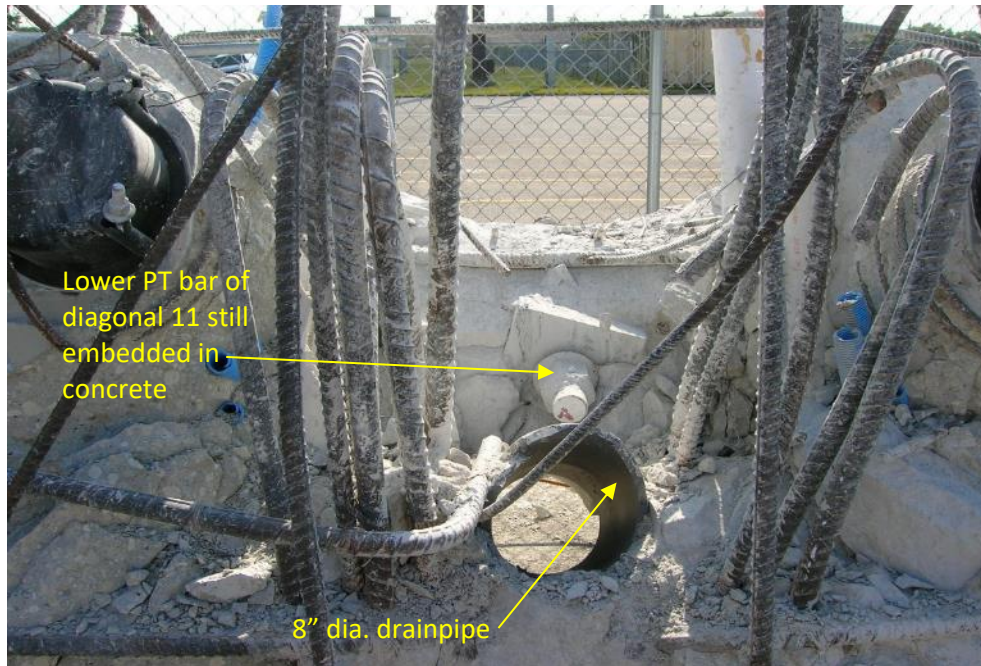
Figure 64 Punched hole in Diaphragm II at the time of the bridge collapse – from south looking towards north, April 9, 2018, by OSHA

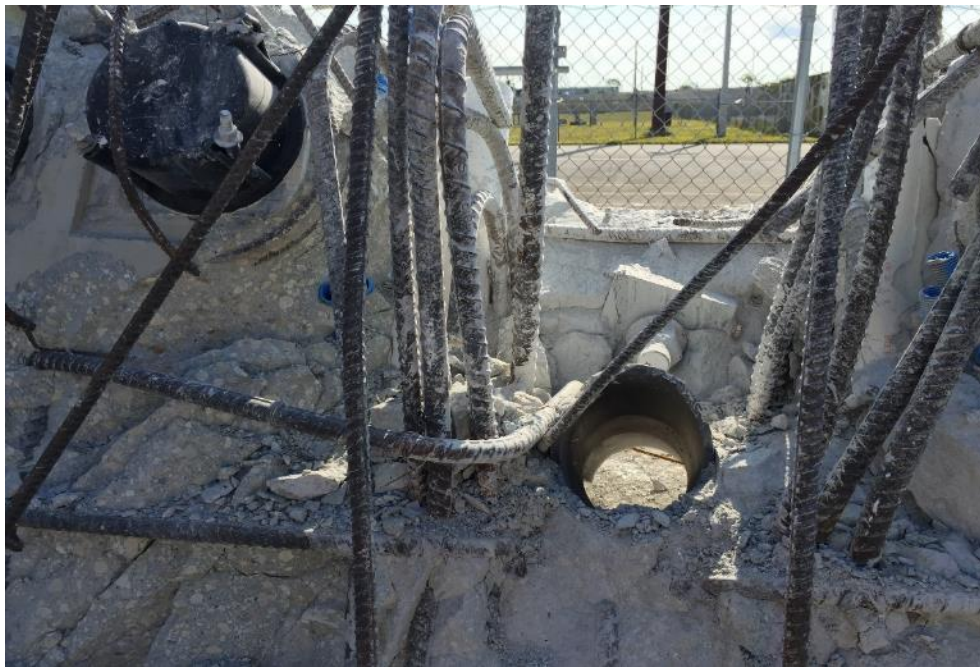
Figure 65 Punched hole in Diaphragm II at the time of the bridge collapse – from south looking towards north, April 9, 2018, by OSHA

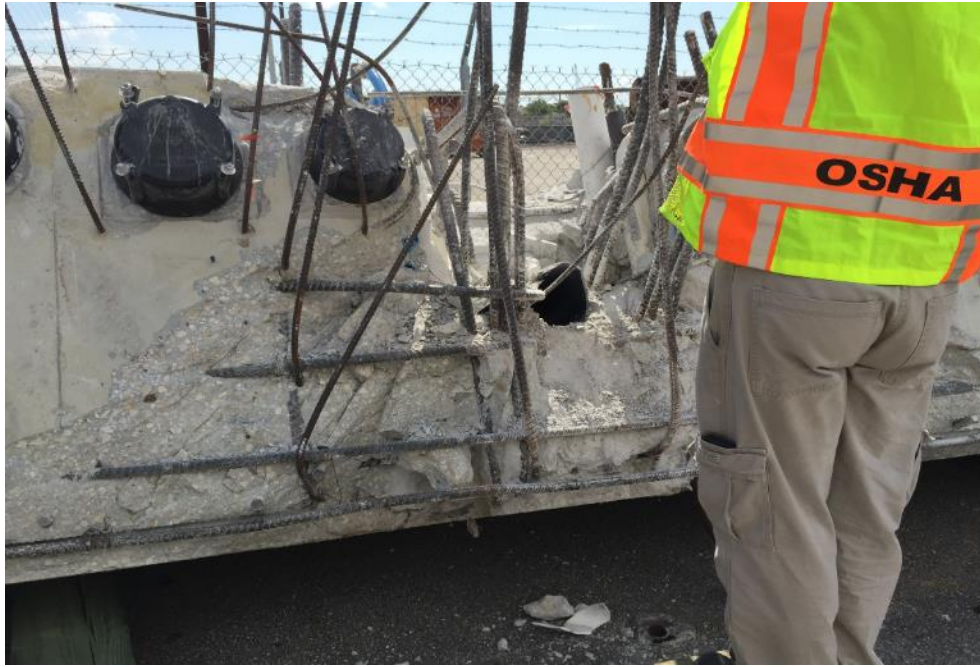
Figure 66 Punched hole in Diaphragm II at the time of the bridge collapse – from south looking towards north, April 9, 2018, by OSHA

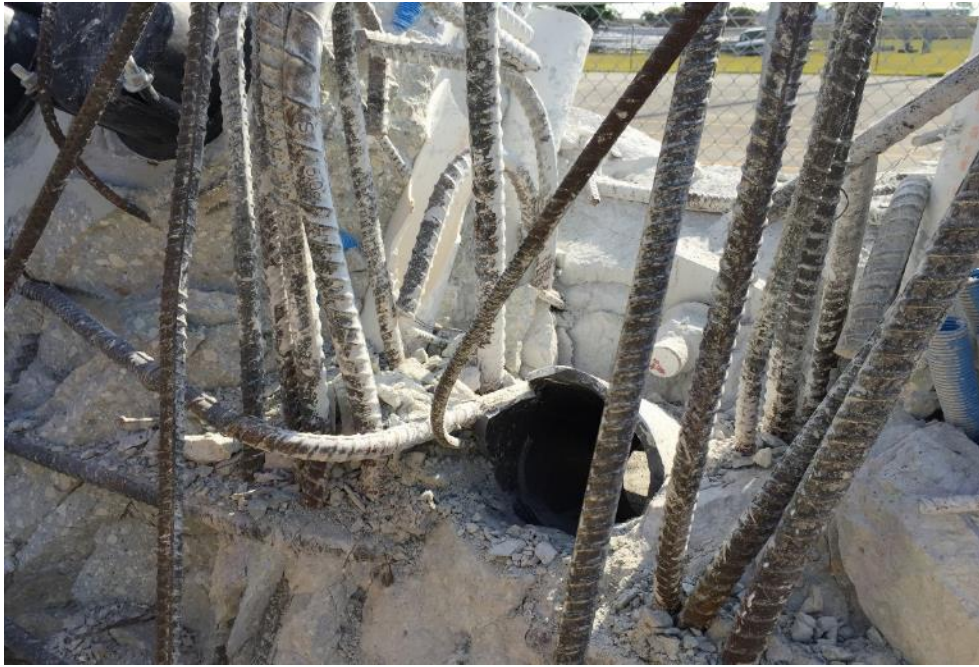
Figure 70 Punched hole in Diaphragm II at the time of the bridge collapse – from south looking towards north, April 9, 2018, by OSHA

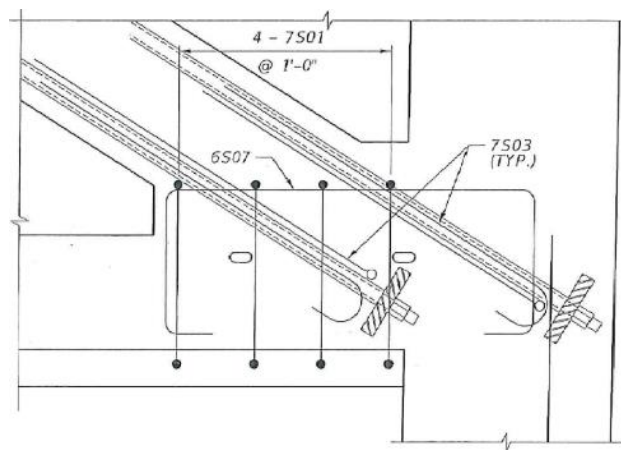
Figure 77 Construction joint detail at diagonal 11 and deck.

Reproduced below in Figure 77 is the detail entitled “Truss members 11 & 12 connection detail” from drawing B-61 with construction joint identified. Industry standard is to “consider shear transfer across a given plane, such as an existing or potential crack, an interface between dissimilar materials or an interface between two concrete cast at different times.” The construction joint at the bottom of the diagonal 11, therefore, qualifies for evaluation of the shear friction. This bridge is a concrete truss bridge weighing approximately 1,900 kips. Therefore the forces in the truss members are high. We will analyze the construction joint for shear friction by LRFD Bridge Design Specifications by AASHTO, seventh edition.

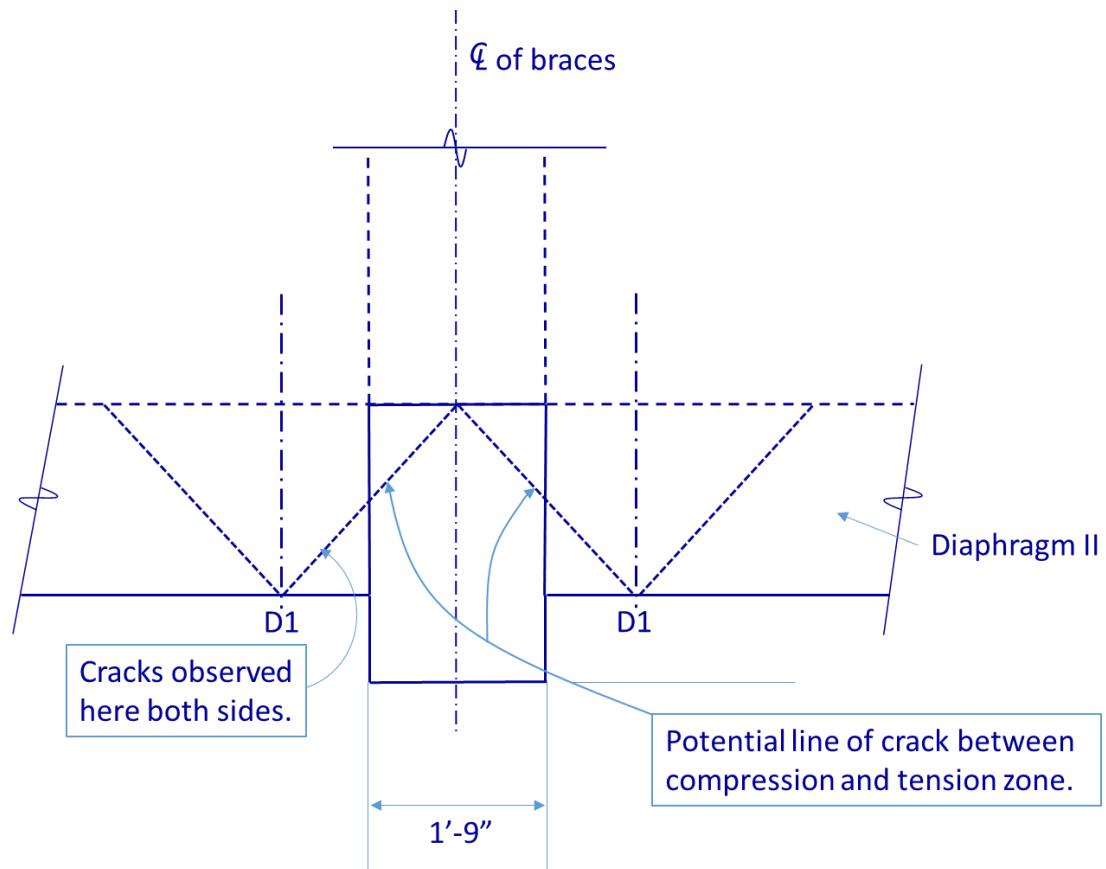
A 12" dia. semicircular cut was made in the center of the deck to accommodate an 8" round drain pipe. This not only reduced the cross sectional area of the deck at the key location but prevented the placement of any PT tendons or heavy mild reinforcement to capture the horizontal force from the deck. There was a 4" and 4½" diameter plastic pipe placed right against the columns in diaphragm II. Such locations often act as a crack initiator.

Figure 78 Potential line of crack – plan view

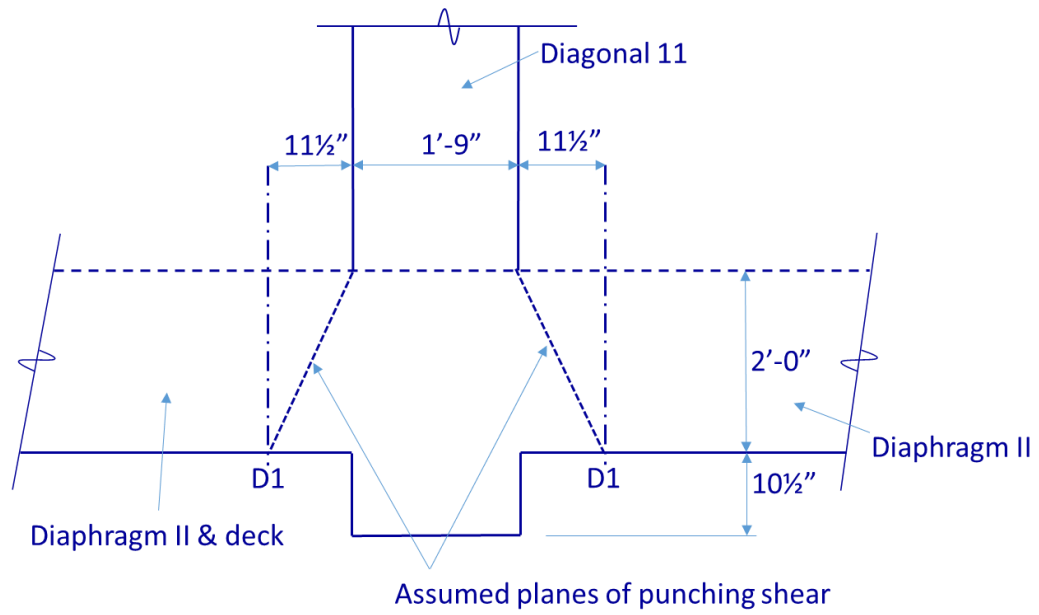
Figure 79 Potential Punching shear failure at north end – plan view
