Surface Breakage of the 1992 Landers Earthquake and Its Effects on Structures

by Carlos A. Lazarte, Jonathan D. Bray, Arvid M. Johnson, and Robert E. Lemmer

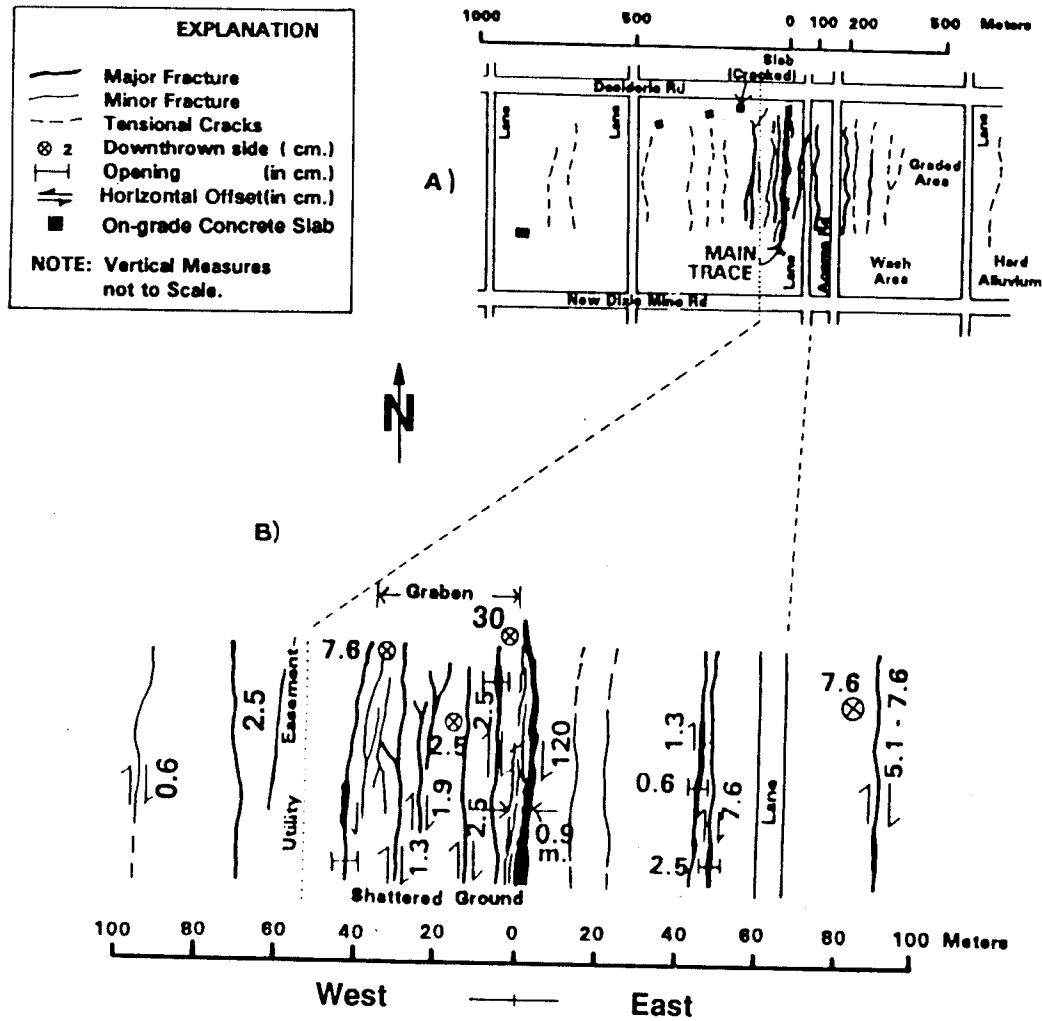
There is less-intense, but still significant, right-lateral displacement within a zone about 100-m wide centered on the main trace. Figure 4b shows fractures within bands of ground 100-m wide on either side of the main trace. Some of the rupture zones contain tensile cracks up to 2.5-cm wide. The amount of accumulated right-lateral displacement across fractures is comparable on either side of the main rupture—15 cm on the east and 11 cm on the west. The total offset across this 200-m-wide zone is estimated to be 146 cm. The features of ground fracturing differ on each side of the main trace. On the east side, lateral displacement is concentrated mostly in a few cracks (Fig. 4b). On the west side, the fracturing is relatively intense and distributed across a zone about 40-m wide. A graben about 25-m wide de-

Figure 4. (a) Distribution of ground rupture across a segment of the Johnson Valley fault at the Acoma site; (b) detail of movement around the main trace.

Some minor cracks occur as far as 750 m from the main trace (Fig. 4a). These are tensile cracks with apertures on the order of 1 mm. The separation between cracks ranges from 50 m close to the main trace to 150 m in the outer section. Fresh tensile cracks, observed in an unreinforced concrete foundation slab located 120 m away from the main trace, indicate the broad zone of damage to structures along this fault segment. No damage was observed in the three most distant unreinforced concrete foundation mats within the surveyed area (Fig. 4a).

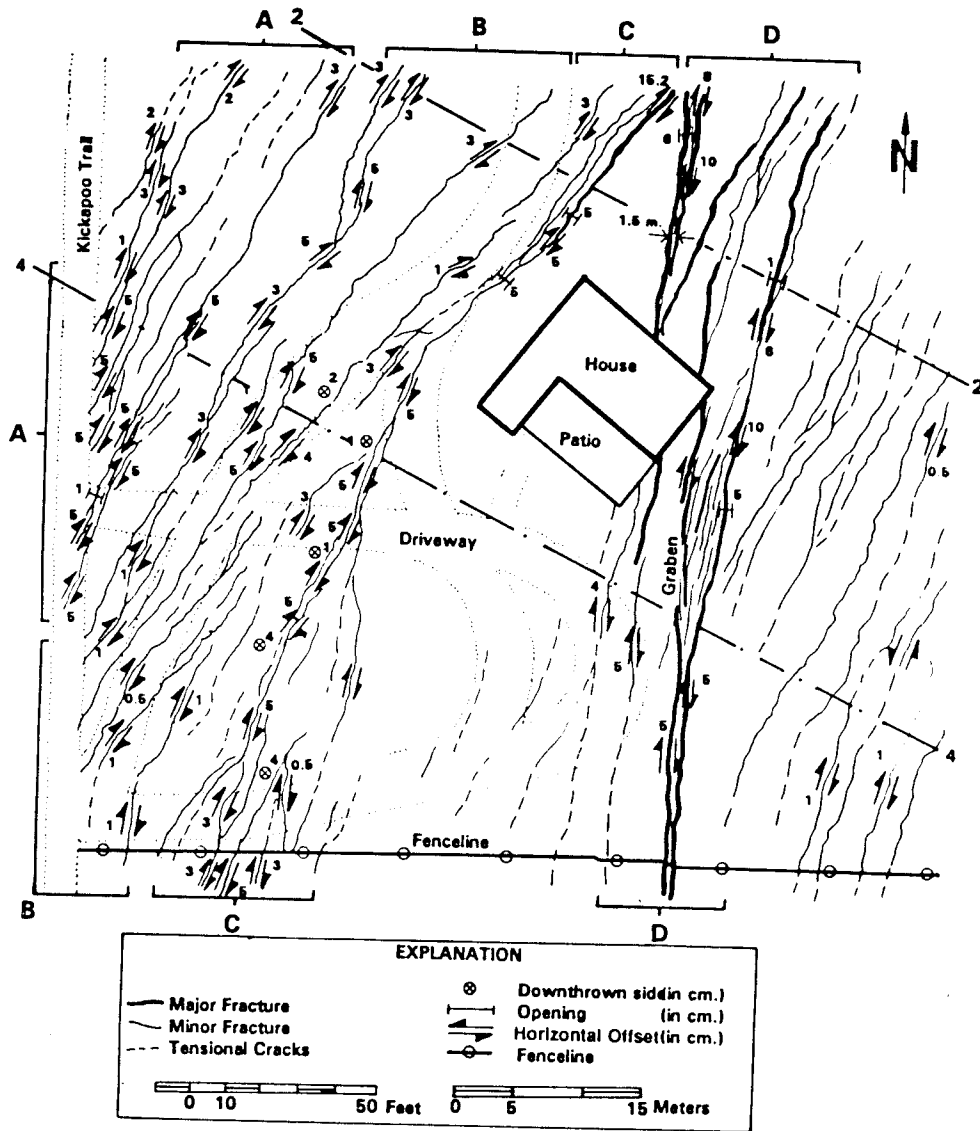
A detailed map of the ground breakage at the Kickapoo Trail site (Fig. 1, site C) is shown in Figure 8. This detailed map also served to study the damage to the structure situated roughly in the center of the mapped area. The west side of the area displays numerous, closely spaced cracks. The number of cracks of all sizes is astonishing. Offset on individual cracks in the west side ranges from 0.5 to 5.0 cm. The accumulated offset in the three western shear zones is: 15 to 20 cm, roughly 5 cm, and 7.5 to 10 cm, for zones A-A, B-B, and C-C, respectively. In the southwestern part of the area, zones A-A and C-C accommodate more slip than zone B-B. In the northern part of the area, the distribution of right-lateral displacement is more uniform, and the accumulated offset is comparable along the three zones. In the southern end of zone B-B, some of the cracks accommodate little slip (on the order of a few millimeters) and develop as extensional cracks with average openings of 2 to 5 mm. In fact, it is characteristic that minor cracks formed as tensile cracks at early stages of fracture development. The rough, unsheared faces of these cracks indicate that the cracks first opened in tension and then accommodated slip (Johnson and Fleming, 1993). Zones on the west side, especially B-B and C-C, veer progressively from a general trend of N20E to N30 to 45E from south to north. A relatively intact wedge in the center of the surveyed area is bounded by zones C-C and D-D. Only minor, barely visible tensile cracks were noticed in this wedge. The ground is relatively firm in this area.

On the east side, a narrow shear zone D-D accommodates 65 cm of offset which is readily observable along the fence line. The trend of this narrow shear zone is N5 to 10E. The concentrated shear zone degenerates into a graben, which expands laterally to the north. The graben is bounded by shear zones which are branches initiating from zone D-D. Approximately 100 m beyond the structure, zone D-D progressively returns to a general trend of N20 to 30E, and movement across the rupture zone becomes more distributed over that area. Twenty meters north of the house, zones C-C and D-D merge to form a narrow zone 1.5-m wide, containing several subparallel cracks and severe ground breakage. The offset across the zone is 15.2 cm. Beyond this zone, the ground fracturing is more uniform.

Figure 8. Detailed mapping of ground fracturing at the Kickapoo Trail site.

The location of the house relative to the ground breakage is shown in Figure 8. Perhaps the most important ground rupture zone, with respect to damage to the house, is D-D, which trends about N5 to 10E. This shear zone is about 10-m wide and accommodates 65 cm of right-lateral offset. At the fence line along the southern edge of the map area, most of the offset is concentrated along a very narrow zone. The map suggests that this zone steps across 10 m and continues with the same trend toward the north. Near the house, the zone becomes a graben, about 5-m wide and a few cm deep. Movement within the graben produced major damage to the building and supporting slab. West of the graben, subparallel fractures, which accommodated 4 to 5 cm of offset, also damaged the house. The NE corner of the house is situated in a minor step-over feature. In this left step, the foundation of the house is subjected to N-S compression (Segall and Pollard, 1980). Measurements of offsets across the ground fractures indicate that 30 to 50 cm of differential horizontal displacement occurs in the ground beneath the foundation of the house.

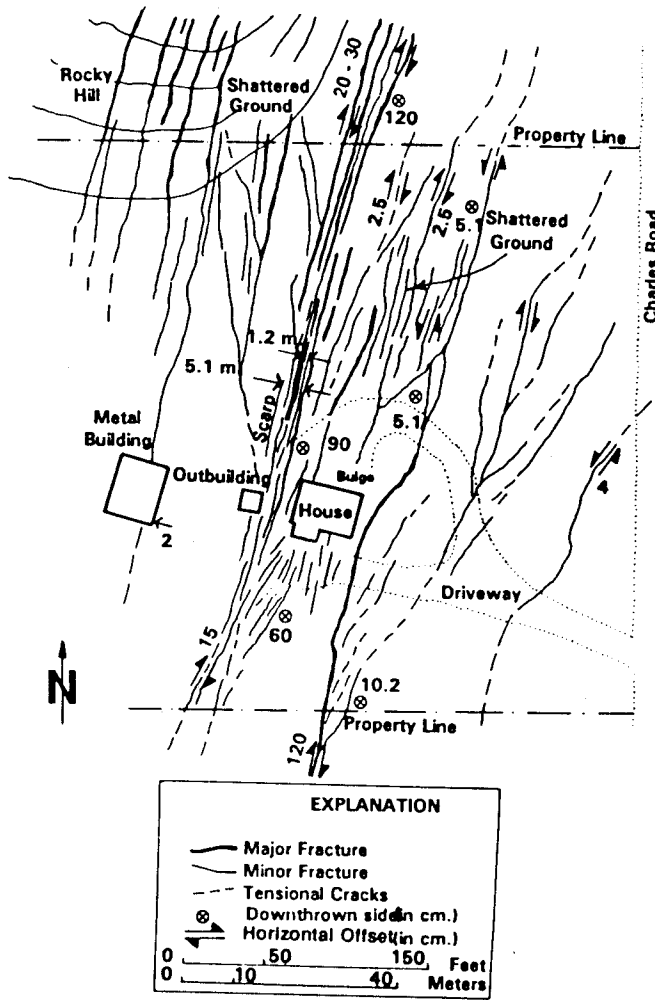
Figure 9. Detailed mapping of ground fracturing at the Charles Road site.

The west side of the house is about 3 m east of the eastern edge of the central rupture zone (Fig. 9). There are many subparallel fractures in a zone about 8-m wide trending about N20E and extending from the main trace to the south side of the house. Across most of these fractures, the ground is drowndropped a few cm on the east side. There are only a few fractures extending NE from

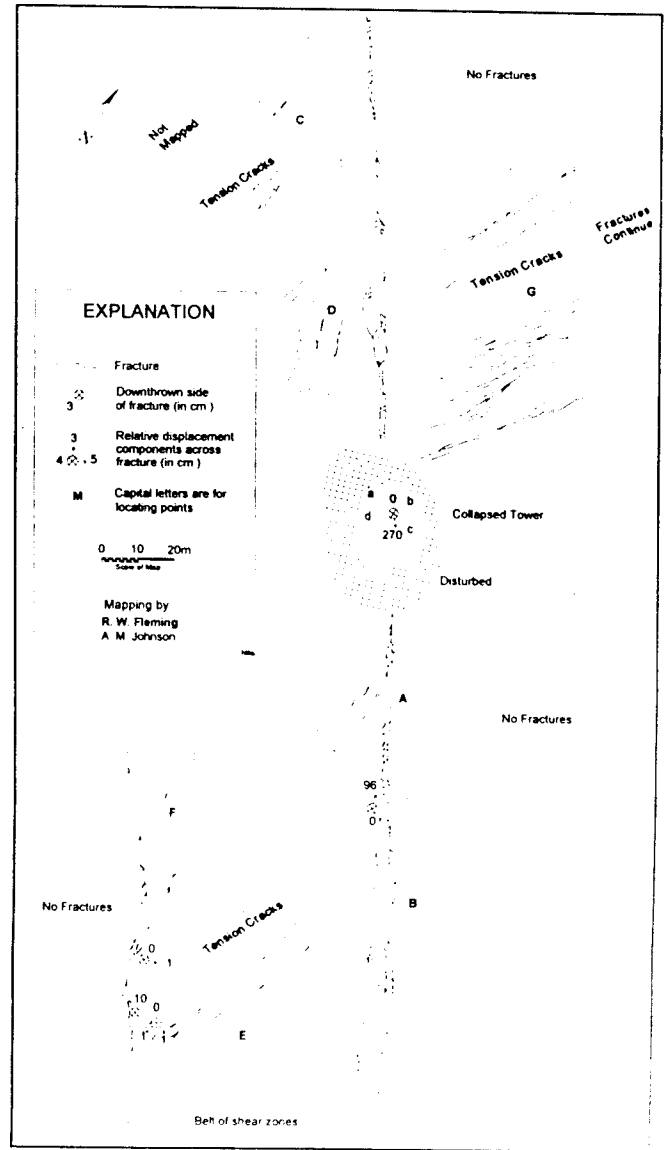
Figure 10. Detailed map of fractures that define the rupture zone along the Emerson fault zone at the single-tower power line. Overall shift across 70-m-wide belt is about 3.5 m. Each side defined by relatively straight, narrow shear zones. Narrow shear zone on right (NE) side is main trace, which accommodated about 2.7 m of right-lateral shifting. Tensile cracks within belt of shear zones generally oriented about N-S to N10E, whereas tensile cracks outside NE side of belt, which apparently are part of a step-over structure with the Camp Rock fault, are oriented about N30E to N40E.

of the broad shear zone; a few of them have some left-lateral shift. There are a few, narrow, right-lateral shear zones within the broad shear zone in the NW part of this area (Fig. 10). Most of the right-lateral shift across the rupture zone is accommodated by narrow shear zones bounding a broad zone of minor shearing (as described by Johnson *et al.*, 1993, along other rupture zones at Landers). The narrow shear zone along the SW wall of the broad shear zone accommodates about 20 cm of right-lateral and up to 10 cm of vertical (downthrown on NE side) relative displacement. Along much of its length, this narrow shear zone consists of NS-oriented fractures several meters long. The blocks of ground between these fractures typically end in low thrusts, directed toward the center of the broad shear zone.

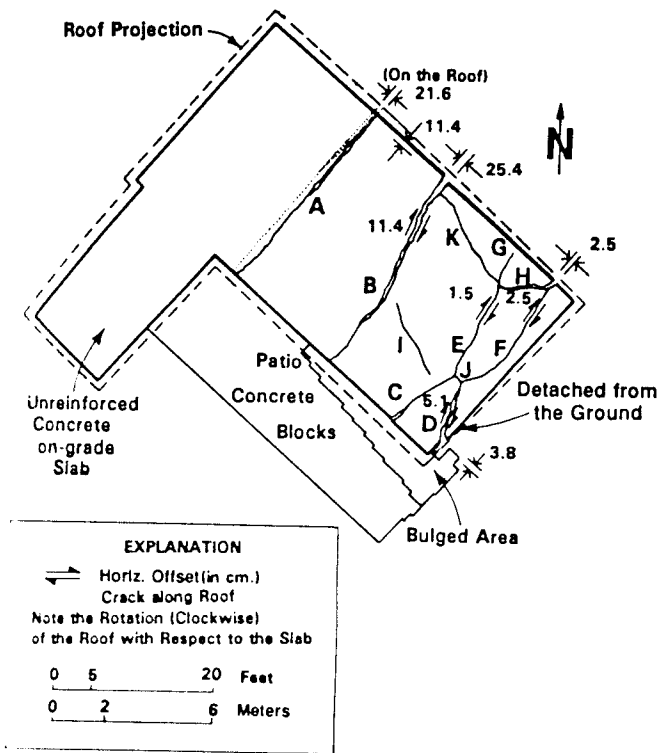
A complex pattern of cracks developed in the foundation slab of the house (Fig. 12). In general, cracks formed in the slab where fractures occurred in the underlying ground. Damage is concentrated in the eastern part of the slab, where the adjacent ground movement is largest. Cracks B, C-E-G, and D-F appear to have formed where fractures impinge on the foundation. Crack A appears to be unassociated with a specific ground fracture, and likely formed to accommodate the torsional displacement induced in the structure.

Figure 12. Distribution of cracking in the unreinforced concrete slab at the Kickapoo Trail site.

The largest crack in the foundation slab is crack B (Fig. 12). At the slab's NE edge, the aperture of crack B is 25.4 cm, with 11.4 cm of right-lateral offset (Fig. 13). The relative vertical displacement is less than 4 cm, so the net displacement is 28 cm, and the direction of the horizontal differential displacement is about N20W. The side of the house east of crack B rotated clockwise and moved right-laterally with respect to the intact side. Cracks that formed oriented approximately NE-SW and NW-SE produced blocks, bounded by fractures B-K-E-C and B-G-K. These blocks constitute a mechanism that

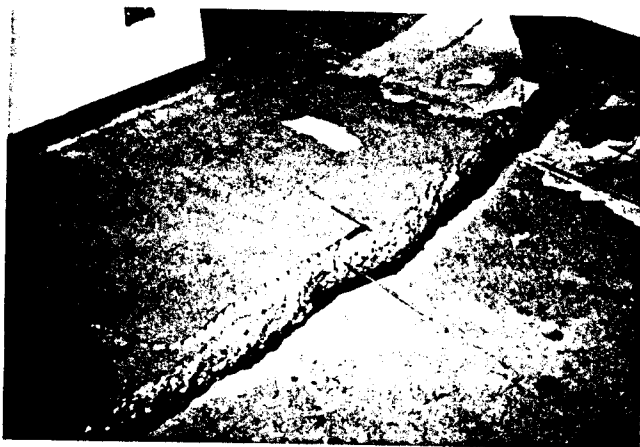
Figure 13. View of ground-rupturing-induced crack in concrete slab at the Kickapoo Trail site.

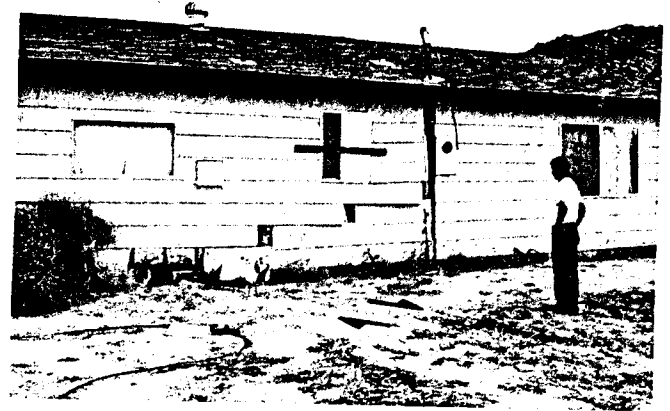
Figure 14. View of the NE side of the house damaged at the Kickapoo Trail site. At the lower left corner, the largest crack (B) is noticeable. Note the influence of the ground rupture extending from the ground, up the wall, and to the roof in the center of the picture.

allows clockwise rotation to accommodate ground deformation. Apparently, the imposed deformation is not sufficient to develop other blocks, such as B-I-C. The shearing deformation at the ground caused the slab to rotate, which, in turn, rotated the roof framed structure clockwise. This torsional movement caused a portion of the wall panel on the NE side to be torn apart at its seams

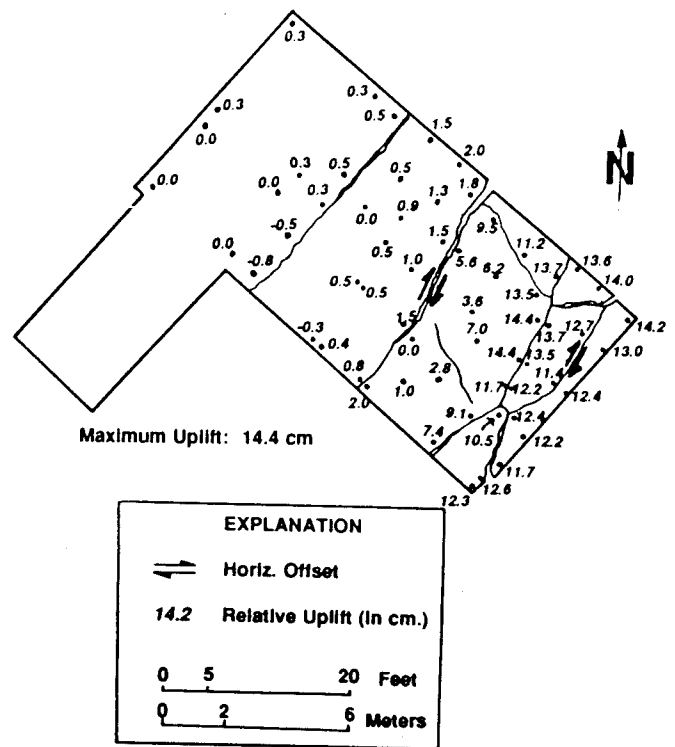
Figure 15. Relative vertical uplift of blocks formed in the cracked unreinforced concrete slab at the Kickapoo Trail site.

(Fig. 14). The torsional movement also induced a permanent twist in the roof structure, and a crack 21.6-cm wide along its NE edge. The relative vertical uplift of the blocks formed in the concrete slab is shown in Figure 15.

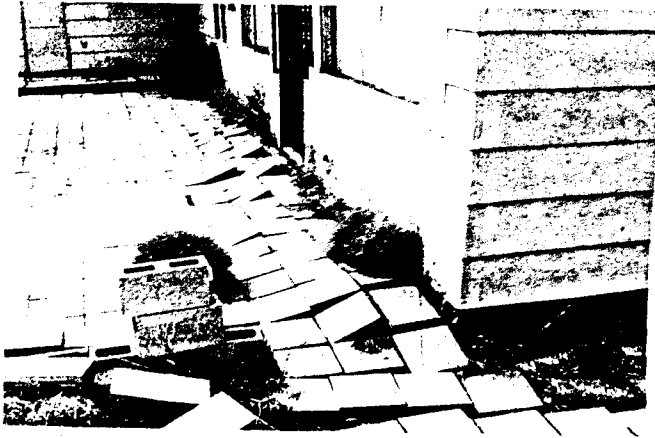
Figure 16. Ground bulging and foundation detachment produced by rotation of the structure's concrete slab.

The relative right-lateral displacement and rotation of the severed part of the slab caused the ground to bulge in the patio at the front of the house, and the foundation to become detached from the surrounding ground at the back of the house (Fig. 16). This situation indicated that passive and active zones developed on the SW and NE edges, respectively, of the concrete foundation slab. This situation can be referred to as the development of conjugate zones of principal stress, i.e., active and passive zones, in the soil. These observations are in accord with the findings by Duncan and Lefebvre (1973), who studied the field of stress induced around a rigid buried body subjected to an underlying strike-slip fault movement.

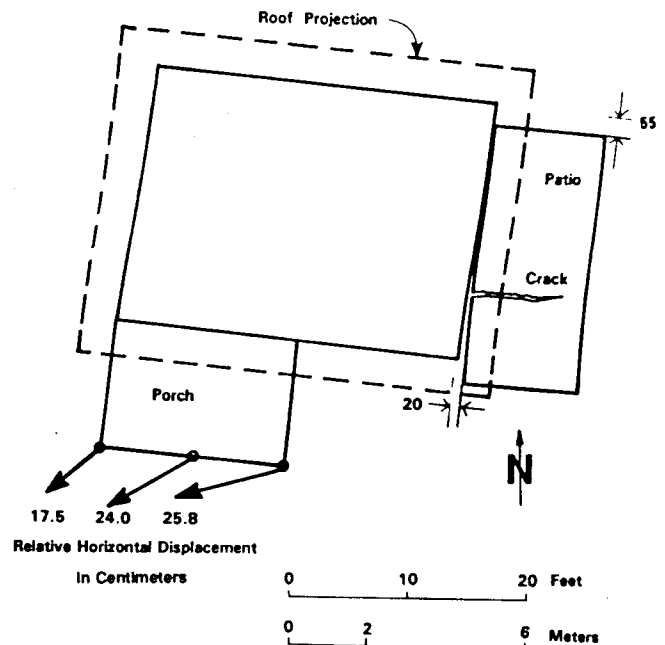
Figure 17. Schematic representation of the visible damage to the house at the Charles Road site. The relative horizontal displacement between the roof (height = 2 m) and the ground is also shown.

The distribution of fractures in the vicinity of the house indicates that, like the house at the Kickapoo Trail site, the house at Charles Road is situated within a left step between two right-lateral rupture segments. The relatively large (120 cm) right-lateral offset measured at the southern end of the property (Fig. 9) appears to have been transferred through the subparallel fractures in the ground south of the house to the more-northerly segment that passes between the house and the small building. Measurements of net displacement of posts supporting the porch roof at the south side of the house indicate that ground beneath the western half of the house moved 18 to 26 cm in a right-lateral sense relative to the ground beneath the eastern half of the house (Fig. 17). The patio slab on the eastern side of the house also moved relative to the house. There is a right-lateral offset of 55 cm between the house and the slab. The house rotated in a clockwise sense with respect to the slab so that its SE corner became separated 20 cm from the slab. It is likely that the transfer of the right-lateral displacement between the two segments of the main trace occurred immediately beneath the house. The unreinforced concrete foundation slab was twisted and broken into discrete sections by numerous fractures.
