*Written for "Safe Buildings for This Century"  
Australian Institute of Building Surveyors  
National Conference, 12 – 13 August 2002  
Darling Harbour, Sydney, Australia*

## **THE WORLD TRADE CENTER AND 9/11: A DISCUSSION ON SOME ENGINEERING DESIGN ISSUES**

Tim Wilkinson

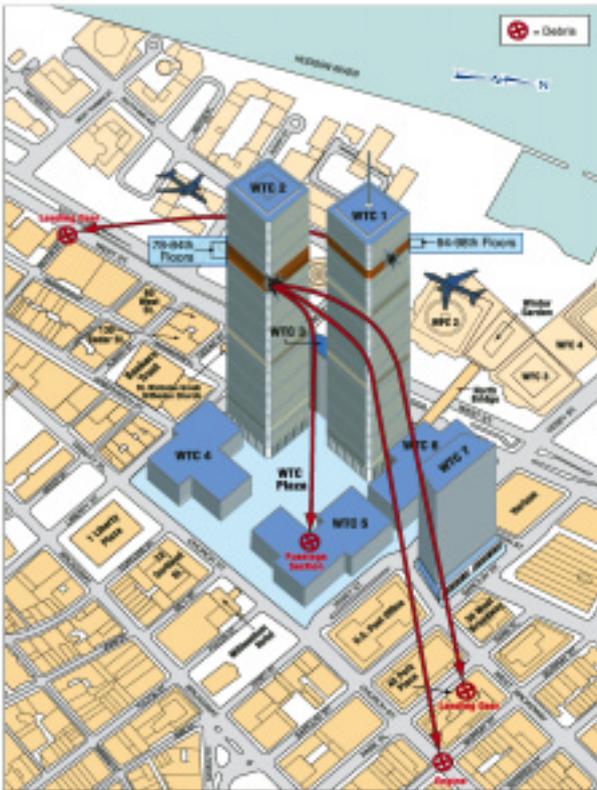
Figure 4: Representation of Impact  
(Source: FEMA report)

Readers would be well aware of the terrorist attacks on the World Trade Center on September 11, 2001. Hijacked Boeing 767s were flown directly into the towers. Figure 4 gives a representation of the impacts. No further elaboration is required.

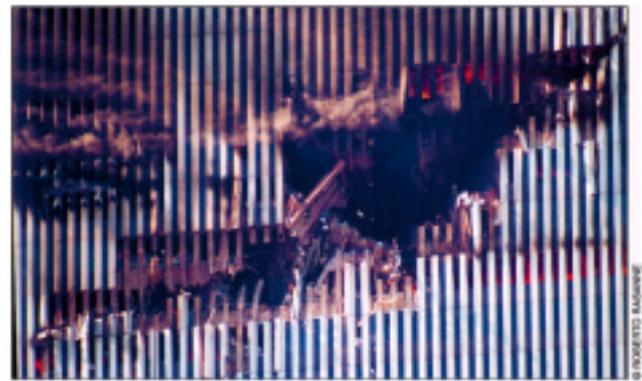
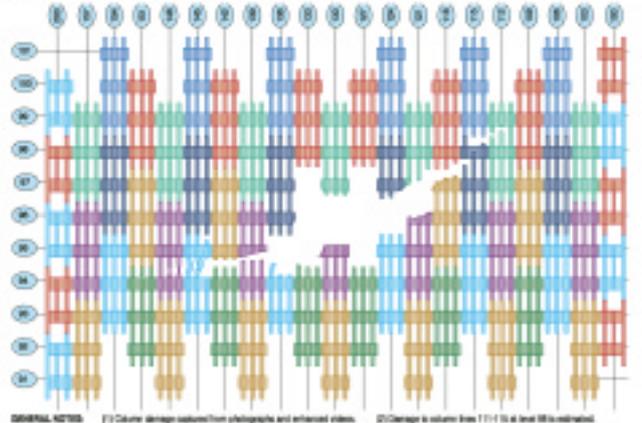
Figure 5: Damage to North Face of WTC 1  
(Source: FEMA report)

The Boeing 767-200ER has a wing span of approximately 48 m, whereas each side of the WTC towers was approximately 64 m. Each impact was roughly centred on a building face, and consequently, as shown in Figure 5, the corners of the building were relatively “unharmd”. However, several of the external columns were completely destroyed. The extent of the damage to the core is unknown. The force of the impact removed a significant amount of the fire retardant from structural elements.

Figure 2-13 Impact damage to the north face of WTC 1.

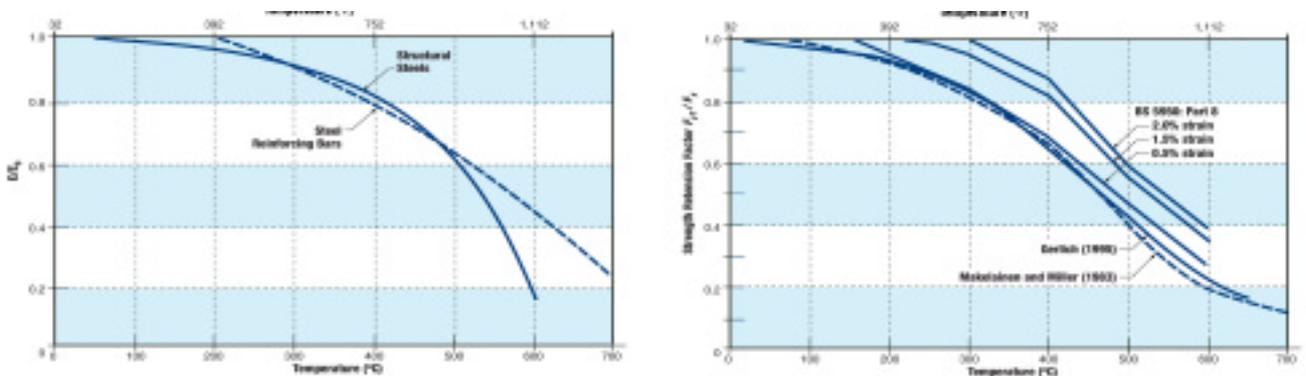
Figure 6: Effect of Fire on Elastic Modulus and Yield Stress of Steel  
(Source: FEMA report)

The mechanical properties of steel change with prolonged exposure to high temperatures as illustrated in Figure 6. After approximately 1 hour at 600°C the elastic modulus and yield strength of steel drops by approximately 50%. This implies that the remaining beams and columns in the towers around the impact zone had their strength cut in half, and the deformations of the beams would have been roughly doubled.

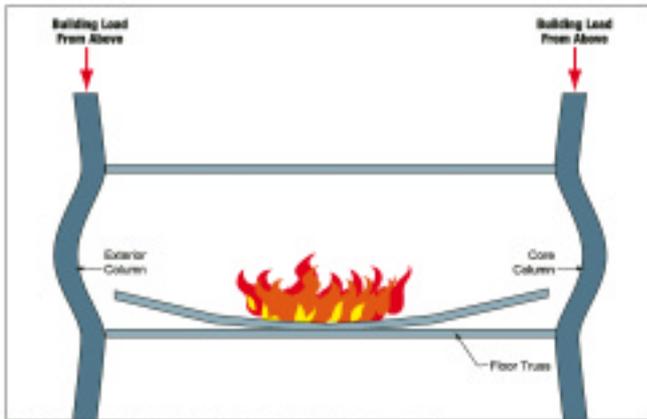
Figure 7: Possible Column Failure Mechanism  
(Source: FEMA report)

The exact mechanism that initiated failure is not known, but it is most likely that a combination of loss of strength, increased sagging, and stresses due to thermal expansion caused a failure of the joint

which connected the floor system to the external columns. This removed the restraint provided to the external columns and allowed the columns on a floor to buckle outwards as illustrated in Figure 7. Progressive collapse followed.
