# Investigation of March 15, 2018 Pedestrian Bridge Collapse at Florida International University, Miami, FL

U.S Department of Labor  
Occupational Safety and Health Administration  
Directorate of Construction

July 2019

**Report prepared by**  
**Mohammad Ayub, PE, SE**  
Director, Office of Engineering Services  
Directorate of Construction  
OSHA National Office  
Washington, D.C.

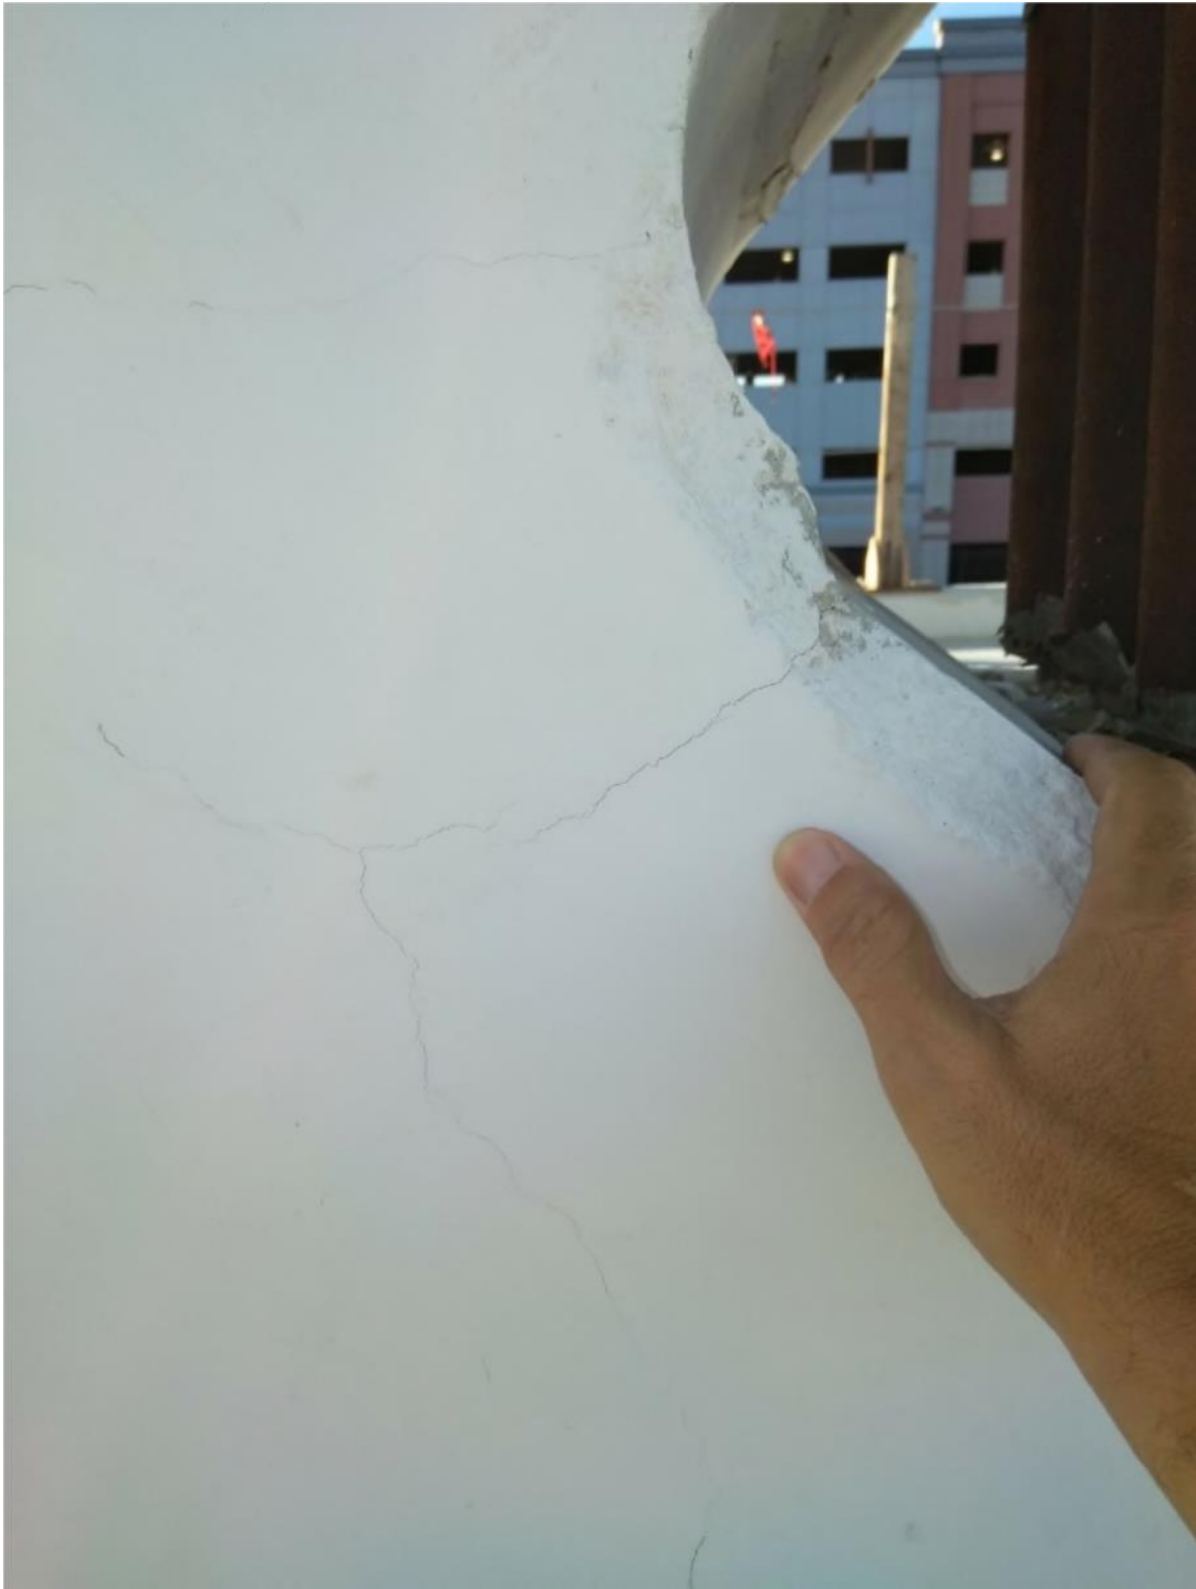
Figure 16 Photo #2 in 2/28/2018 E-mail from MCM to FIGG

Photo 2 (Figure 16): Cracks expected.

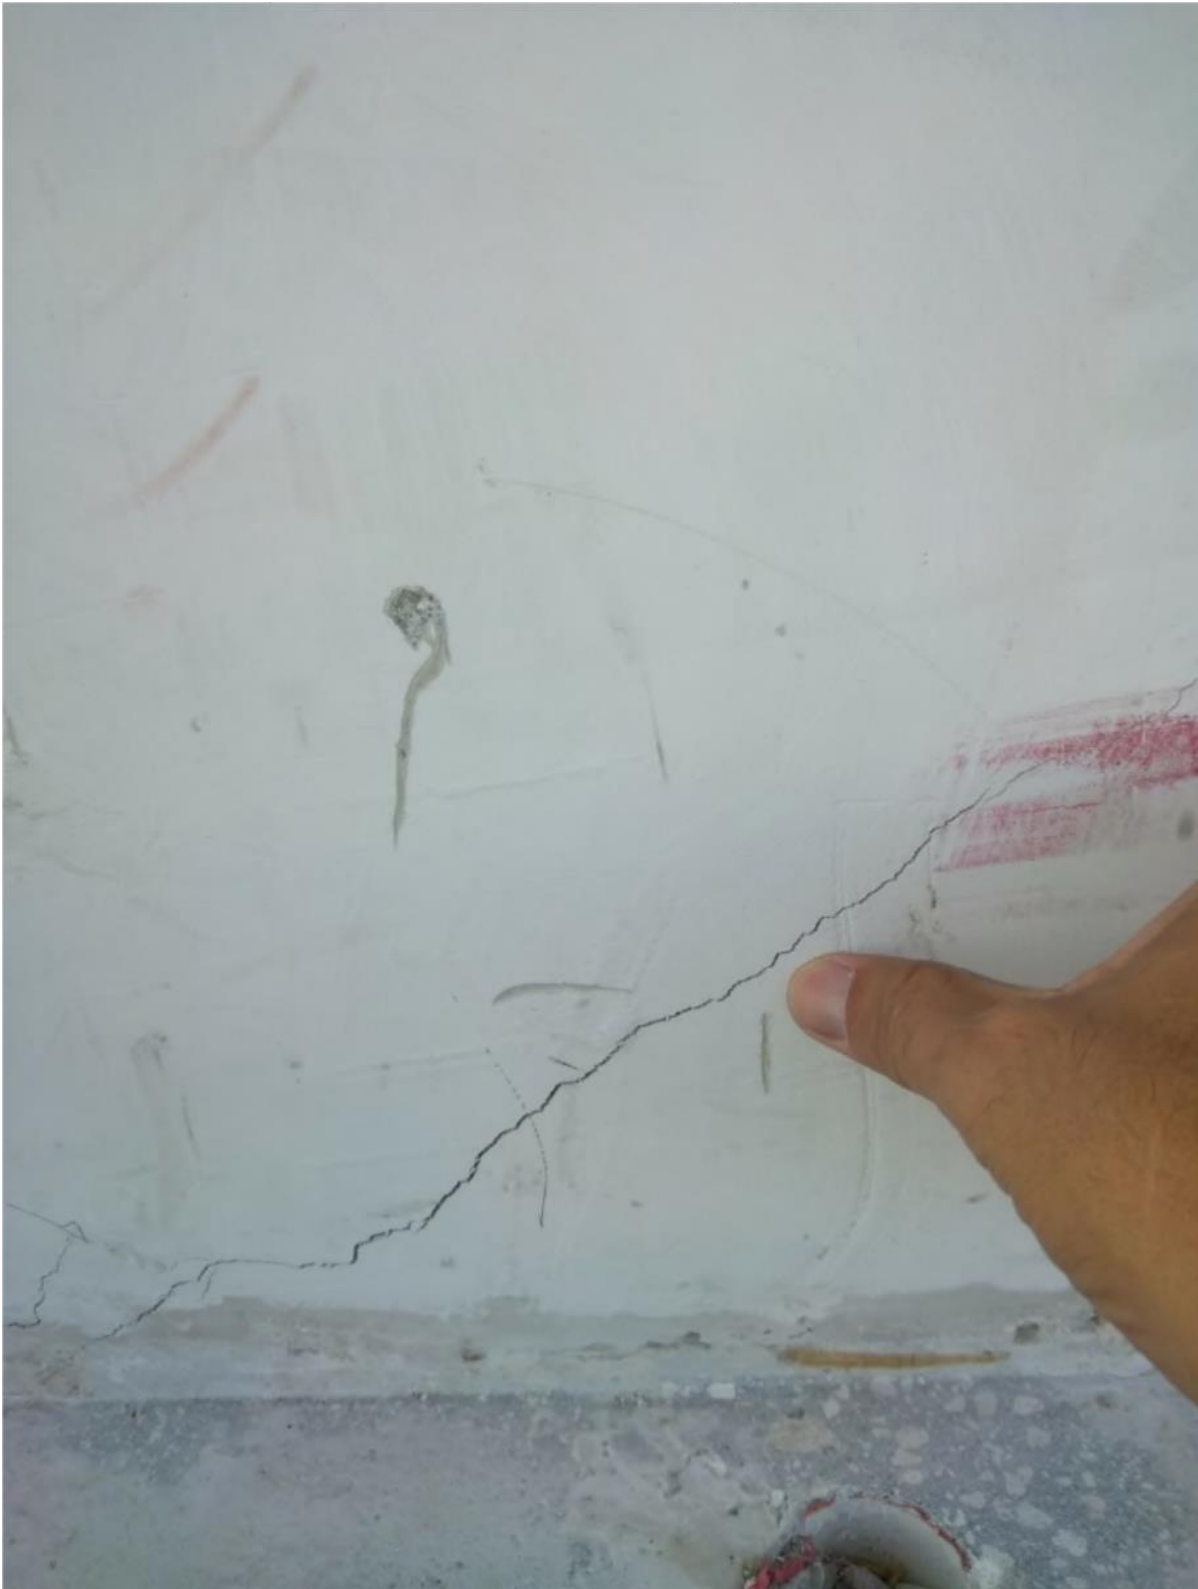
Figure 17 Photo #3 in 2/28/2018 E-mail from MCM to FIGG

Photo 3 (Figure 17): No concern.

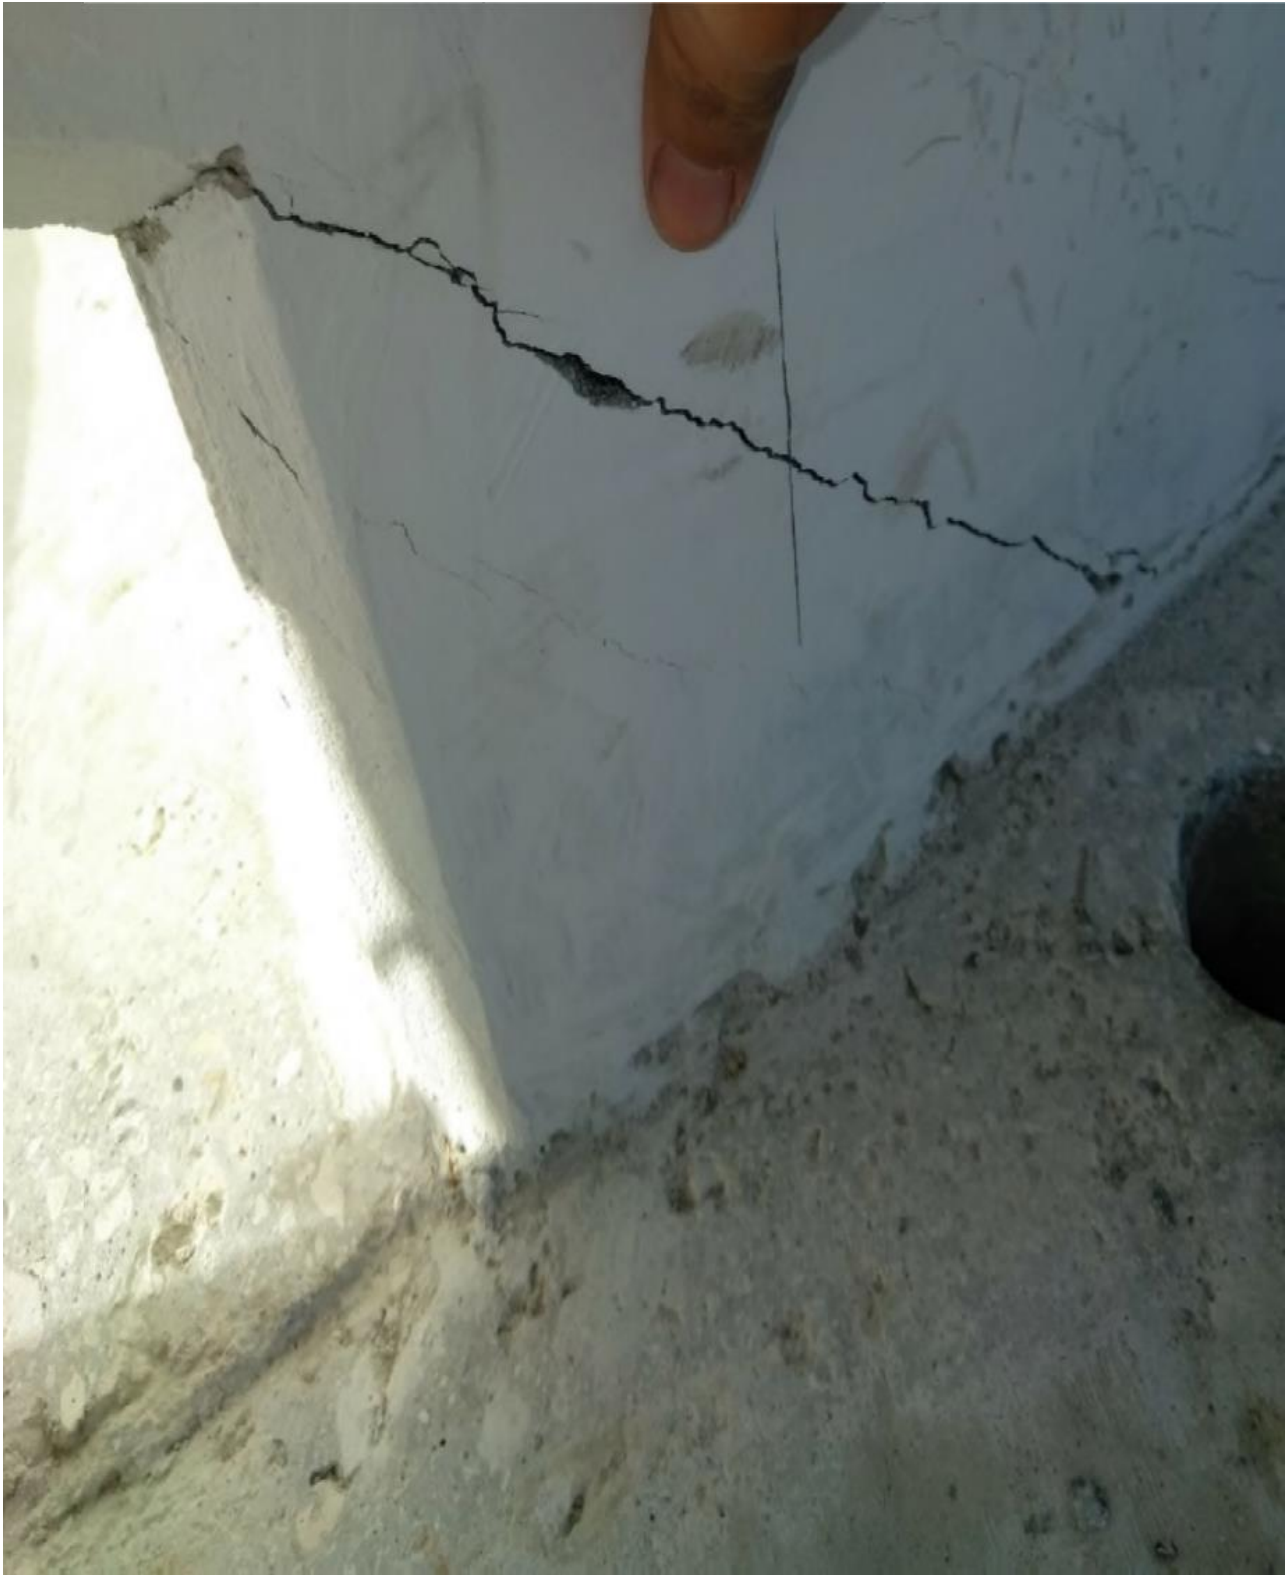
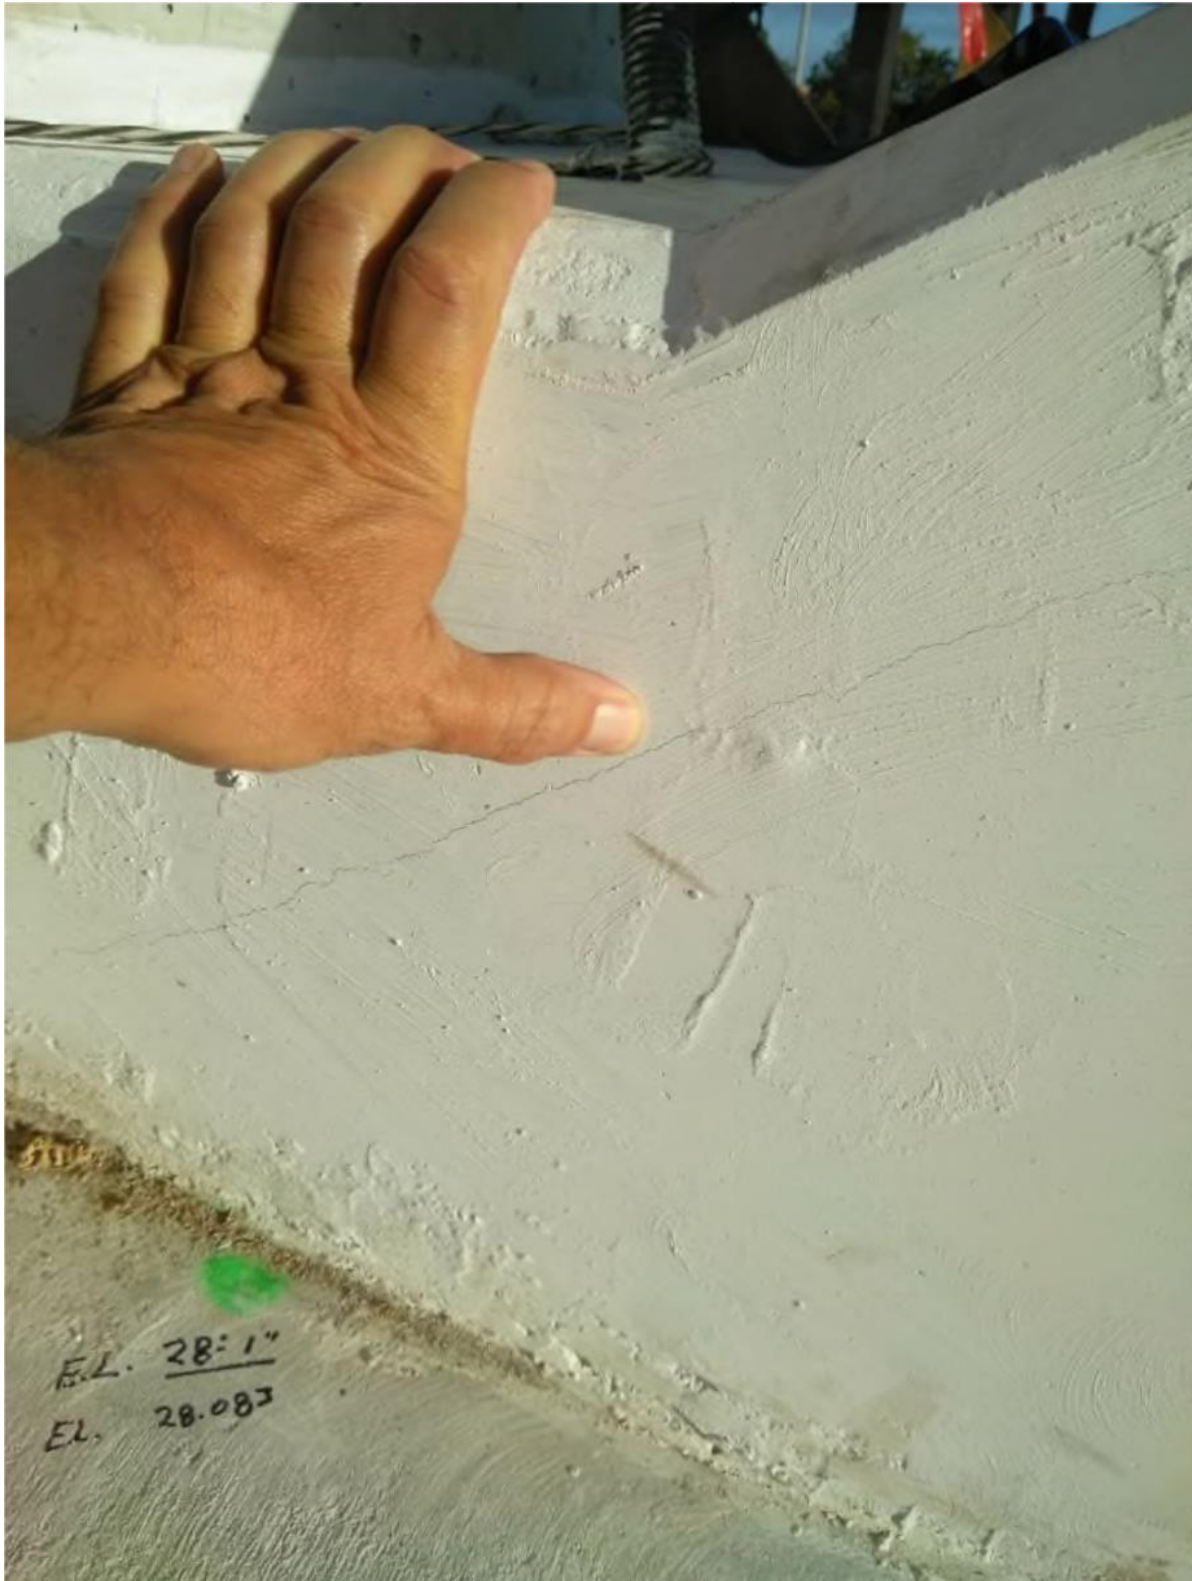
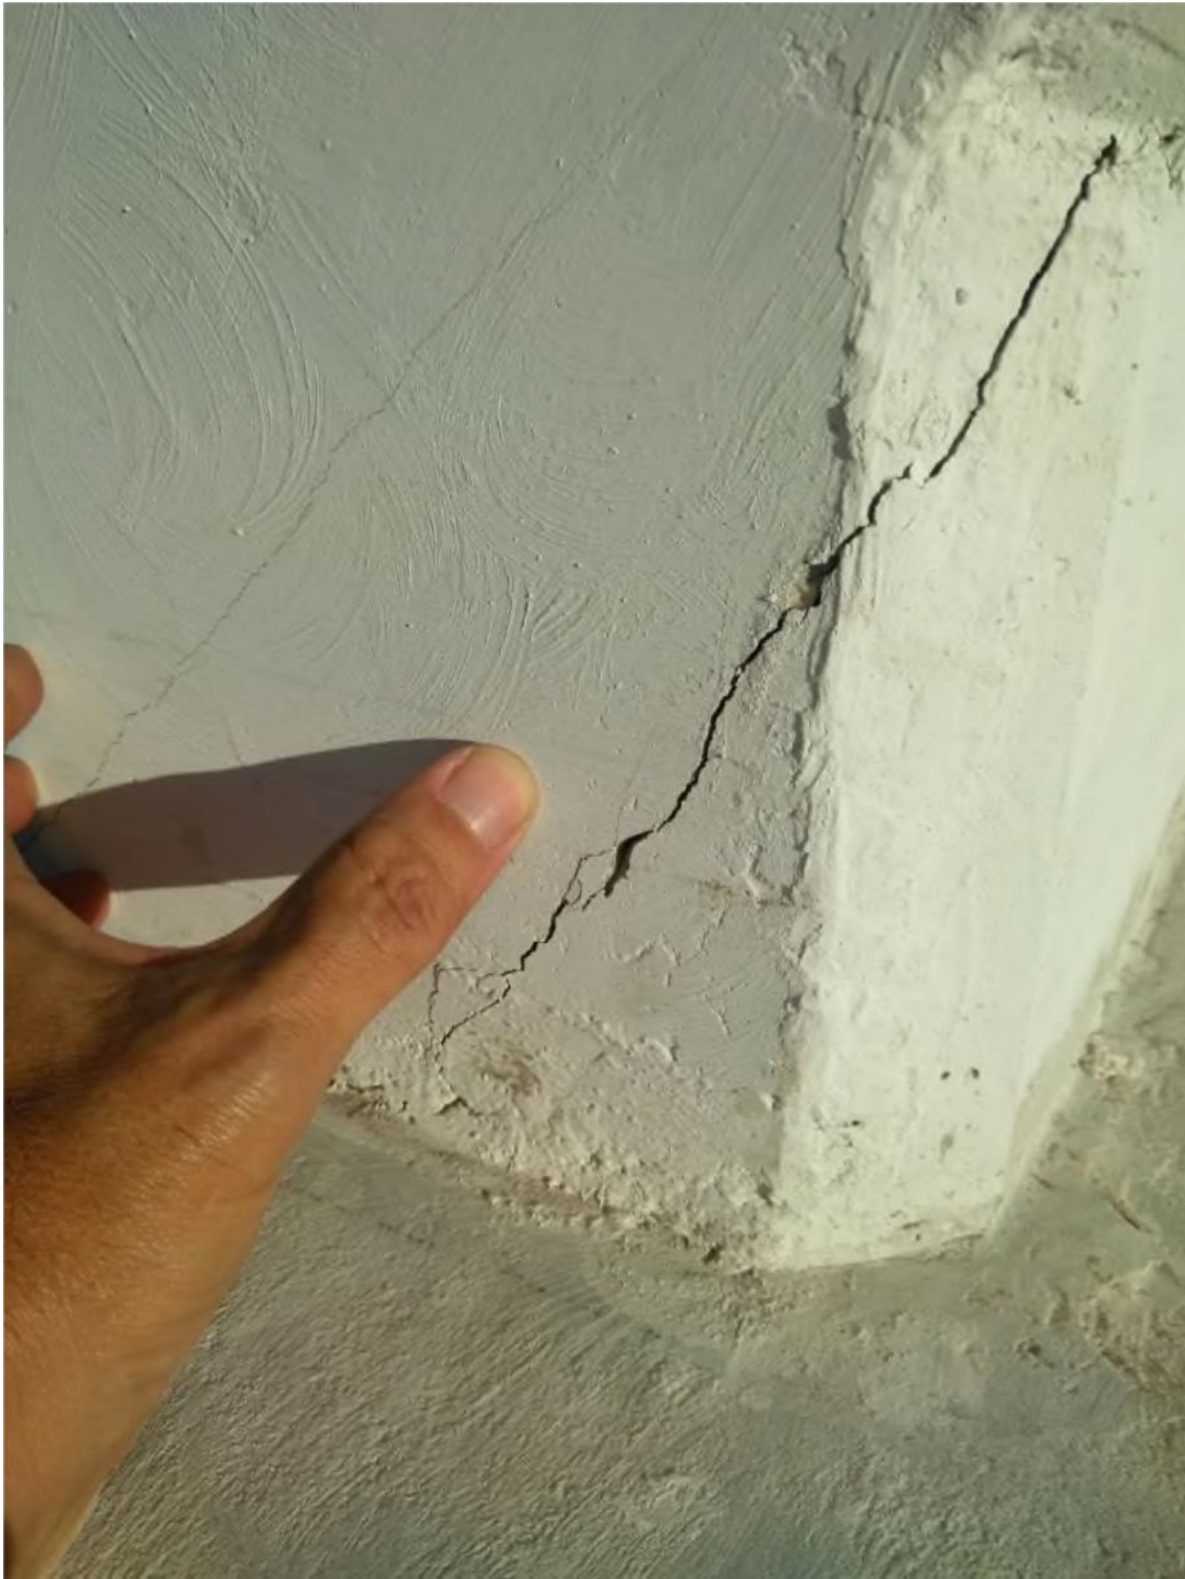
Figure 18 Photo #4 in 2/28/2018 E-mail from MCM to FIGG

Figure 19 Photo #5 in 2/28/2018 E-mail from MCM to FIGG

Figure 20 Photo #6 in 2/28/2018 E-mail from MCM to FIGG

Photos 4, 5 and 6 (Figure 18, Figure 19 and Figure 20): Cracks developed at diagonal 11 and its bottom chamfer. No concern expressed by FIGG. FIGG anticipated that “MCM will seal these cracks in accordance with FDOT Standard Specifications.” These cracks were, however, never sealed.

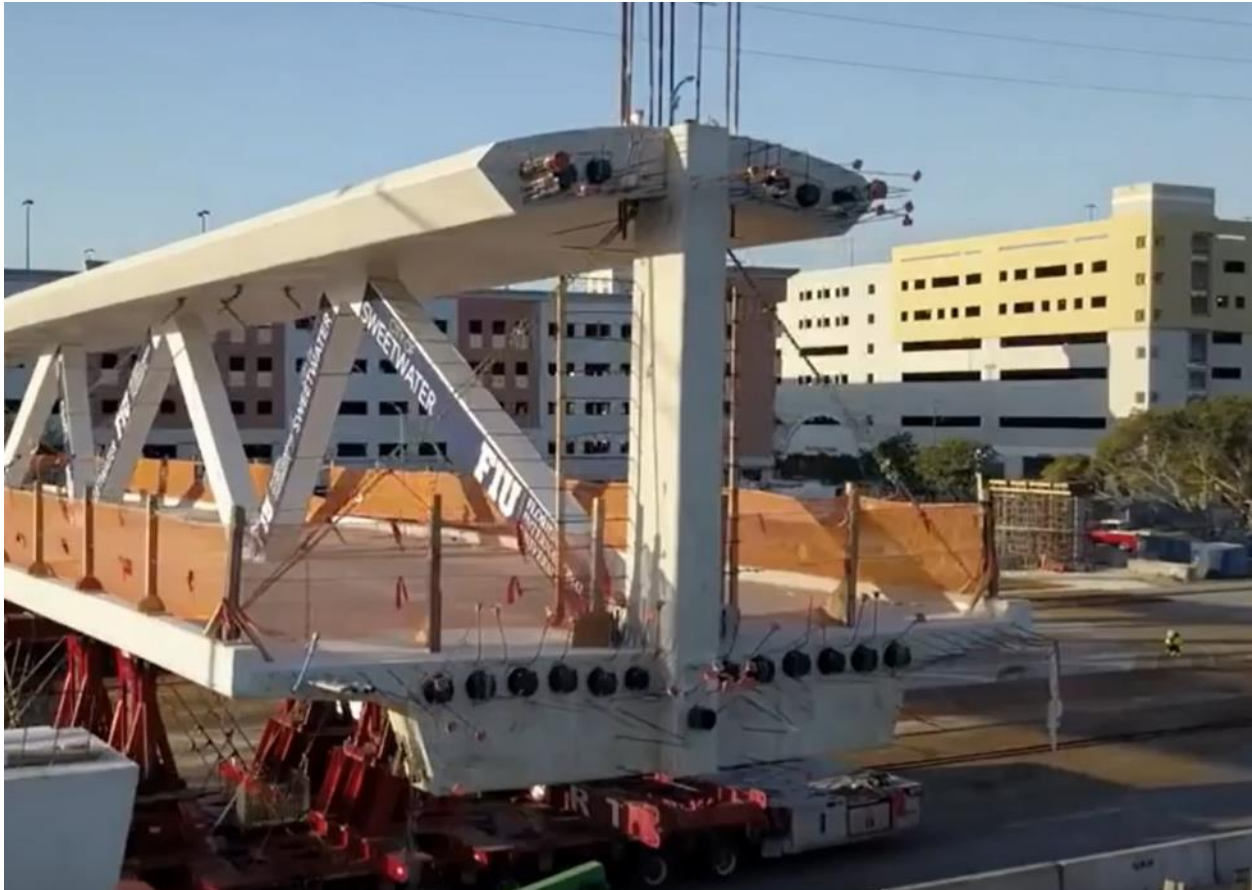
Figure 22 North end of the main span truss during transportation, generally free of cracks

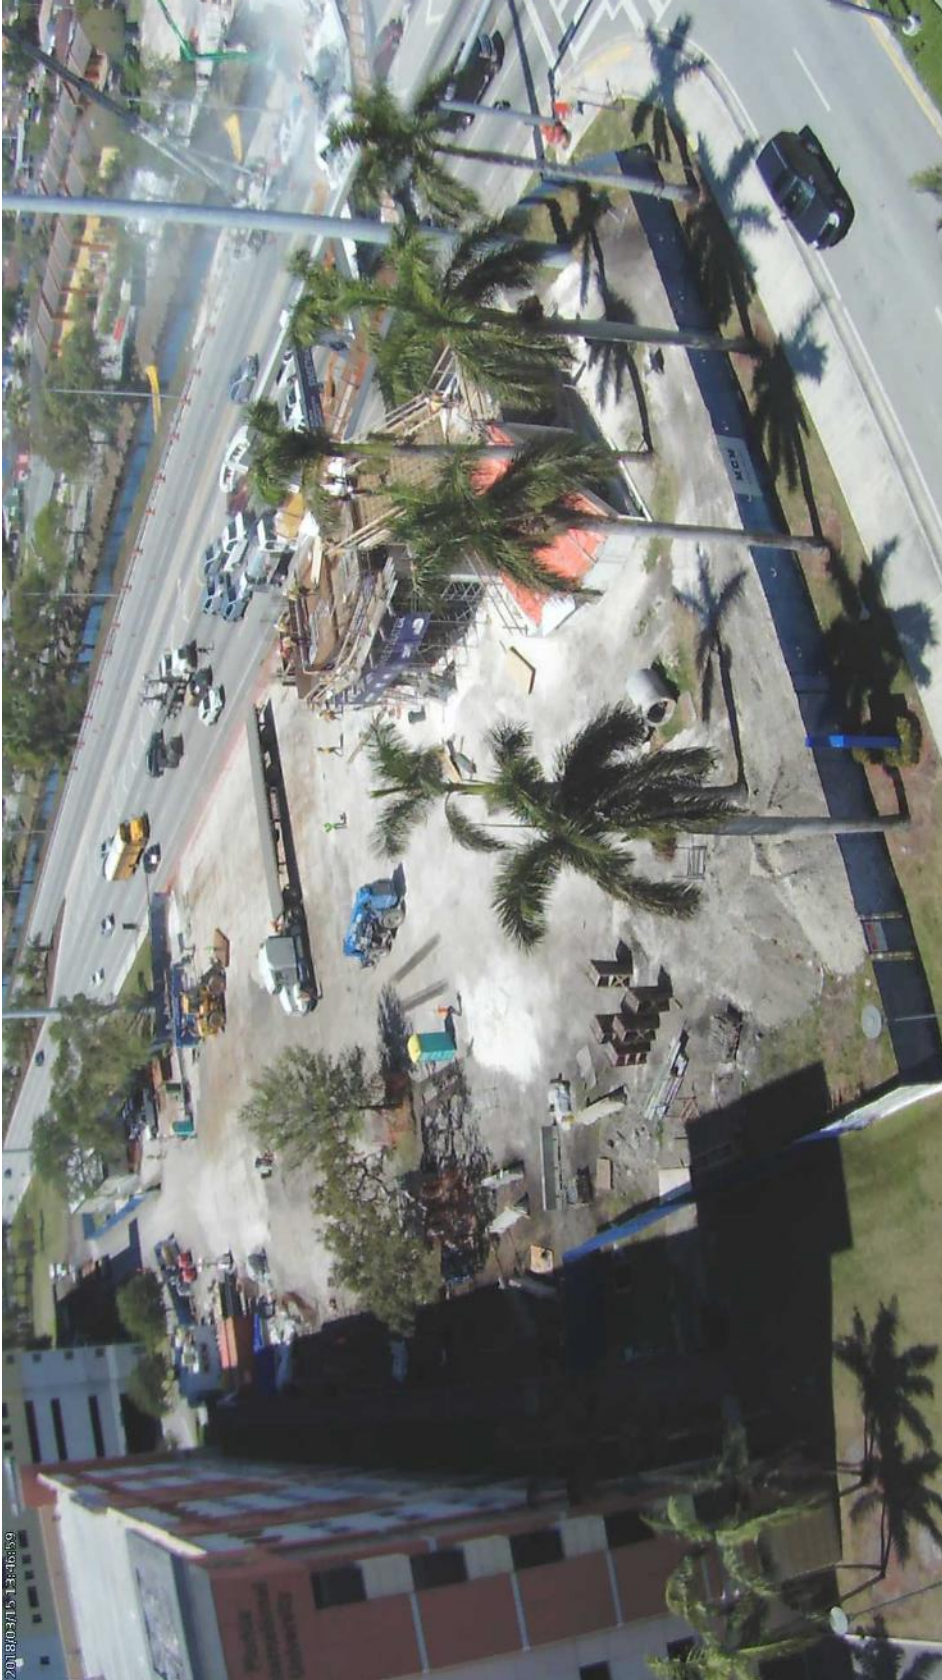
Figure 47 Bridge immediately after the collapse, March 15, 2018 – camera #1

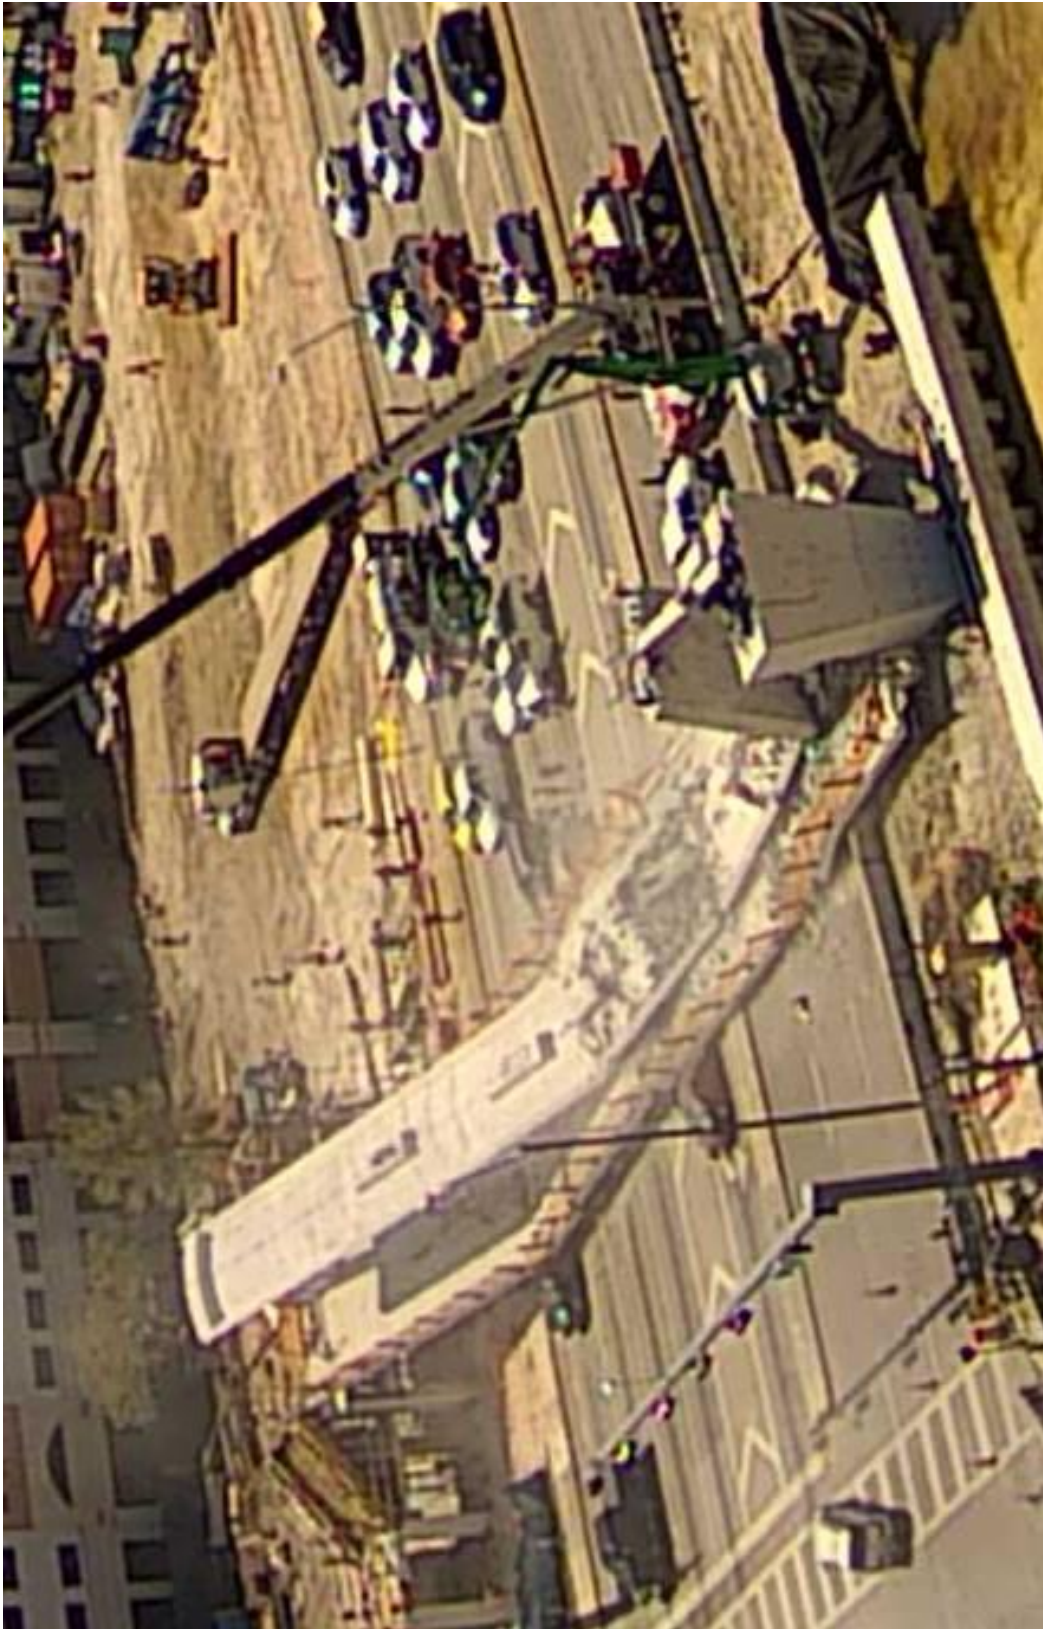
Figure 49 Bridge immediately after the collapse, March 15, 2018 – camera #2  
Employees engaged in re-tensioning the PT bars in diagonal 11

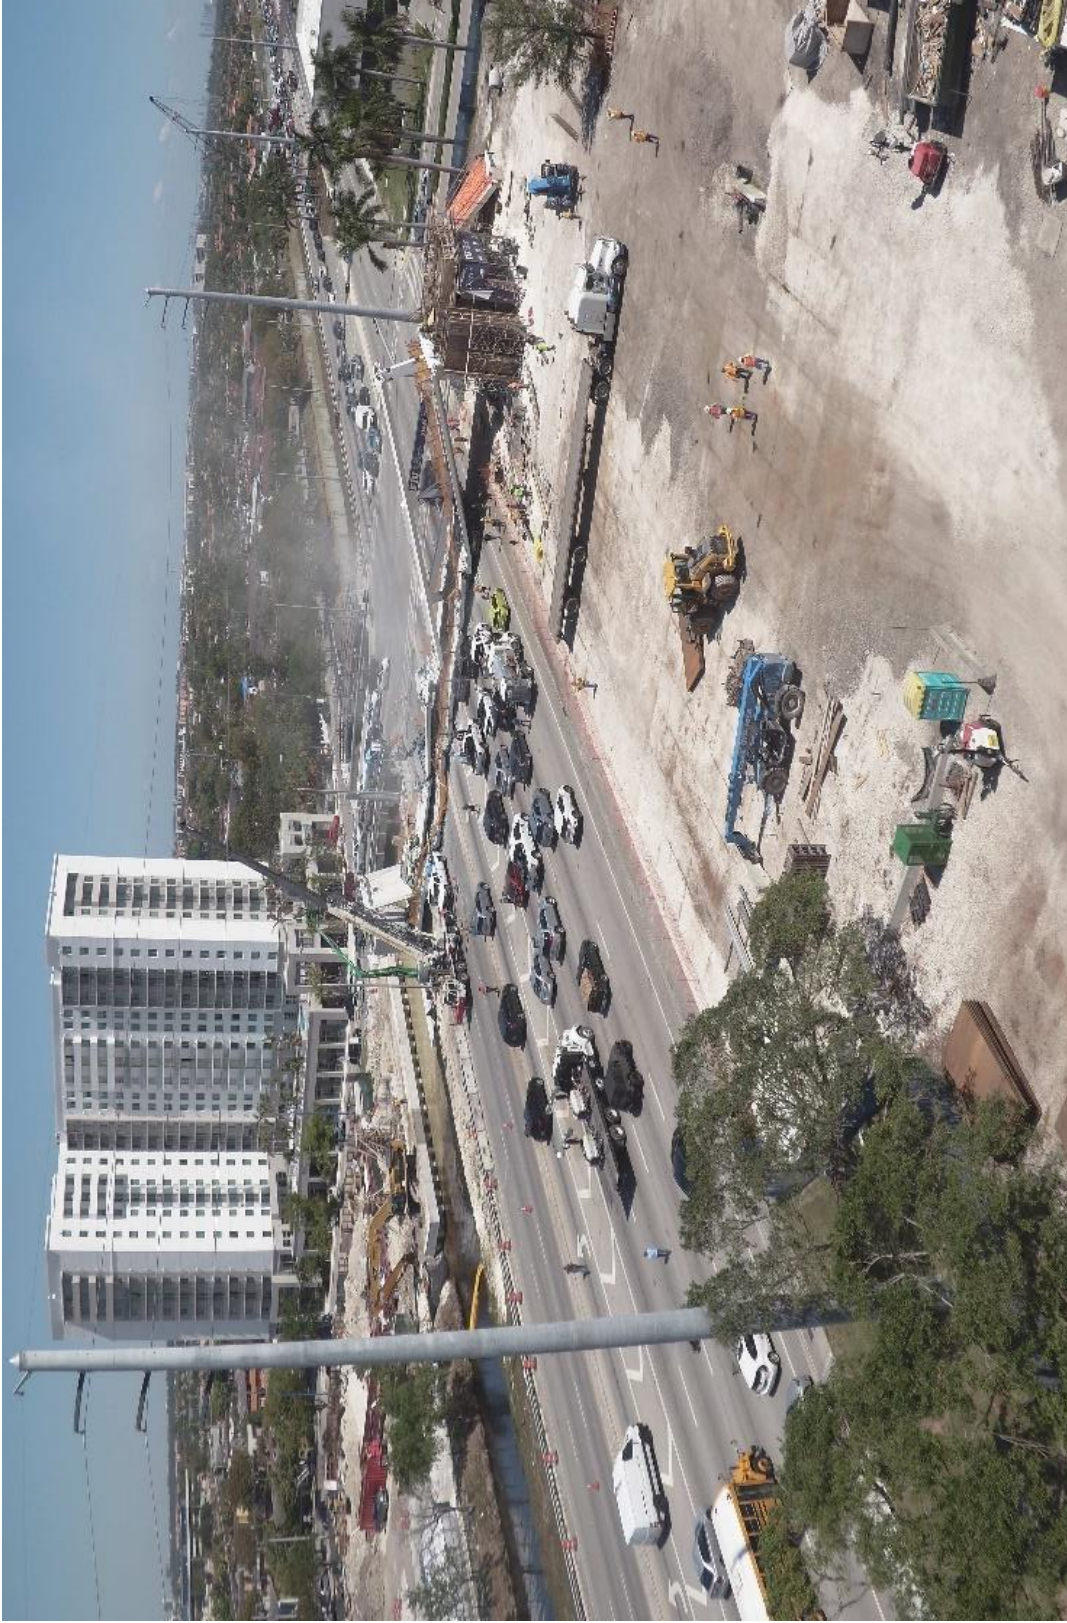
Figure 51 Bridge immediately after the collapse, March 15, 2018 – camera #3  
(north on the left and south on the right)

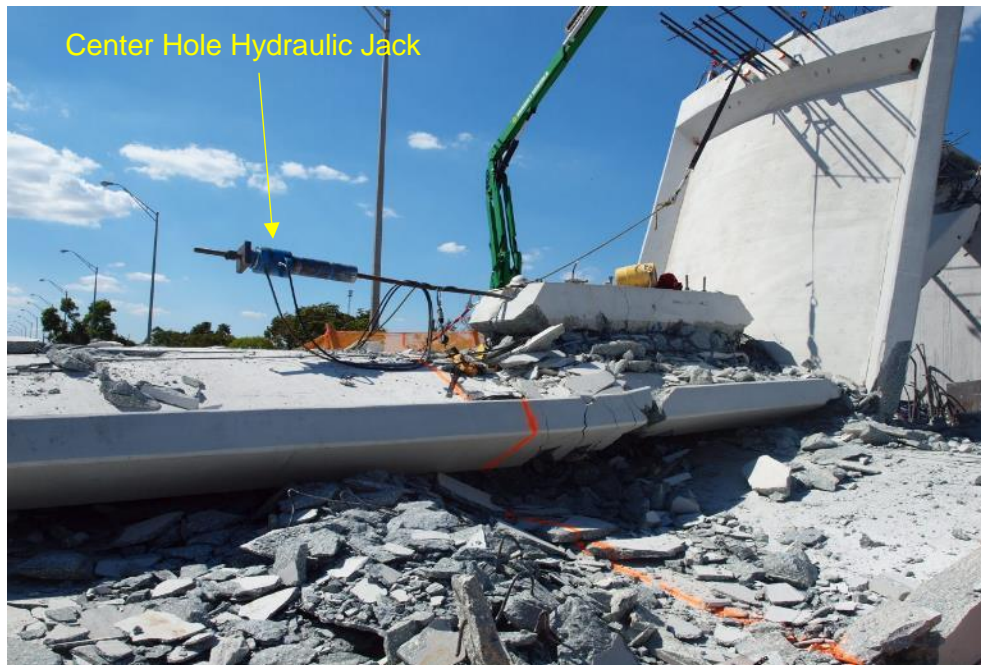
Figure 53 Northernmost blister and hydraulic jack attached to the lower PT bar of diagonal 11 after bridge collapse – side view, March 17, 2018 by OSHA

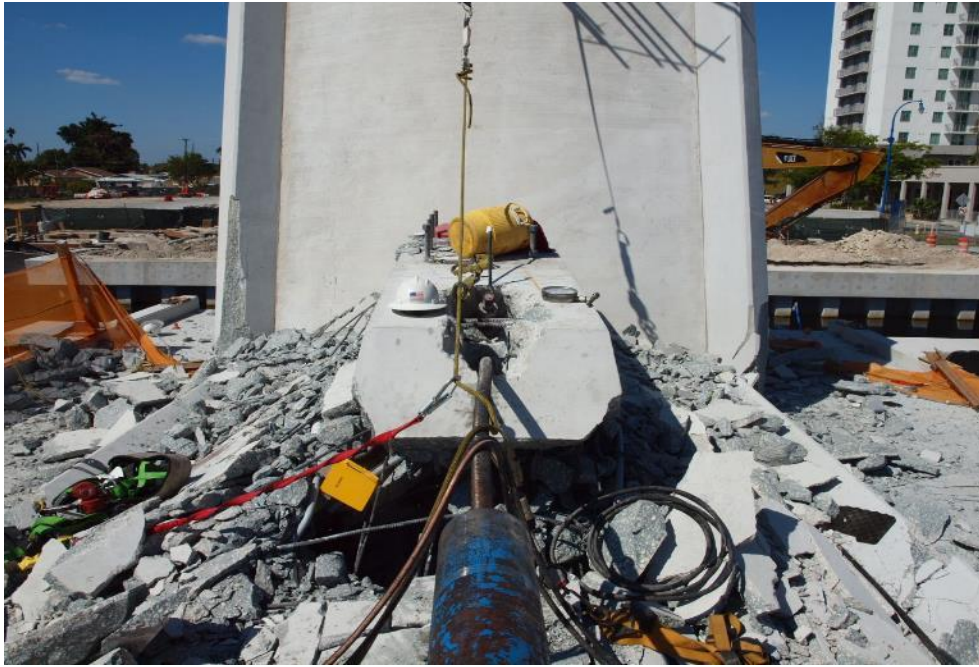
Figure 54 Northernmost blister and hydraulic jack attached to the lower PT bar of diagonal 11 after bridge collapse – front view, March 17, 2018 by OSHA

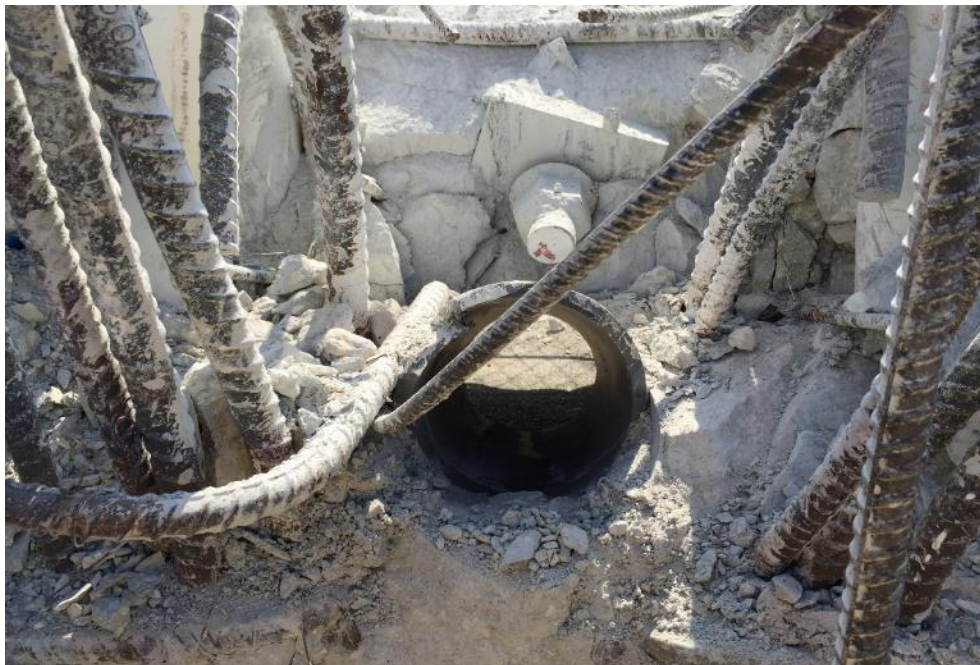
Diaphragm II experienced a blow-out of concrete at the junction of diagonal 11 and column 12 creating a hole shown below in Figure 58 through Figure 70. As a result, column 12 lost support over the pylon and failed with the top tilting approximately 80 degrees towards the south, as shown in Figure 52. The base of column 12 shifted a few feet towards the north but remained on the top of the pylon. Thereafter, collapse of the canopy, diagonal 11 and the deck followed. The canopy partially remained attached to column 12. The remaining diaphragm II and the deck fell approximately 18 ft. to the ground below, see Figure 52. One end of the diagonal 11 remained

Figure 67 Punched hole in Diaphragm II at the time of the bridge collapse – from south looking towards north, April 9, 2018, by OSHA

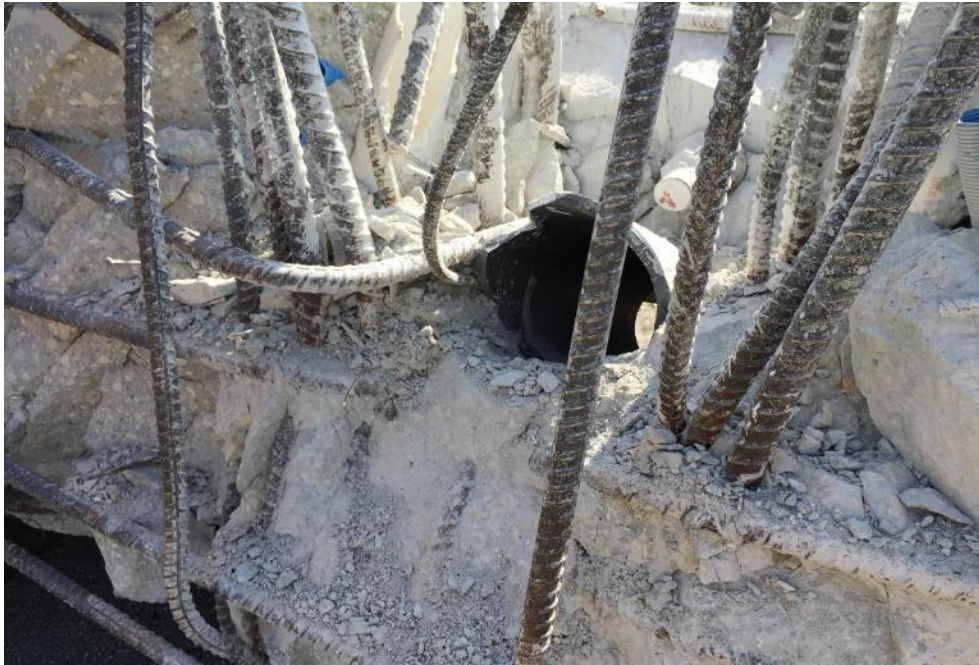
Figure 68 Punched hole in Diaphragm II at the time of the bridge collapse – from south looking towards north, April 9, 2018, by OSHA

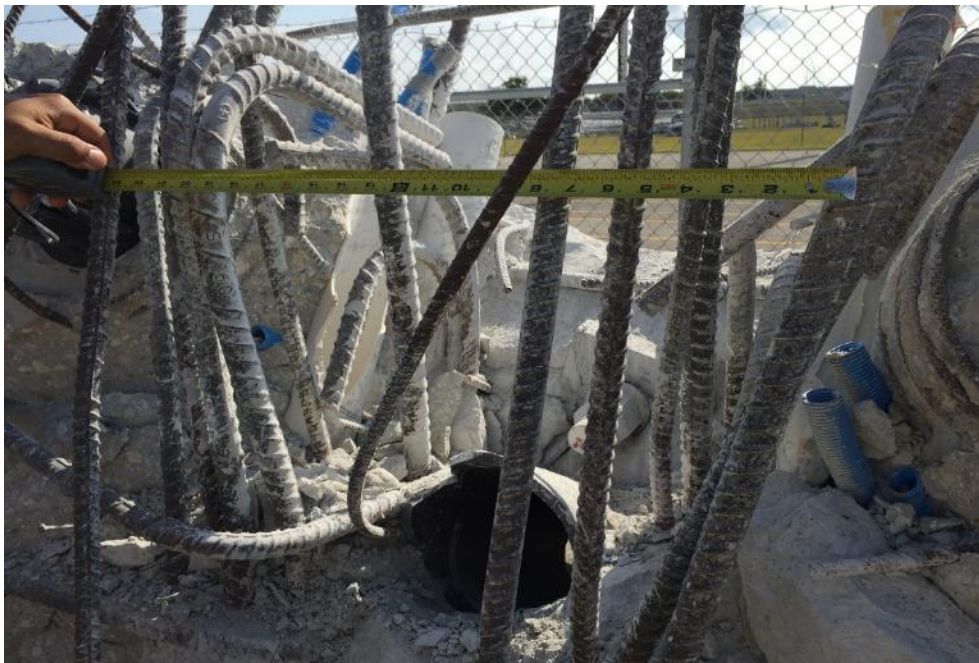
Figure 69 Punched hole in Diaphragm II at the time of the bridge collapse – from south looking towards north, April 9, 2018, by OSHA

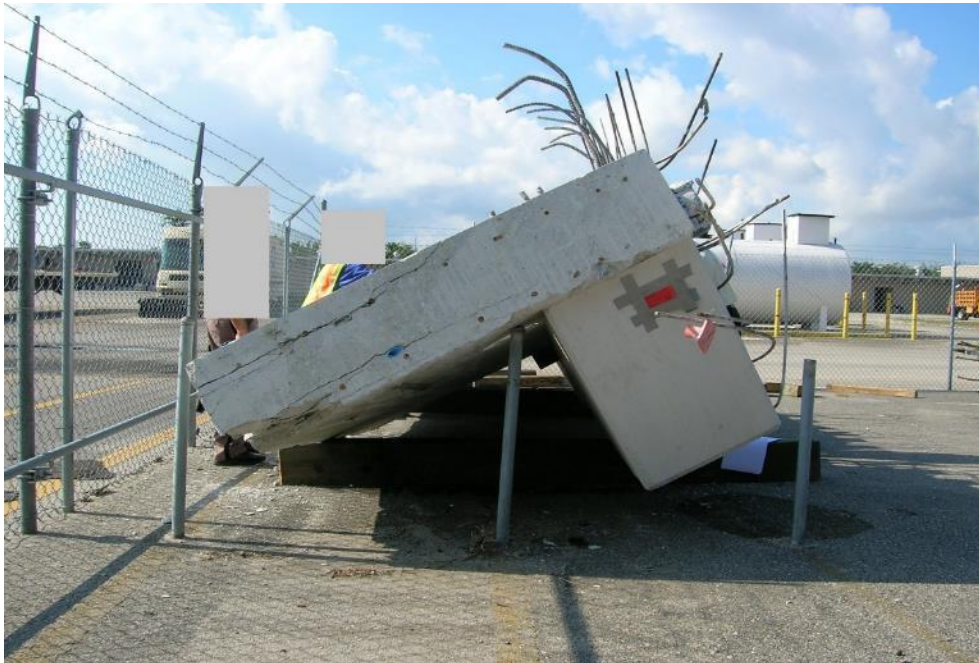
Figure 71 Side view of the saved portion of the diaphragm II in storage yard, April 9, 2018, by OSHA

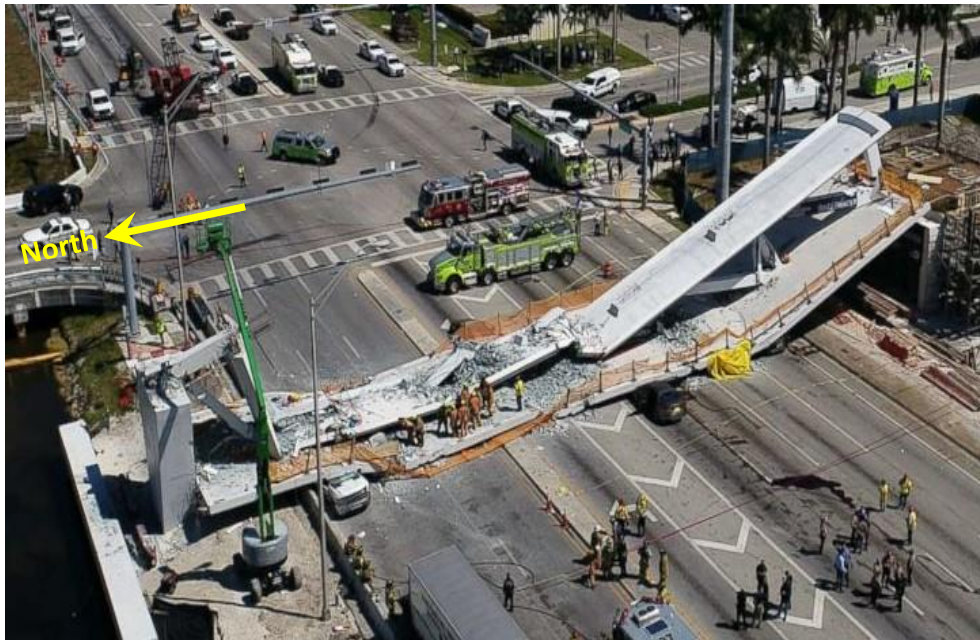
Figure 72 Aerial view of the collapsed bridge, March 15~18, 2018

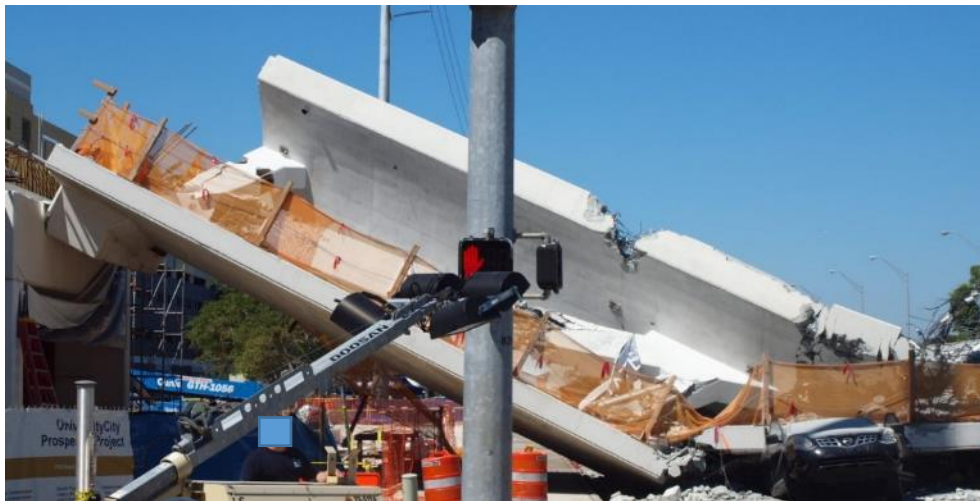
Figure 73 South end of the bridge after collapse – looking west

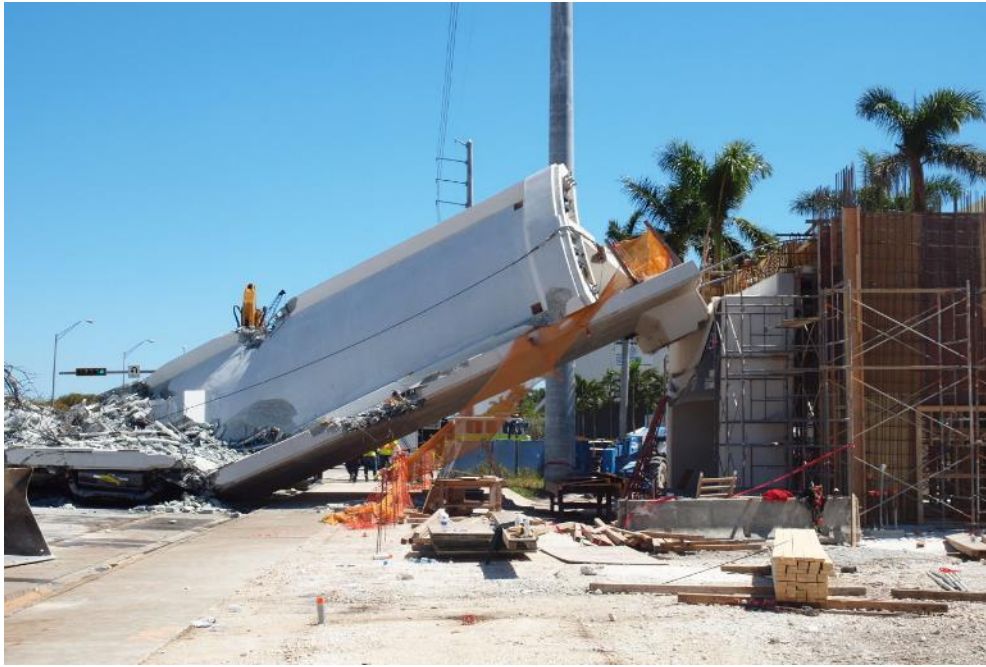
Figure 74 South end of the bridge after collapse – looking east

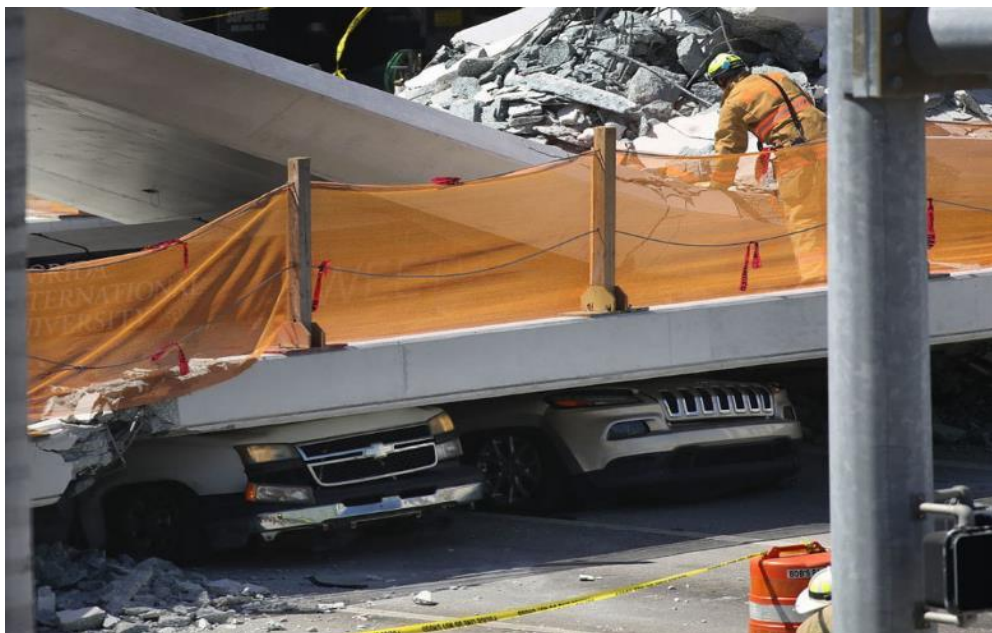
The collapse crushed five motorists in their cars that were stopped at the traffic light at the time of the collapse, see Figure 75. As stated earlier, one VSL employee was fatally injured and another VSL employee was critically injured.

Figure 75 Vehicles crushed by falling bridge
