# Investigation of March 15, 2018 Pedestrian Bridge Collapse at Florida International University, Miami, FL

U.S Department of Labor  
Occupational Safety and Health Administration  
Directorate of Construction

July 2019

**Report prepared by**  
**Mohammad Ayub, PE, SE**  
Director, Office of Engineering Services  
Directorate of Construction  
OSHA National Office  
Washington, D.C.

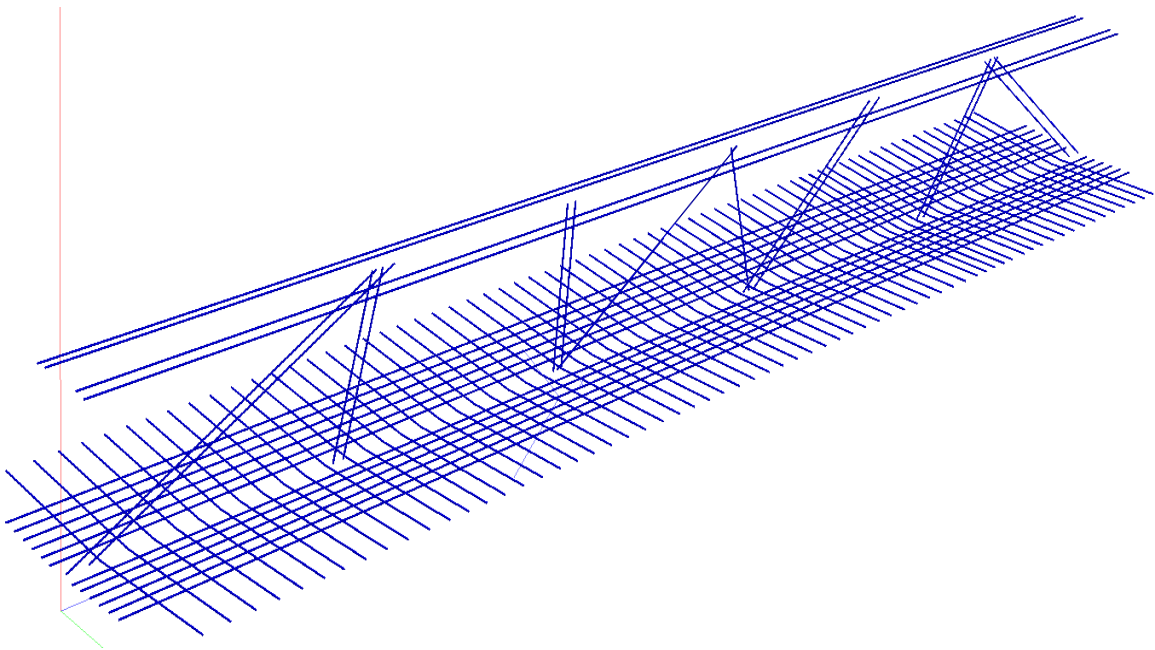
Figure 76 Overview of the main span truss system model

Three-dimensional (3D) finite element models of the main span truss system of the bridge were created in STAAD.Pro, as shown in Figure 76. All concrete components, including the canopy, the vertical and diagonal truss members (members 1 to 12), the deck, and deck diaphragms I and II, were modeled using 3D plate elements. All the steel post-tensioning tendons were modeled using truss elements by sharing the nodes with the plate elements. Therefore, the post-tensioning tendons were coupled to the concrete structures.

The plate element in STAAD.Pro is a 3-noded (triangular) or a 4-noded (quadrilateral) element to which thickness was assigned as a property. The plate element had both attribute membrane (in-plane effect) and bending (out-of-plane effect). To check whether the plate element in STAAD.Pro was valid to model 3D frame systems, verification studies had been carried out before the main span truss system was modeled using the plate elements in STAAD.Pro. Structural models of the bridge main span are shown in Figure 76.
