Surface Breakage of the 1992 Landers Earthquake and Its Effects on Structures

by Carlos A. Lazarte, Jonathan D. Bray, Arvid M. Johnson, and Robert E. Lemmer

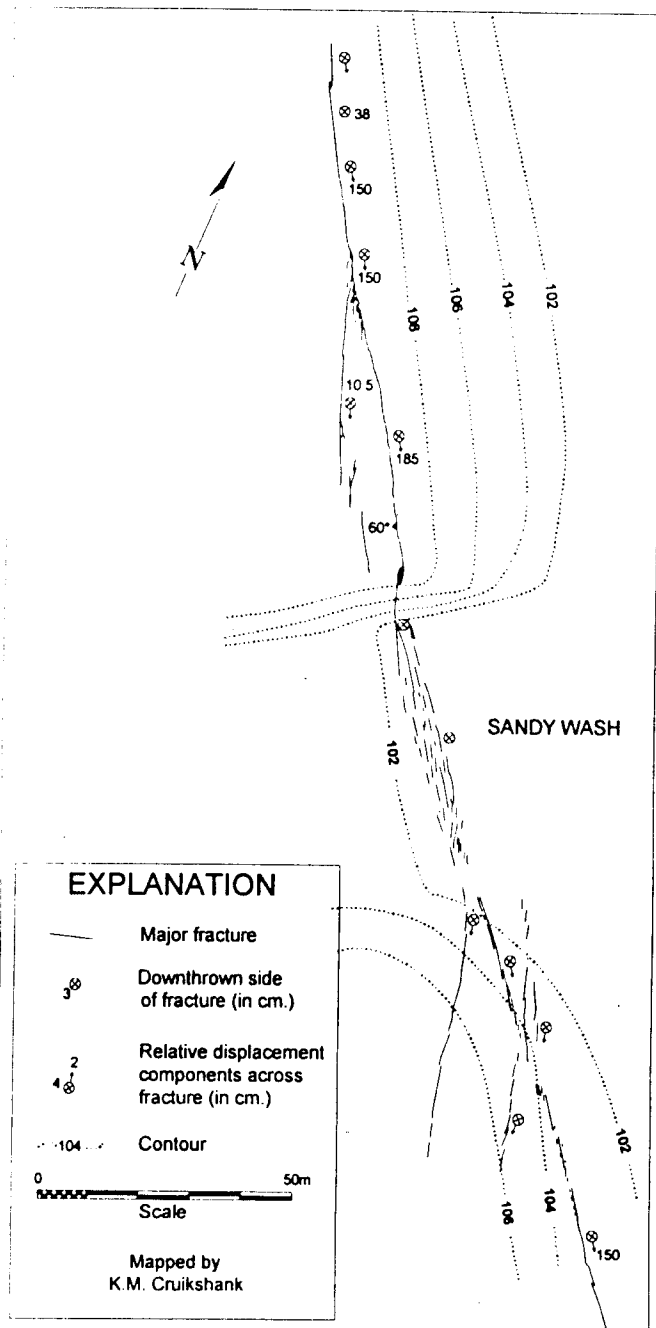
al., 1994). There appears to be a tendency for surface fracturing to be more spread out in soft alluvium than in compact alluvium and competent bedrock at Landers. A map of the main trace of the Homestead Valley fault, where it crosses a sandy alluvial wash between weathered bedrock outcrops, about 1 km north of Bodick Road, illustrates this tendency (Fig. 3). The ruptures along the main trace in weathered bedrock were restricted to shear zones about 0.5-m wide. In the alluvial material deposited over the bedrock, the rupture zone was about 5-m

Figure 3. Surface expression of the main trace of the Homestead Valley fault as it crossed an alluvial wash located between weathered bedrock outcrops.

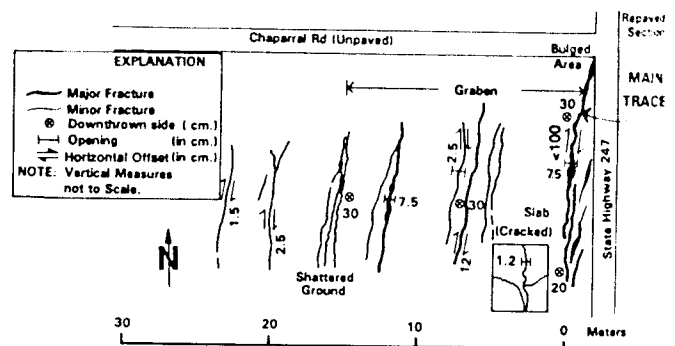
The main trace of the Johnson Valley fault zone at the Chaparral site (Fig. 1, site B) traverses State Road 247 at 5° to 10° clockwise (Fig. 5). The main trace occupies a width of about 2 m and consists of a series of en-echelon fractures generally stepping left. The amount

Figure 5. Distribution of ground rupture across a segment of the Johnson Valley fault at the Chaparral site.

of right-lateral displacement could not be measured precisely here, but it is less than 1 m. Adjacent to the repaved section of State Road 247, an area of bulging and shattered ground develops along the main trace. A few meters south of the bulged area, the main trace has a

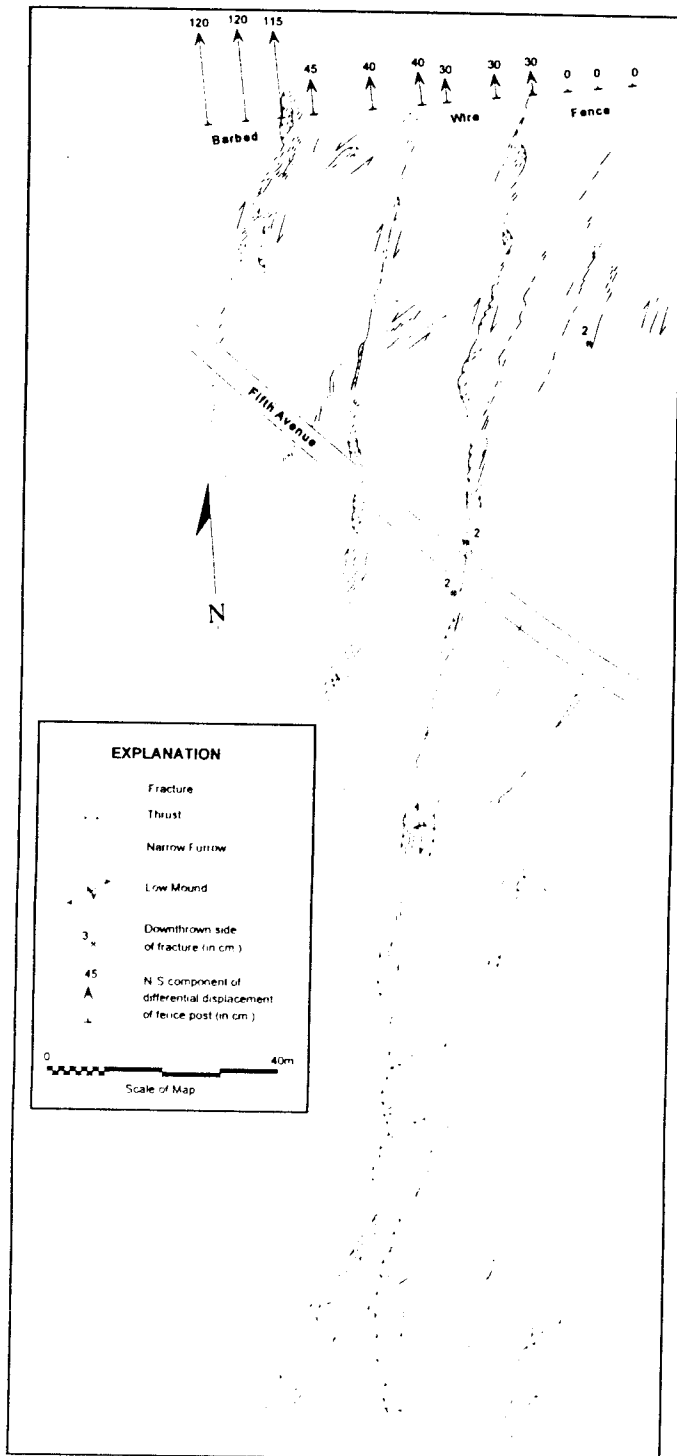
Figure 7. Detailed map of en-echelon shear zones in Kickapoo step-over, immediately east of intersection of Fifth Avenue and Kickapoo Trail. Map shows a nearly complete, long shear zone on right, a complete, short shear zone in middle, and the south end of a long shear zone on left. The latter offsets the fence line about 0.7 m, a large fraction of the 1.2 m of offset for the entire en-echelon belt of shear zones.

of the Kickapoo and Johnson Valley faults (Fig. 6). At the smaller scale, intense ground fracturing in transfer areas was also damaging (Fig. 7). Two heavily damaged structures (which will be described later) were located where significant lateral transfer took place.

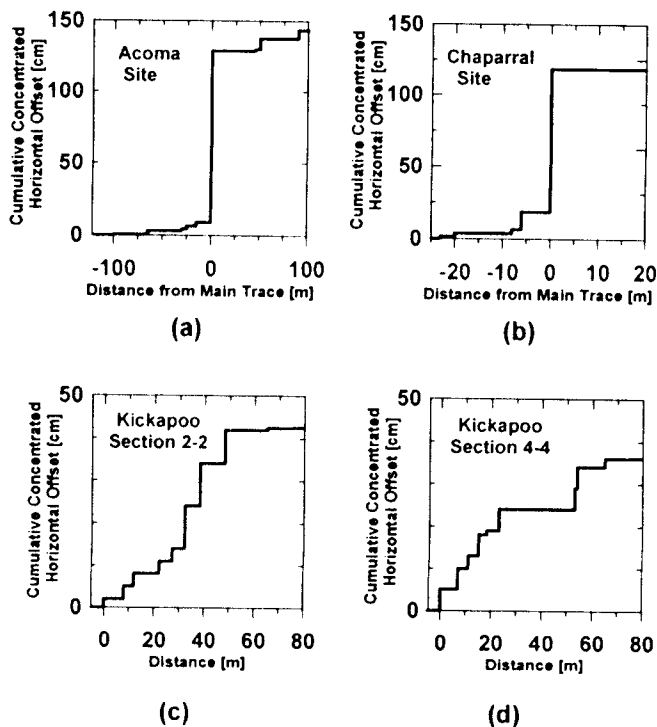
Figure 11. Cumulative concentrated right-lateral horizontal offset across selected fault zones: (a) Acoma site, (b) Chaparral site, (c) section 2-2 at the Kickapoo Trail site, and (d) section 4-4 at the Kickapoo Trail site.

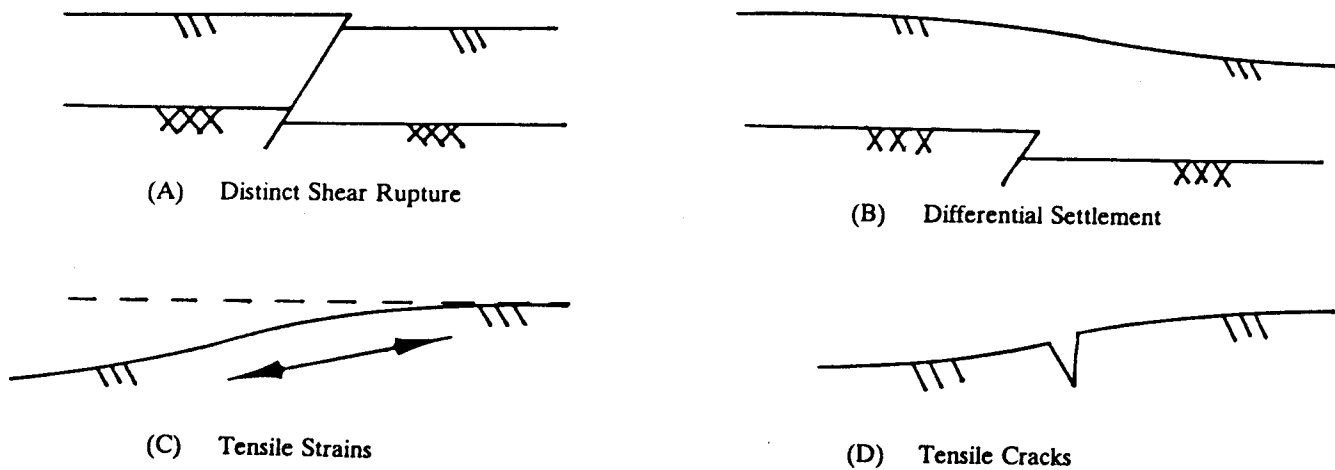
The principal surficial hazards of earthquake fault rupture are as follows (Fig. 19):

Figure 19. Principal surficial hazards of earthquake fault rupture (2D dip-slip fault movement shown for clarity).

There are three principal means of mitigating the potential hazards associated with earthquake fault rupture: avoidance, geotechnical engineering, and structural engineering. The success of each of these methods depends, first and foremost, on proper interpretation of the geology on regional and project level scales. Although the profession requires continual enhancement of its understanding of the complex fault rupture phenomenon, sound judgment, coupled with reasonable interpretations of surficial geology and crack propagation theory, can be applied to develop earthquake-resistant designs without resorting to arbitrary, specified setback criteria. More realistic criteria can be established on a project/site-specific basis (e.g., Bray *et al.*, 1993). Once detailed studies of the geology and local site conditions (soil and topography) are completed, a combination of the methods described below may be employed to reduce damage resulting from surface rupturing.

The first method is avoidance. All structures and lifelines may be deliberately positioned to avoid crossing identified shear rupture zones. Obviously, this method's success depends on identifying all likely rupture zones, and on the characteristics of the next earthquake complying with our expectations. The 1992 Landers earthquake provides numerous examples of our imperfect understanding, and shows that some movement should be

anticipated throughout fault zones. For example, Hart *et al.* (1993) noted that 45% of all 1992 Landers earthquake surface ruptures fell outside established A-P Special Studies Zones that delineate "approximately wide . . . zones to encompass all potentially and recently active [fault] traces." In another study of over 1200 active faults strands exposed in fault trenches, Bonilla and Lienkaemper (1991) found that about 45% of these strands either appeared to die out, or actually did die out, even though surface faulting was known to have occurred recently. They concluded that a fault strand overlain by an apparently undisturbed deposit is not necessarily older than the deposit.
